ASSESSMENT OF A STEP-POOL URBAN STREAM RESTORATION:
SAN PEDRO CREEK, PACIFICA, CALIFORNIA

A thesis submitted to the faculty of
San Francisco State University
In partial fulfillment of
The requirements for
The degree

Master of Arts
In
Geography

Marilyn Hope Smulyan
San Francisco, California

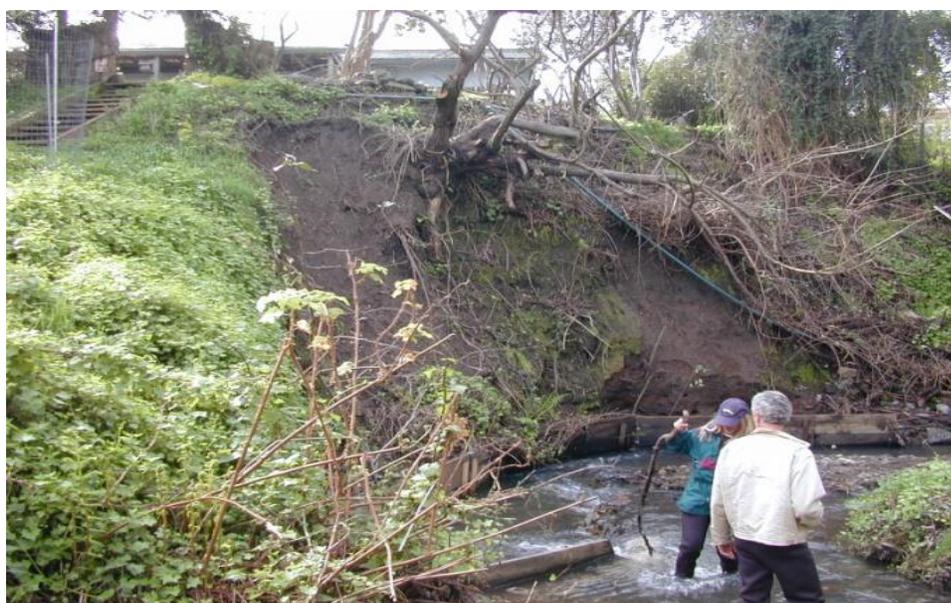
floodplain in parts of the creek (Collins et al. 2001). Incision also initiated at the Capistrano Bridge culvert (Davis et al. 2002). The concrete culvert acted like a knickpoint, an abrupt change in a stream profile formed by a more resistant surface which prevented the stream from eroding back. The first fish ladder was installed in 1965 and the second in the late 1980s (Lee 2003). By the late 1990s, overall incision had reached 5 m (15 ft), creating a 3.6 m (12 ft) jump from the creek to the culvert. The fish could no longer get up the ladder, creating a barrier to fish passage for threatened steelhead trout (Davis et al. 2002). Bridge incision, and related downstream bank failure, are evident in Photos 1 and 2. In 2001, NOAA Marine Fisheries issued a letter warning the City of Pacifica of a potential violation of the 4(d) rule of the US Endangered Species Act of 1973, as amended, and a temporary weir was installed to improve fish passage. The Capistrano Bridge was temporarily closed in 2002, and repairs were made to undercuts that were ~ 3 m (10 feet) deep on each side.

Photo 2: Bank erosion below Capistrano Bridge 2004.
Photo courtesy of San Pedro Creek Watershed Coalition.

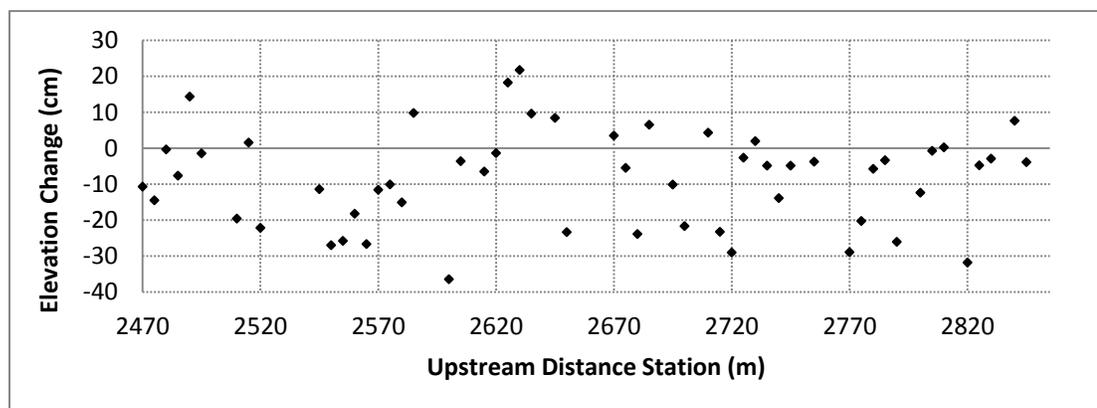
The longitudinal profile suggests (Figure 6), and interpolated data from the two matched datasets (Figure 7) confirms that, while aggradation occurred in some places within the reach, degradation has occurred throughout most of it. When the data was interpolated, 21 of the 79 matched points required crossing steps to calculate the interpolation so they were rejected. Therefore, the results are slightly more reflective of areas further away from the steps than close to them. The mean elevation change between 2008 and 2011 was -8.5 cm (-0.28 ft) with an average annual rate of change of -2.8 cm (-0.9 ft). According to the survey data, the most degradation occurred in two pools, both located immediately above log steps; -40 cm (-1.3 ft) above Log Weir 4 and -30 cm (-1.0 ft) above Log Weir 2. Correlation between elevation change and distance station was tested and rejected using Spearman's test. The correlation coefficient was 0.008 and the single-tailed p-value of 0.478 was greater than 0.05; therefore, it is not significant at a 95% confidence level.

Figure 7: Restoration Reach interpolated elevation change 2008-2011. Datasets matched and interpolated every 5 m.

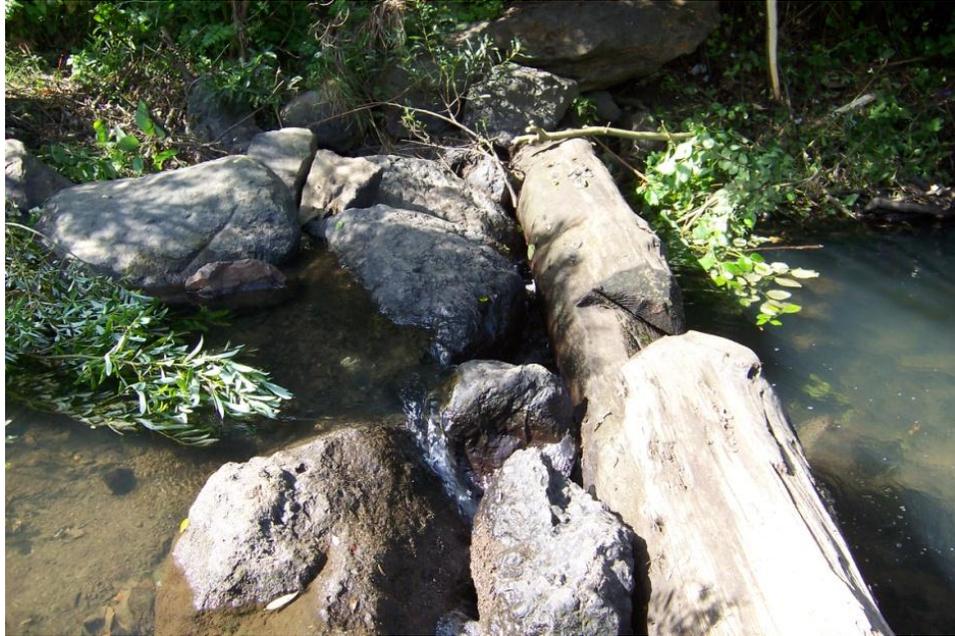
Undercut steps were identified as a problem in two of the reviewed step-pool projects (Table 2 p. 31), and they were also observed in the Restoration Reach. Two logs were undercut, at Log Weirs 12 and 14, and a vortex was developing above Log Weir 13 that may indicate an undercut forming. Log Weir 14 was also recorded as being undercut in the 2008 survey although its location, as identified in the 2008 survey data, was misrepresented in the report (TRA and Balance 2008). Photo 5 shows the undercut Log Weir 14, and in contrast, Photo 6 is a view of a well-performing log. In addition, property owners at the upstream end of the reach reported having filled in undercuts at the logs abutting their properties (Basset 2011).

Photo 5: Undercut at Log Weir 14 at 2513 m.

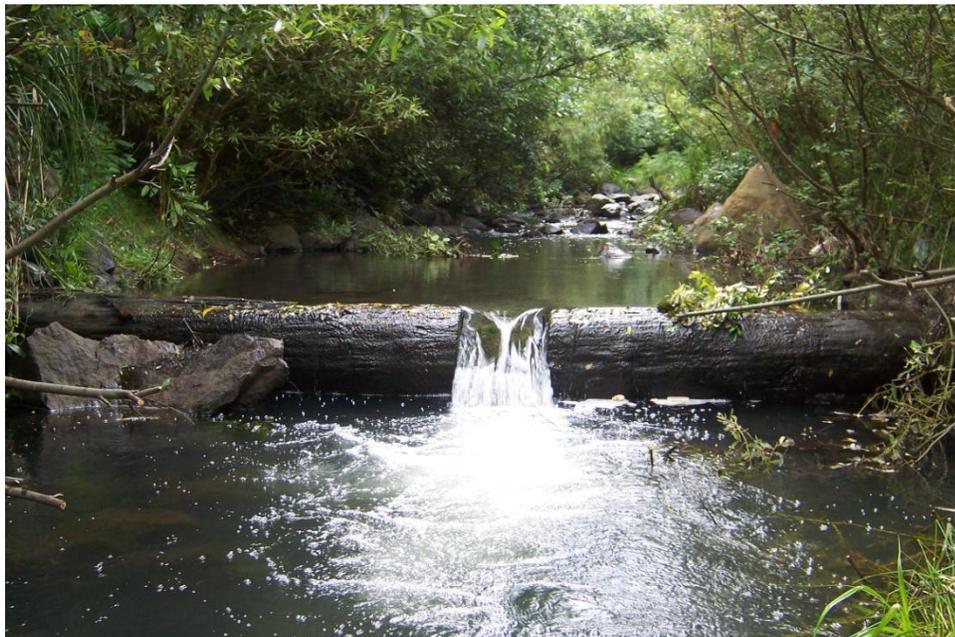
Photo 6: A well-performing log step, Log Weir 9 at 2437 m.

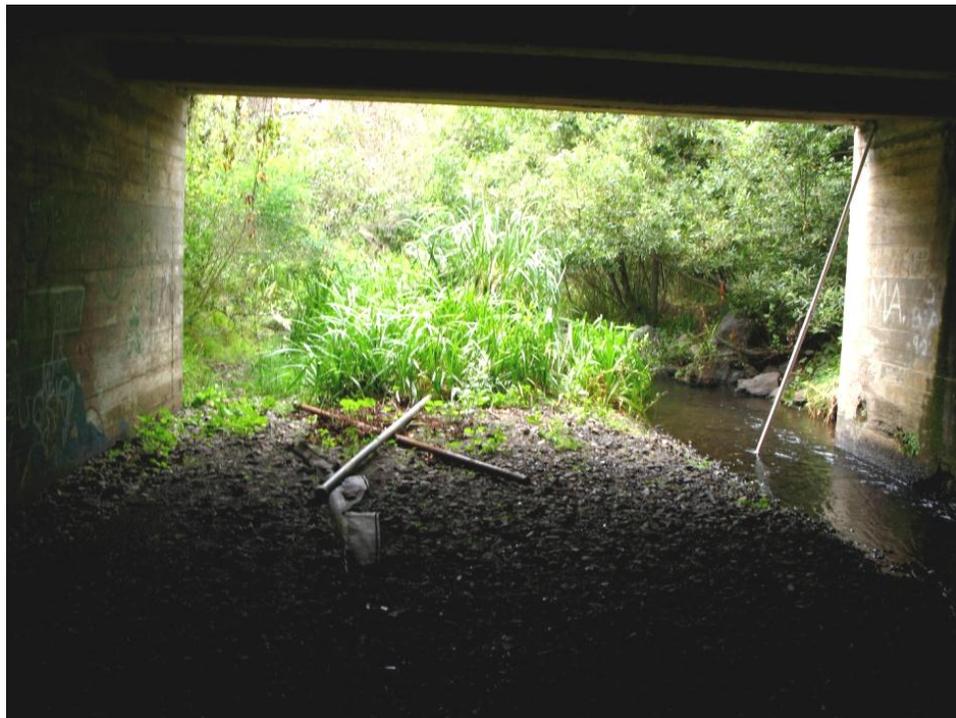
Photo 7: Downstream view of pampas grass island at Capistrano Bridge culvert at ~2850

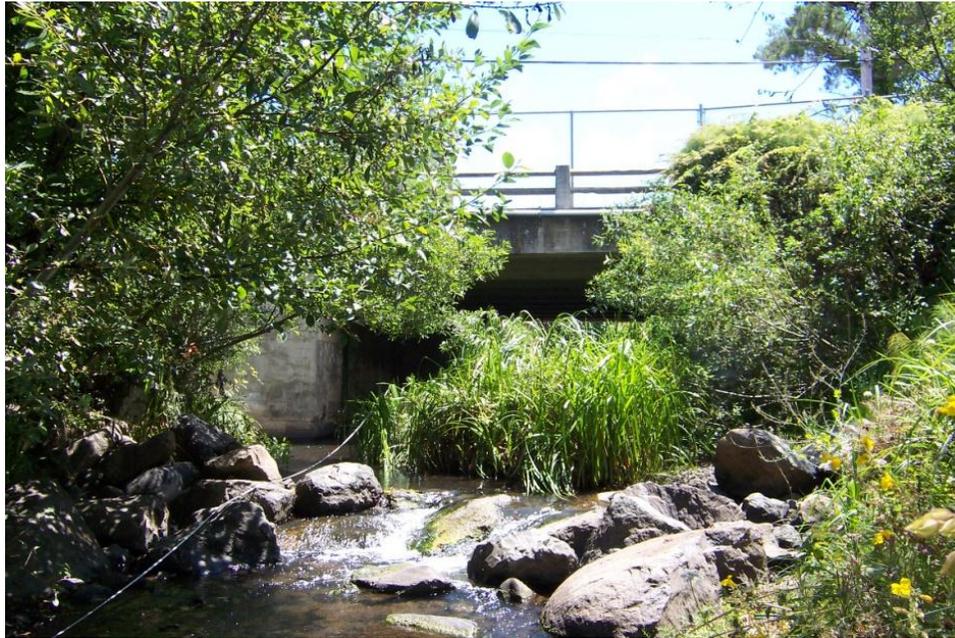
Photo 8: Upstream view of pampas grass island at Capistrano Bridge Culvert at ~ 2850

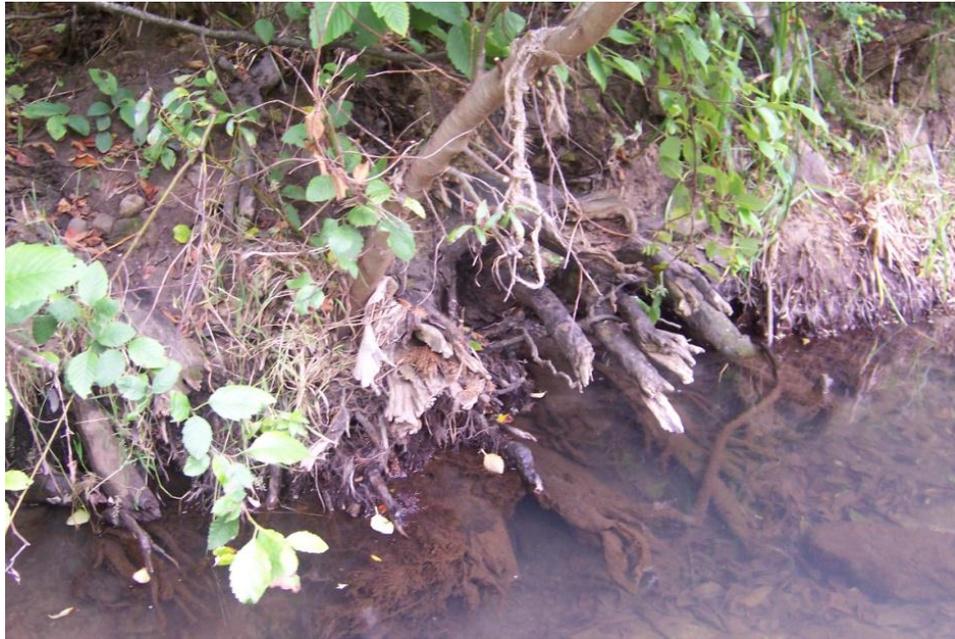
Photo 9: Possible erosion at alder roots around bend at ~2550 m

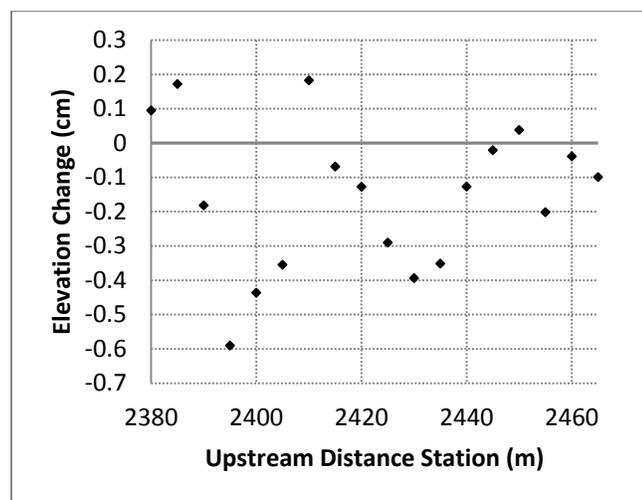
The longitudinal profile (Figure 10) suggests, and interpolated data from the two matched datasets (Figure 11) confirm, degradation throughout most of the reach. The mean elevation change over the ten year period was -15.6cm (-0.51 ft) or -1.55 cm (-.05 ft) per year. The highest amount of degradation occurred in a downstream pool located approximately 6 m (19.6 ft) downstream from a 30.48 cm (1 ft) culvert that comes in on the left bank. Correlation between elevation change and distance station was tested and rejected using Spearman's test. The correlation coefficient was 0.437 and the single-tailed p-value of 0.062 was greater than 0.05; therefore, it is not significant at a 95% confidence level. Four distinct pools were identified, separated by three riffle areas and a riffle/step area upstream. The areas with the most aggradation were two riffle areas; one above and the other below the area of deepest degradation. An approximate 7 m (23 ft) long area of recent erosion was identified on the right bank, immediately below the area where the two logs from the restoration area were cabled to

Figure 11: Downstream Reach interpolated elevation change 2001-2011. Datasets matched and interpolated every 5 m (16.4 ft).

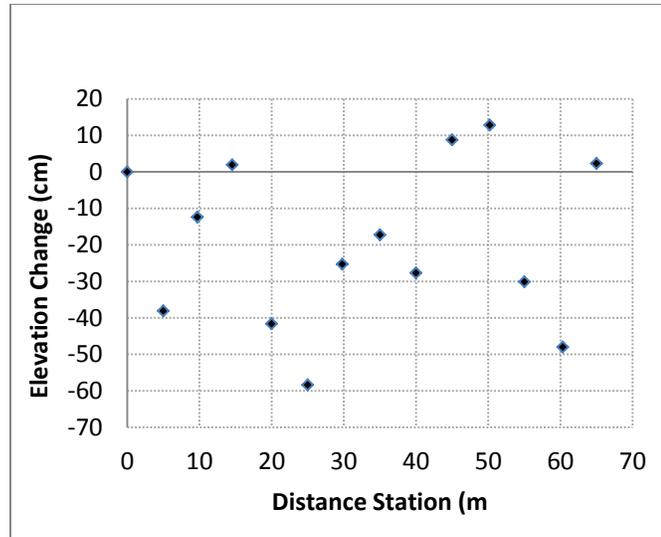
The longitudinal thalweg profile indicates (Figure 12), and the estimate of elevation change as determined by interpolated data from the two matched datasets confirms (Figure 13), a pattern of continuing degradation throughout most of the reach. The mean elevation change was -19.6 cm (-0.6 ft) over the past 12 years with an annual rate of change of -1.6 cm (-0.5 ft).

Figure 13: North Fork Reach interpolated elevationchange1999-2001. Computed from interpolated matched points every 5 m.

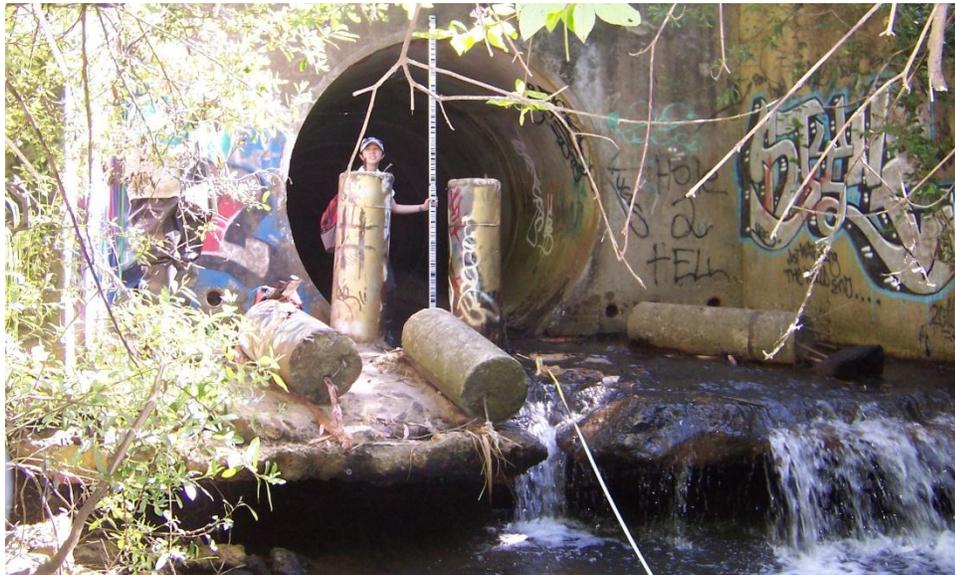
Photo 11: North Fork culvert. Eroded apron at lower center.

Distance Station	Description
64.28-63.75	<ul style="list-style-type: none"> The culvert apron has eroded back horizontally 16 cm (6.3 in) and vertically 53 cm (20.9 in)
62.3	<ul style="list-style-type: none"> Blow the apron, degradation was ~40 cm (15.7 in) in the pool.
56.5-51.8	<ul style="list-style-type: none"> Area of small steps
~53.0-52.0	<ul style="list-style-type: none"> Plywood in creek
41.9-35.8	<ul style="list-style-type: none"> Riffle area that has degraded
21.8-16.9	<ul style="list-style-type: none"> Riffle area with some aggradation 12 cm (4.7 in)
19.3-15.7	<ul style="list-style-type: none"> Wire fence revetment left bank
14.5-12.0	<ul style="list-style-type: none"> Wood bank revetment left bank
10.49	<ul style="list-style-type: none"> Deepest degradation ~70 cm (27.6 in)
~2.0	<ul style="list-style-type: none"> Location of cross-section

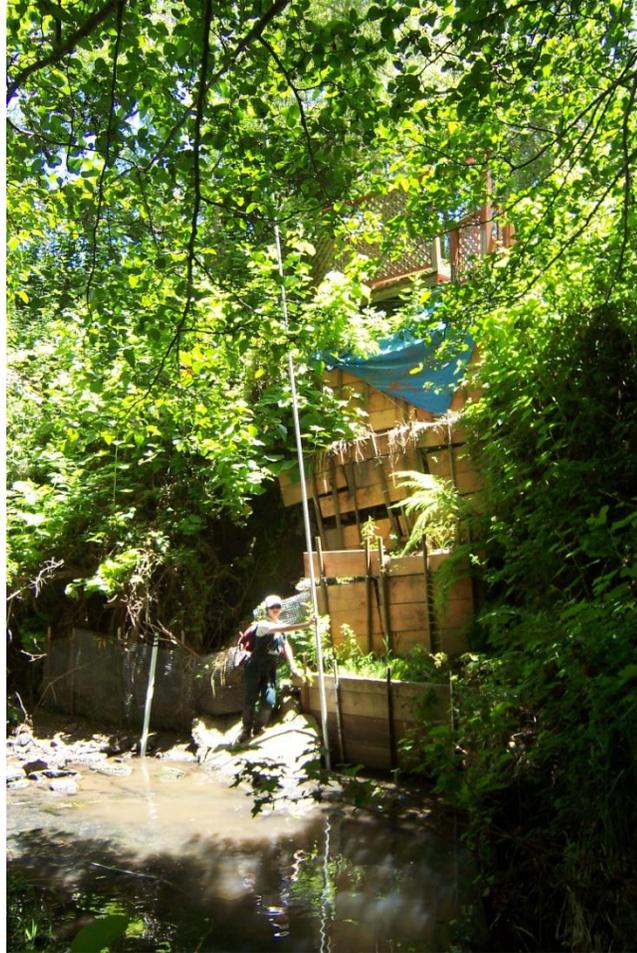
Correlation between elevation change and distance station was tested and rejected using Spearman's test. The correlation coefficient was 0.121 and the single-tailed p-value of 0.340 was greater than 0.05; therefore, it is not significant at a 95% confidence level. All areas were degrading except an ~ 4 m (13.1 ft) area of small steps formed from pieces of broken concrete that have not changed, and an ~8 m (26.2 ft) riffle area where some aggradation has occurred (12 cm where it is highest). Erosion began on the concrete apron (Photo 11); the lip has eroded back horizontally -16 cm (-0.5 ft) and vertically -53 cm (-1.7 ft). Immediately below the apron, the pool has deepened by 33-45 cm (1.1-1.5 ft). After the small steps, where no change had occurred, degradation resumed at the location of a piece of plywood that was found lying across more steps. A 4 m (13.1 ft) long wire fence was located on the left bank, and next to it was a wood

revetment of 2.4 m (7.8 ft) that was installed after a recent landslide (Photo 12).

Photo 12: North Fork revetment at site of recent landslide
