EFFECTS OF URBANIZATION ON STORM RESPONSE
IN THE NORTH FORK SAN PEDRO CREEK

A thesis submitted to the faculty of
San Francisco State University
In partial fulfillment of
The requirements for
The degree

Master of Arts
In
Geography

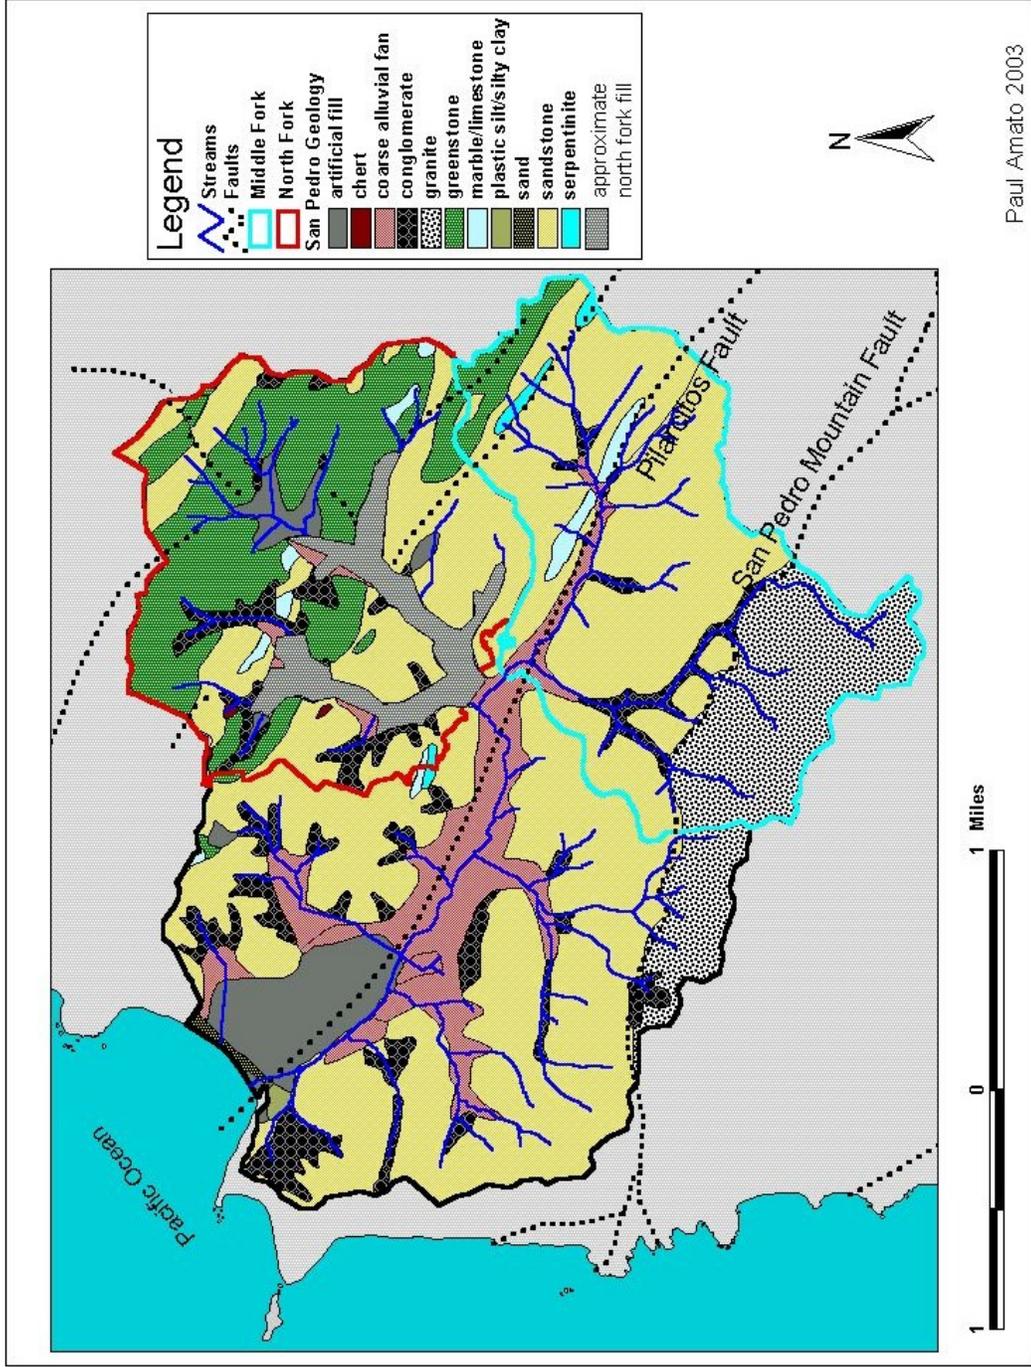
Figure 2. Geology Map of San Pedro Creek Watershed

The Pilarcitos Fault divides two structural blocks that lie beneath the watershed. To the northeast, delineated by the San Andreas and Pilarcitos Faults, is the Pilarcitos Block, and to the south is the La Honda Block, delineated by the Pilarcitos and Seal Cove-San Gregorio Faults (Figure 2). Basement rock of the Pilarcitos Block is composed primarily of Franciscan Complex.

This geologic assemblage is thought to be Jurassic and Cretaceous in age (Pampeyan 1994). The Franciscan Complex of the Pilarcitos Block is composed primarily of sandstone (greywacke) interbedded with pyroclastic greenstones, and a sheared rock section along the fault. Limestone, serpentine, conglomerate, chert, and glaucophane schist, in order of abundance, are also present. Igneous and sedimentary units of the Franciscan Complex are predominantly metamorphosed and thought to be amongst the oldest formations in the area (Pampeyan 1994). The greywacke is so severely crushed from tectonic activity that it weathers to depths of up to 50 feet (15.2 m) (Bailey et al. 1964). Significant weathering and shearing along the fault have resulted in unconsolidated soils and colluvium on the northern side of the watershed. This unit forms slopes that are “unstable, especially when wet.” (Pampeyan 1994).

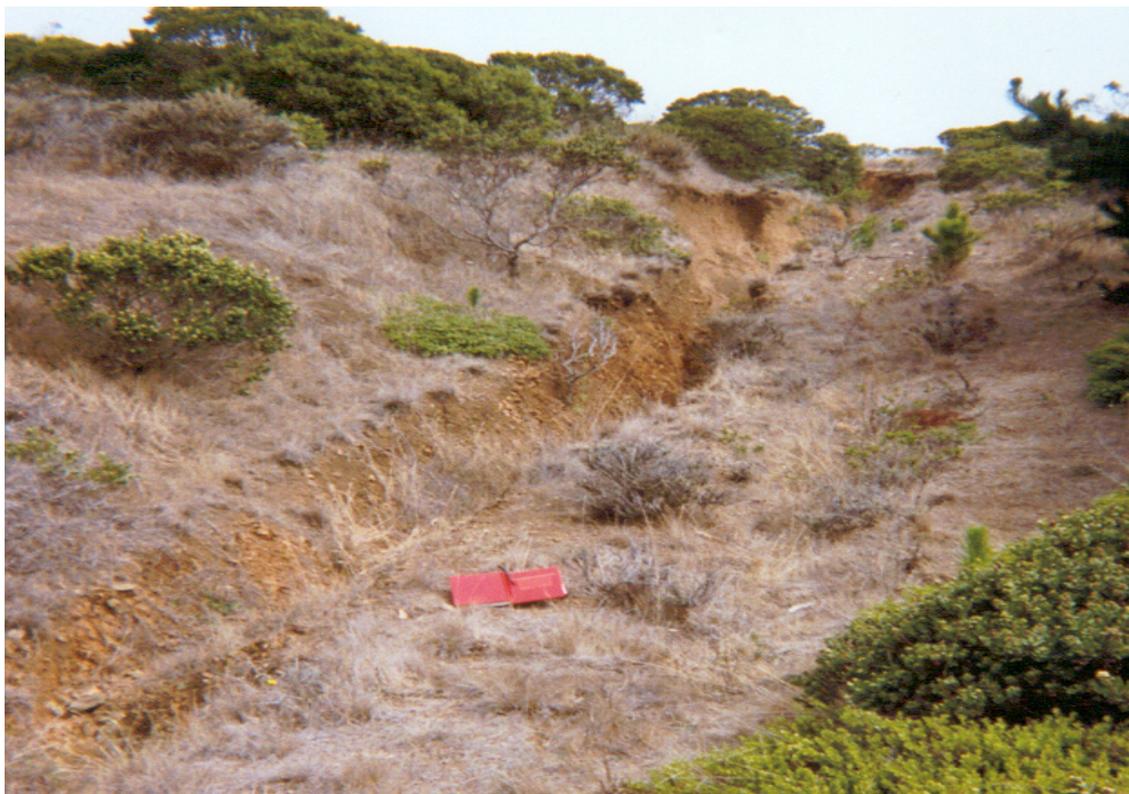
Photo 1. Gully on Cattle Hill

Landslide activity is common in this part of the Coastal Range. Under saturated conditions, steep slopes and unconsolidated soils have led to several landslides in the watershed. In 1982, 6-8 inches (152.4-203.2 mm) of rain fell over the City of Pacifica in less than 30 hours, causing 475 detectable landslides (Howard et al. 1982). Half of these landslides were concentrated in the San Pedro Creek watershed with approximately 100 occurring in the North Fork and 60 in the Middle Fork. The majority of the landslides were classified as surficial

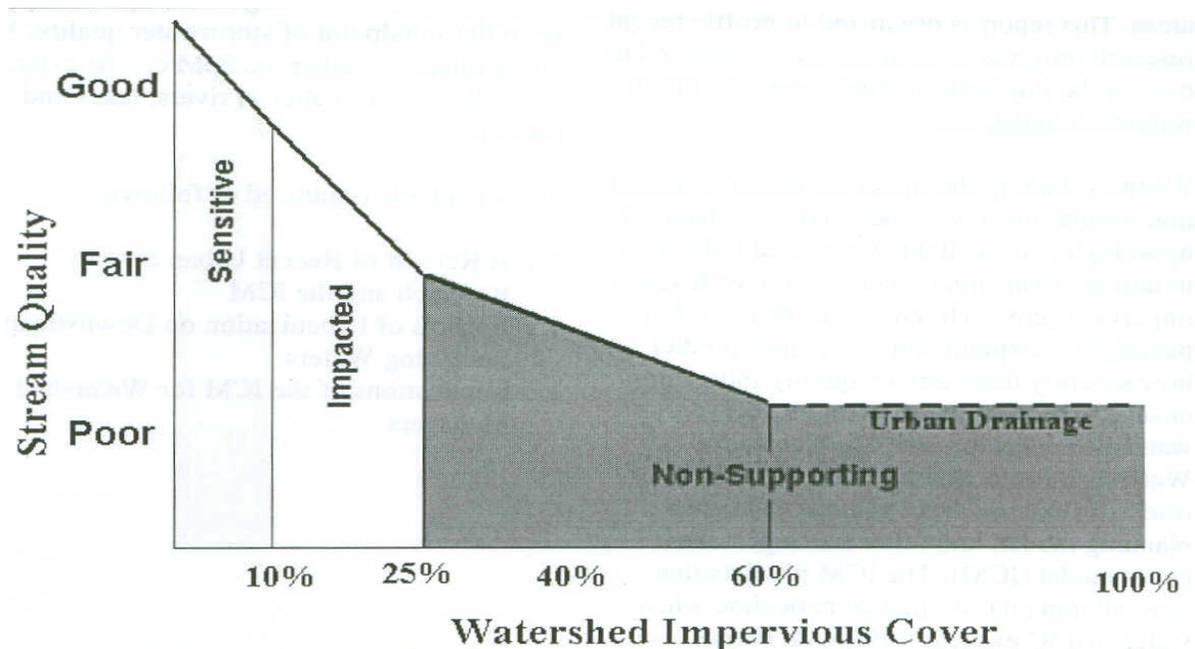
Figure 6. Impacts of Impervious Cover. Center for Watershed Protection, 2003:2

transportation (City of Olympia 1994). Schueler (1994) described impervious surface area as a good indicator of development that can be used to characterize the current state of water quality and biological diversity of a stream. He developed categories of stream condition in terms of beneficial uses and impervious area. As shown in Figure 6, watersheds with 10% or less cover are considered sensitive, 11% to 25% are considered impacted and anything above 26% impervious cover is a non-supporting creek.

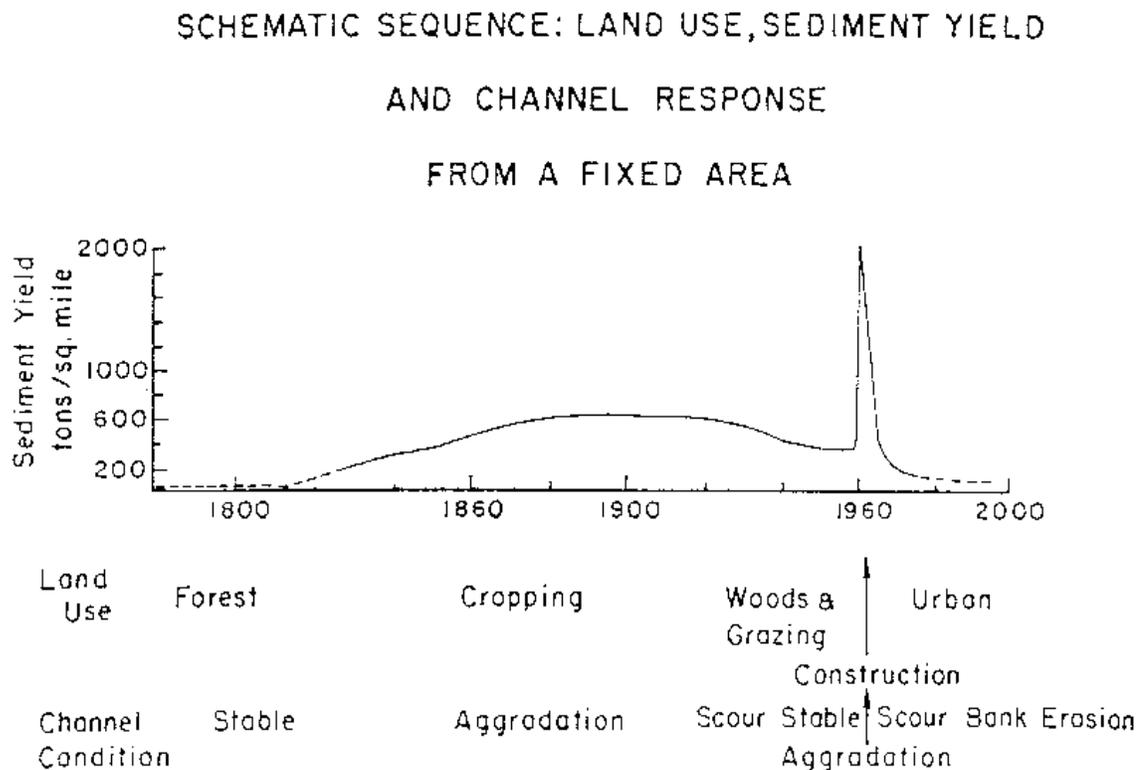
Figure 7. Land Use and Sediment Yield. Wolman, 1967

the watershed is primarily agricultural or forested, 2) the construction period which exposes land to erosion and increased sediment supply, and 3) the final stage consisting of an urbanized landscape which reduces sediment supply by increasing impervious surfaces. Figure 7 illustrates these stages.

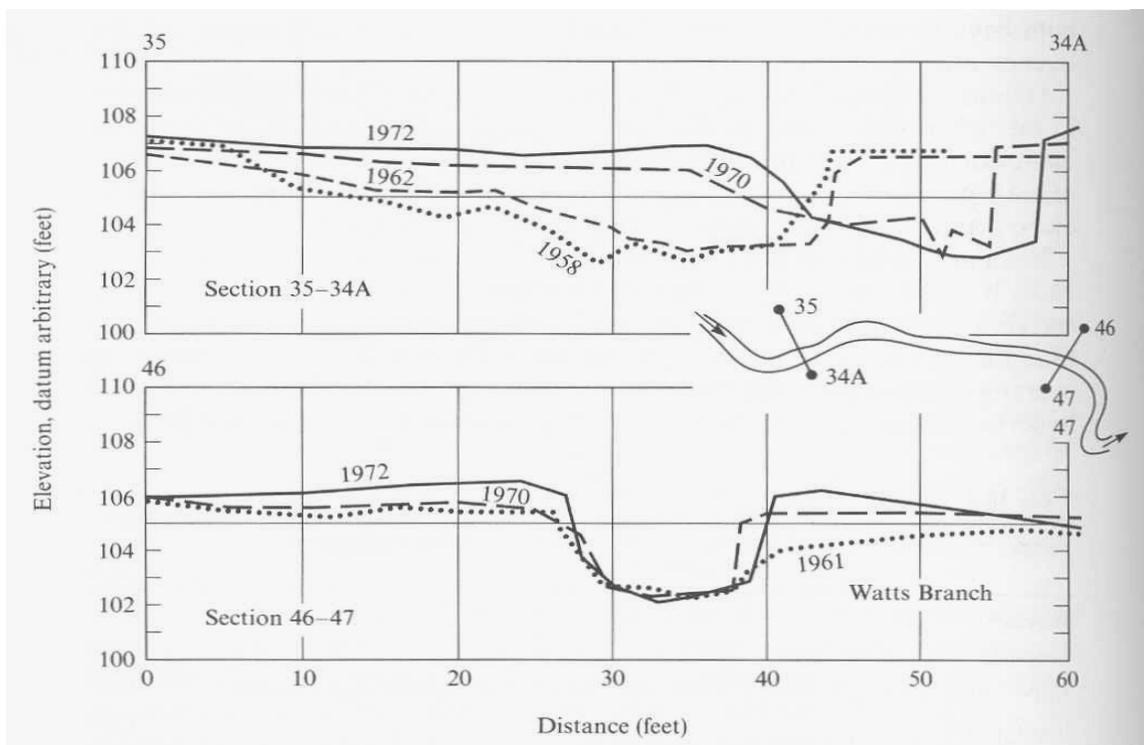
Figure 8. Watts Branch Cross-Sections. Dunne and Leopold, 1978:698

The cross sectional monitoring approach conducted by Leopold, involved measurement of 14 cross sections of a stream channel about every other year for 20-years (1953-1972). Changes in cross sectional area were compared to ascertain changes in channel size resulting from erosion and deposition attributed to increased flood frequency relative to urbanization in the watershed (Leopold 1973). Results of some of the years are represented in Figure 8.

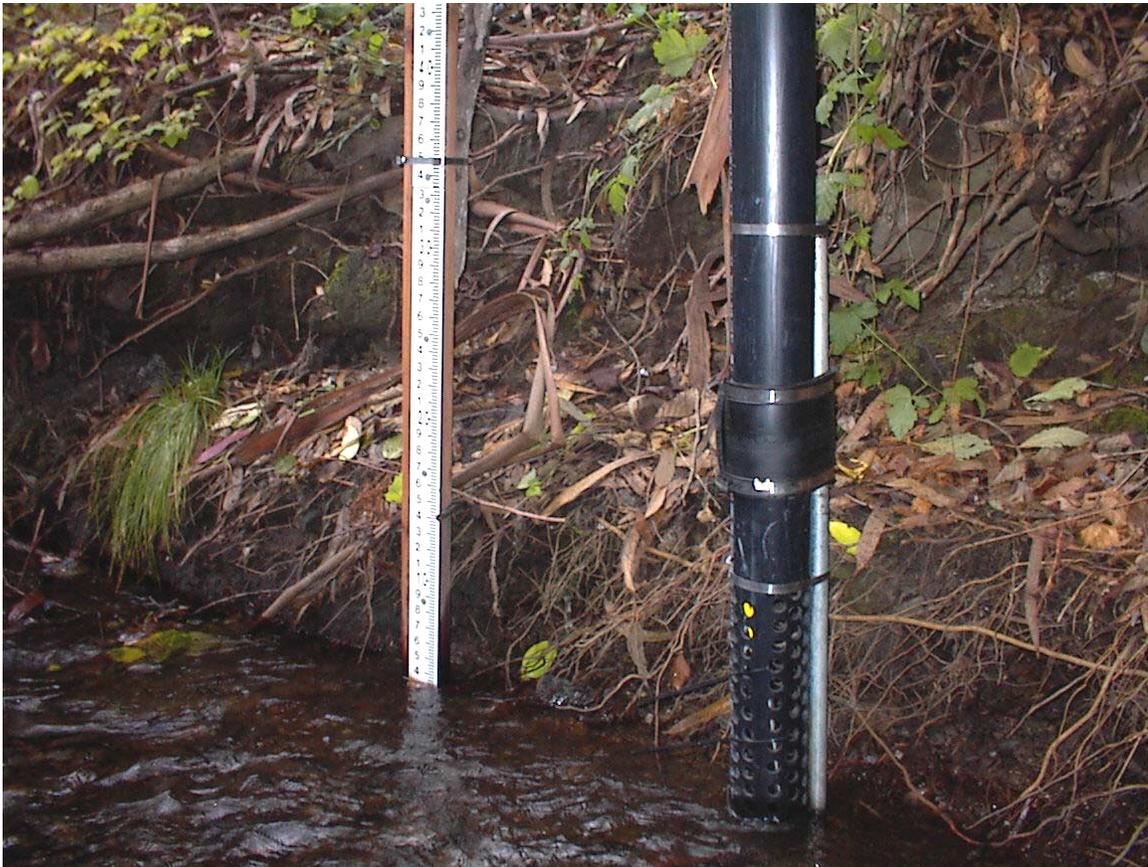
Photo 4. Middle Fork Gage Station

or theft. A staff gage was placed next to the sensors for calibrating the water level data measured by the sensor with actual measured water level.

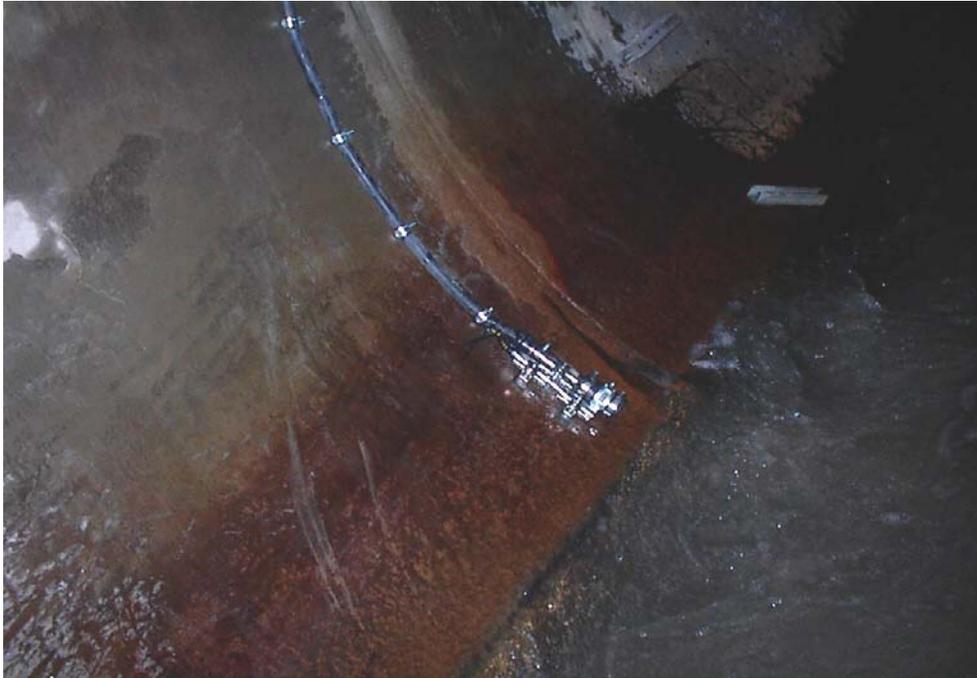
Photo 5. North Fork Gage Station Inside Culvert

The North Fork gage station was located inside the 8-foot (2.4 m) diameter concrete pipe that forms the lower reach of the tributary, approximately 350 feet (106.7 m) upstream of its confluence with the Middle Fork. As shown in Photo 5 and 6, sensors were installed inside the pipe, 50 feet (15.2 m) from the end so they would be out of sight and safe from potential vandalism by juveniles

and transients known to frequent the area. The need for this precaution was reinforced by personal encounters and observations of conditions at the site. The sensors and data cables were bolted to the concrete pipe and routed to a waterproof bucket containing the data logger. A PVC sensor well was originally installed but was washed out by minor storm flows prior to installation of the sensors, providing a timely indication of the velocities at which the culvert conveys flow. The sensors were re-mounted near the bottom of the concrete pipe without any housing.

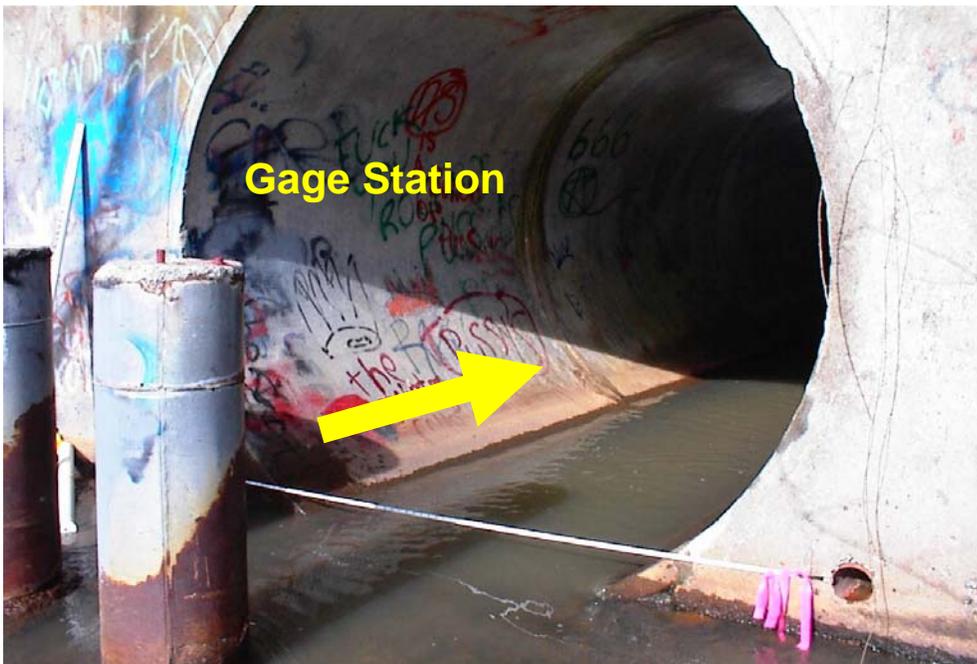
Photo 6. North Fork Culvert

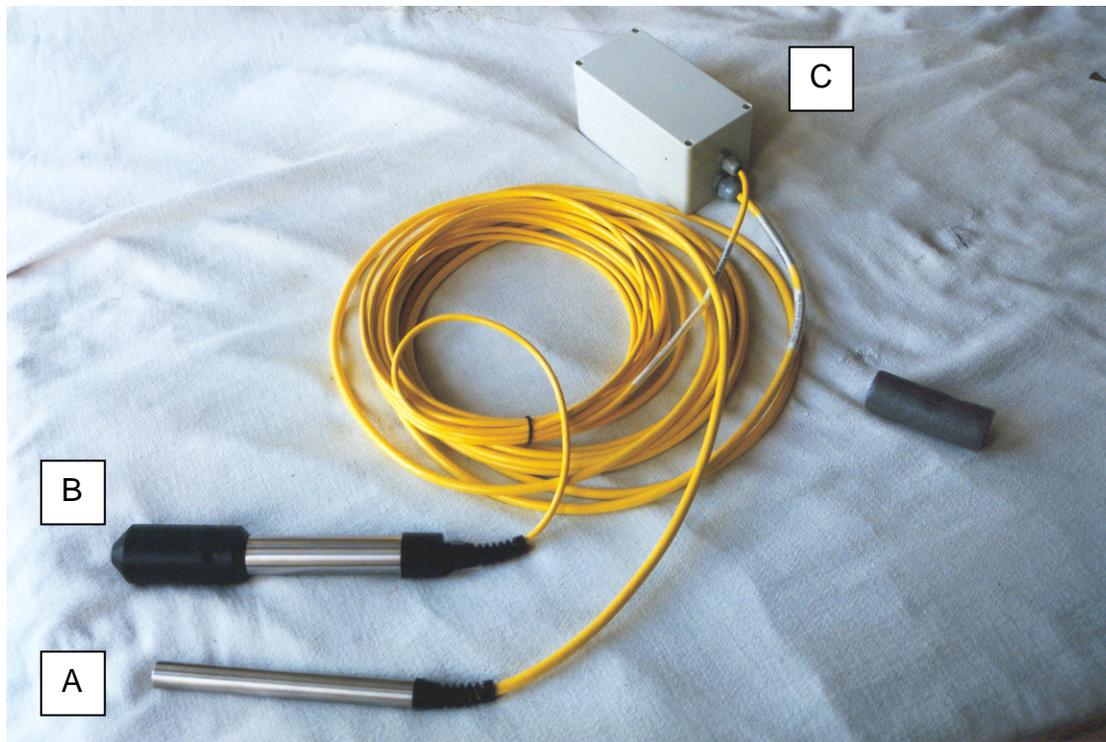
Photo 7. A) Pressure Transducer B) Turbidity Sensor C) Data Logger

A Global Water WL300 Water Level Sensor Pressure Transducer was used at both gage stations to record water depth, or *stage* (Photo 7). Stephenson (1994) used pressure transducers for measuring runoff from water depth in a similar watershed comparison near Johannesburg, South Africa. The WL300 creates an output in milliamps (mA), which must be calibrated to actual depth of water. The water level on the staff gage in the Middle Fork, and water depth measurements in the North Fork were observed at specific times during various depths and compared to the mA output recorded at the same time.

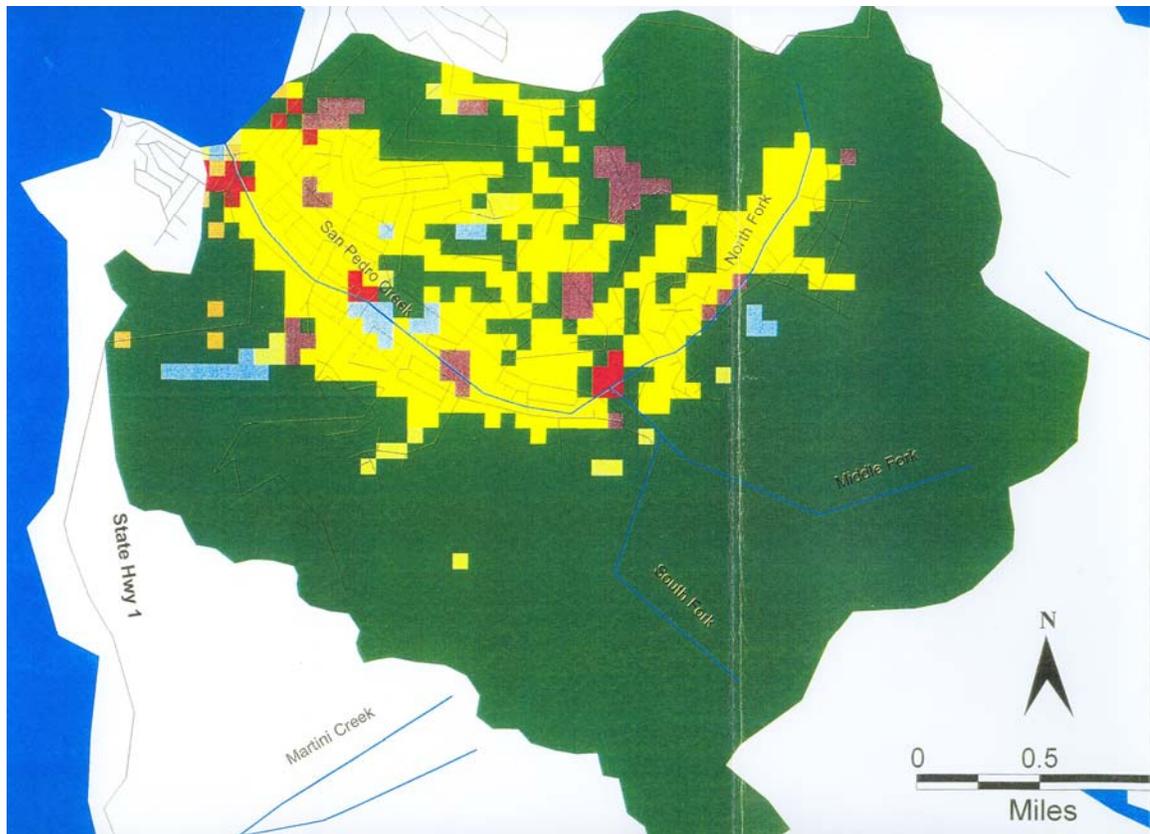
Impervious Percentage

EOA (1998) measured a total impervious surface of 13% in the whole San Pedro Creek watershed, 1.8% in the Middle Fork and 19.1% in the North Fork, (Figure 9). The stream gage station in the Middle Fork was located *upstream* of nearly all impervious surfaces, with the exception of the San Pedro Valley Park maintenance and parking facilities, representing a small fraction of total impervious cover. Conversely, in the North Fork, impervious area downstream of the gage station represents only a small fraction of the total basin. According to the water quality and biological diversity based categories developed by Schueler (1994) the Middle Fork above the gage could be considered sensitive but good (0-10% impervious) though the near absence of impervious cover likely makes these categories inapplicable. The North Fork would be considered impacted and nearing non-supporting. The majority of the developed area (>0% impervious cover) in the North Fork was determined to be 60% impervious in the residential areas with smaller fractions of 30% for Frontierland Park which was built on a former landfill; 70% at Terra Nova and Ortega schools, a horse stable, and residential pocket; and 100% at the Park Mall.

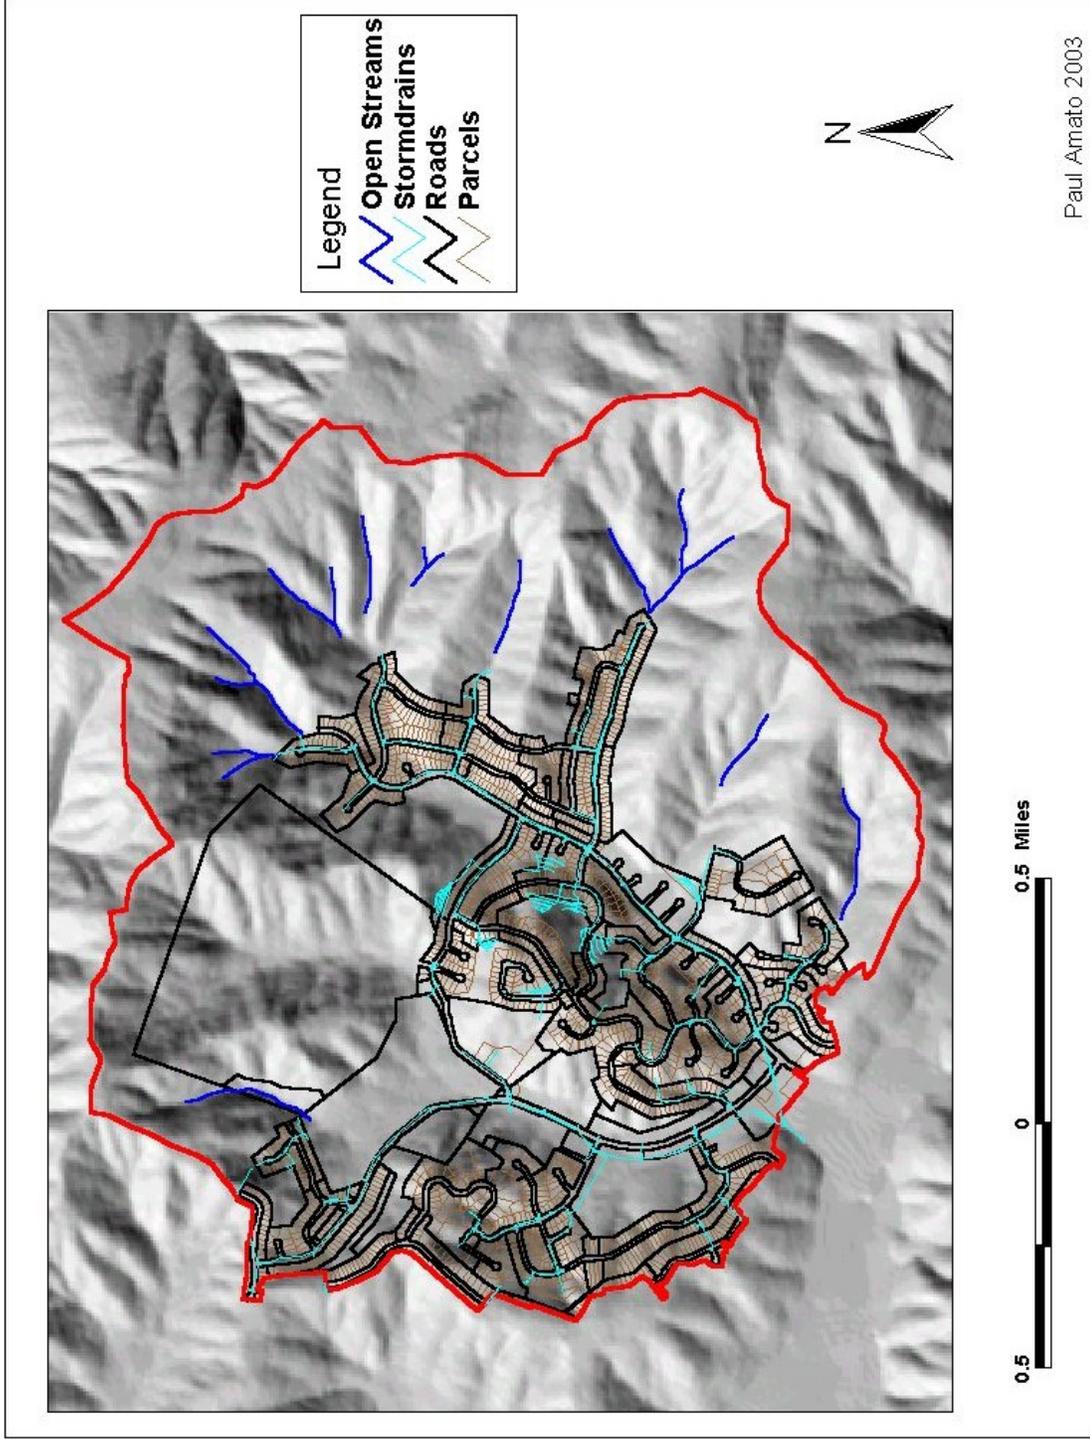
Figure 10. North Fork Stormdrain Network

Based on stormdrain data from the City of Pacifica, impervious surface area is predominantly connected, or effective at all times (Figure 10). Gutters, ditches, and storm drains service drainage needs of all the developed portions of the watershed as well as the upper, undeveloped watersheds. First and second order headward channels and hillside drainage have been connected directly to the storm drain system where stream channels once flowed openly. As a result, upland flows are accelerated downstream as soon as they reach the upstream opening of the stormdrains.

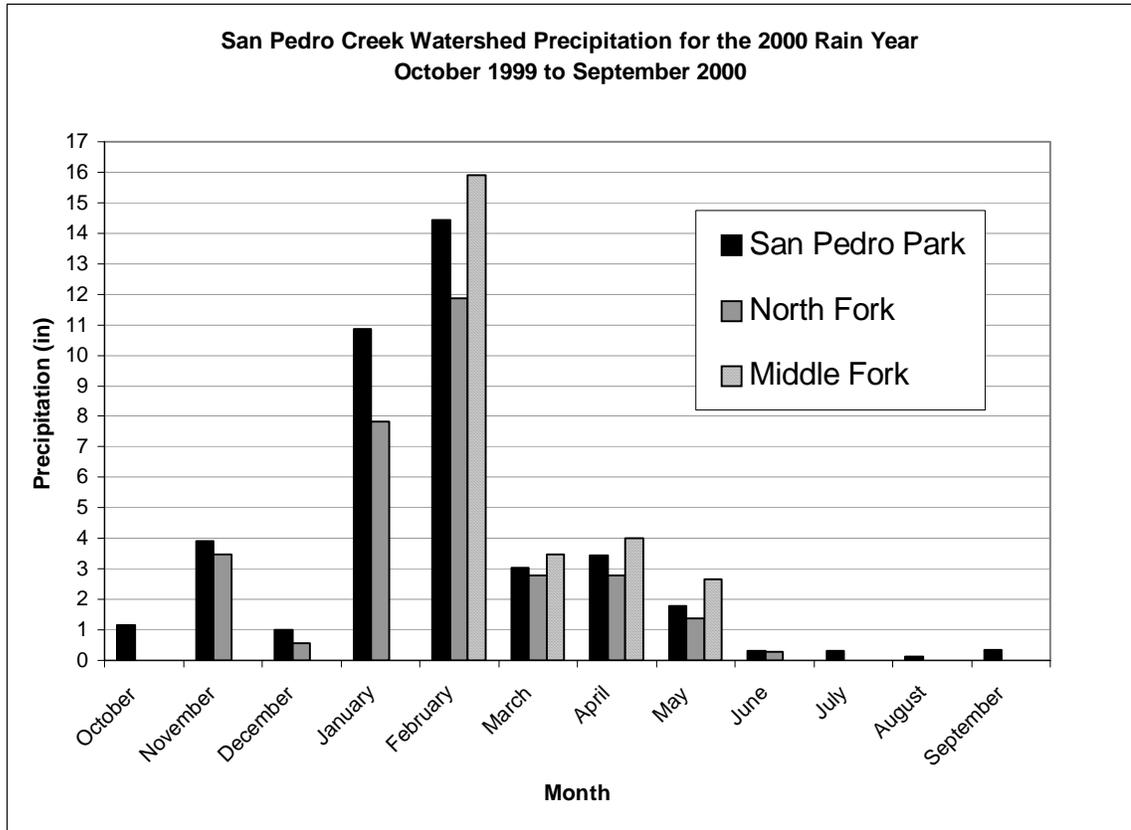
Figure 11. Monthly Rainfall Comparison for Three Rain Gages

Rain data were collected for this study using a tipping bucket rain gage installed on the ridge top of each sub-watershed from February through May and November through June respectively. Simultaneous rain data collection occurred at the Park, and the Middle and North Forks from February to May only. A comparison of data for the Middle and North Forks and San Pedro Valley Park shows that monthly totals were consistently highest on the Middle Fork and lowest on the North Fork (Figure 11). Additional months when only Park and North Fork rain data were available are consistent with this pattern. On average, from February through May, rainfall in the Middle Fork was approximately 31% greater than the North Fork and 17% greater than the Park. The Park gage measured 17% greater than the North Fork gage. Monthly variability can be seen in Table 1. Though the data are compared over a short period of time, it appears that the Park rain gage is a good indicator of average rainfall for the Middle and North Fork drainages. Additional years of data are needed to confirm this.

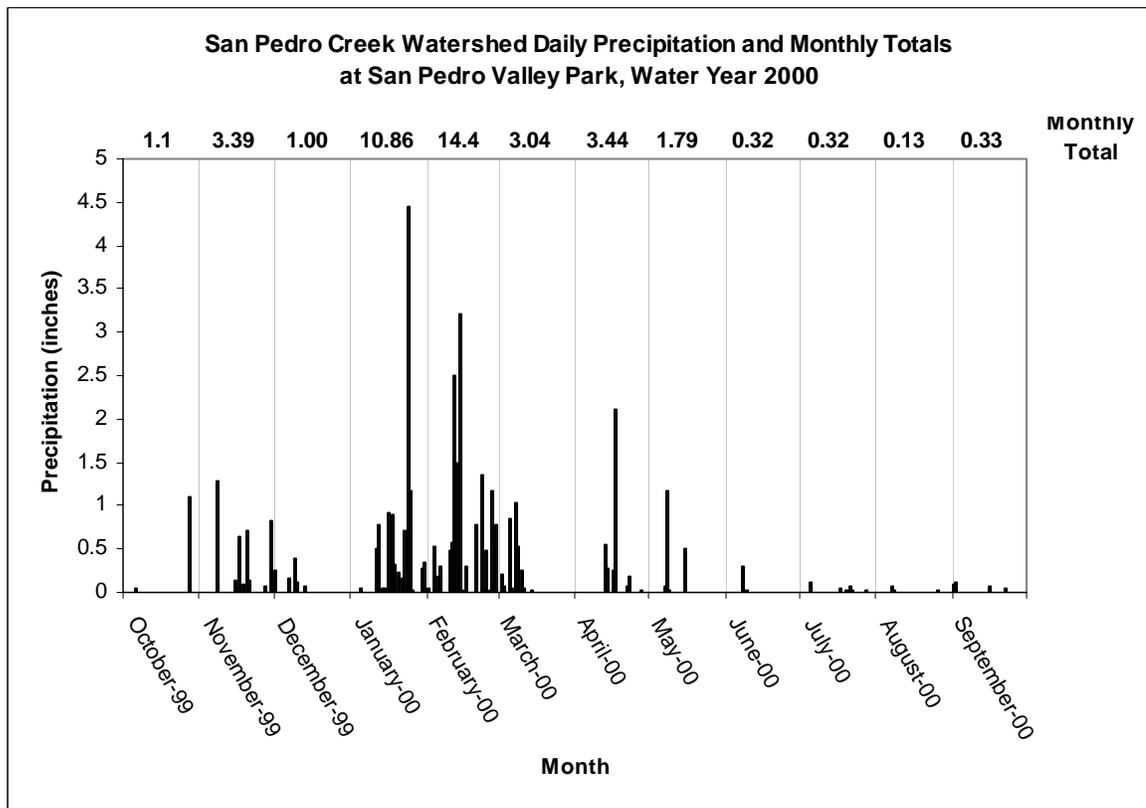
Figure 12. Daily and Monthly Precipitation at San Pedro Valley Park, 2000 WY

Daily and monthly rainfall recorded at the Park during the 2000 water year can be seen in Figure 12. The wettest months by far were January (10.86 inches (274.3 mm)) and February (14.4 inches (365.8 mm)). January 24 was the wettest day with nearly 4.5 inches (114.3 mm) of rain, approximately 60% to 75% of the estimated rainfall that fell in less than 30 hours in 1982, causing 475 landslides throughout Pacifica.

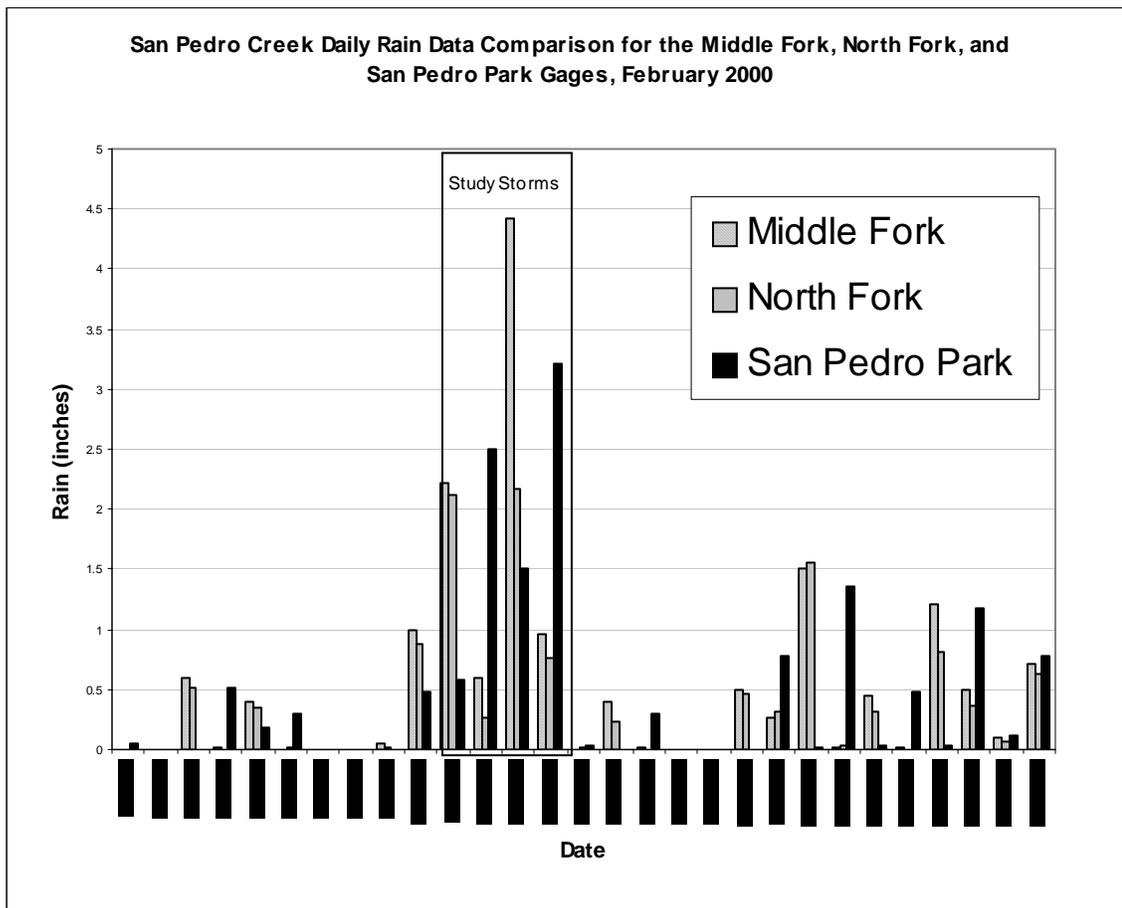
Figure 13. Daily Rain Comparison for the Month of February, 2000

Figure 13 shows daily rainfall for all three gage sites during the month of February, which was selected for additional analysis of rainfall, and storm response because it was the only month in which all the in-stream gaging stations and rain gage tipping buckets were in simultaneous operation. Rainfall, stage (to estimate discharge), and turbidity were all collected from January 30 to February 23, 2000. Of the 24 days where precipitation was measured at all three rain gages, the Middle Fork was wettest on 14 days, the Park on 13 days, and the North Fork only once. This seems to be consistent with the differences in measured monthly totals supported by the observation that coastal storms typically move in from a southwesterly direction, stall over the Middle Fork and then over the Park before reaching the North Fork watershed. Rainfall data appears to indicate that duration and total rainfall are weaker by the time most systems reach the North Fork.

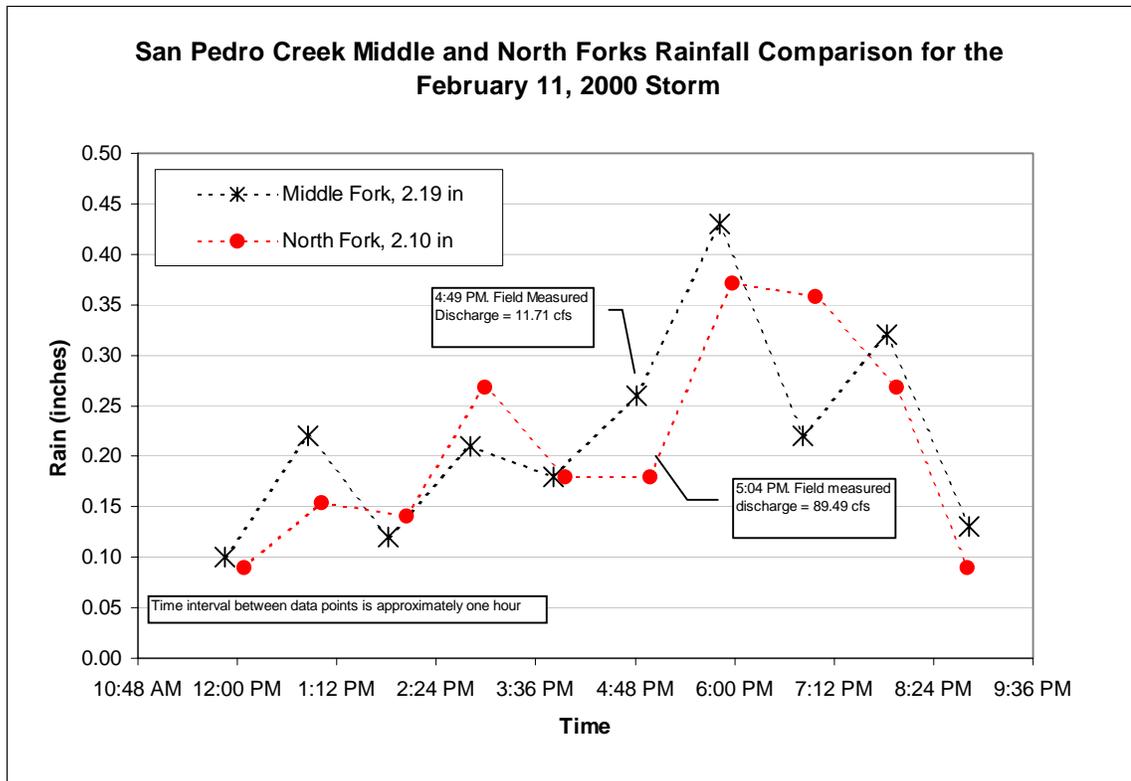
Figure 14. Rainfall Intensity and Duration for the February 11, 2000 Storm

As shown in Figure 14, the February 11 storm lasted for approximately 10 hours and resulted in 2.2 inches (55.9 mm) at the Middle Fork gage and 2.1 inches (53.3 mm) at the North Fork. In each of the three storms, rainfall started earlier in the Middle Fork and ended about the same time in both drainages. On the 11th, rainfall intensity was steady for about the first five hours, peaked two hours later, and ended three hours after that. The most significant difference, when comparing the two gages, was the intensity during the third to last hour of the storm when the Middle Fork dropped 50% and the North Fork hardly dropped at all. Discharge readings are included in Figure 15 for a subsequent discussion of measured discharge.

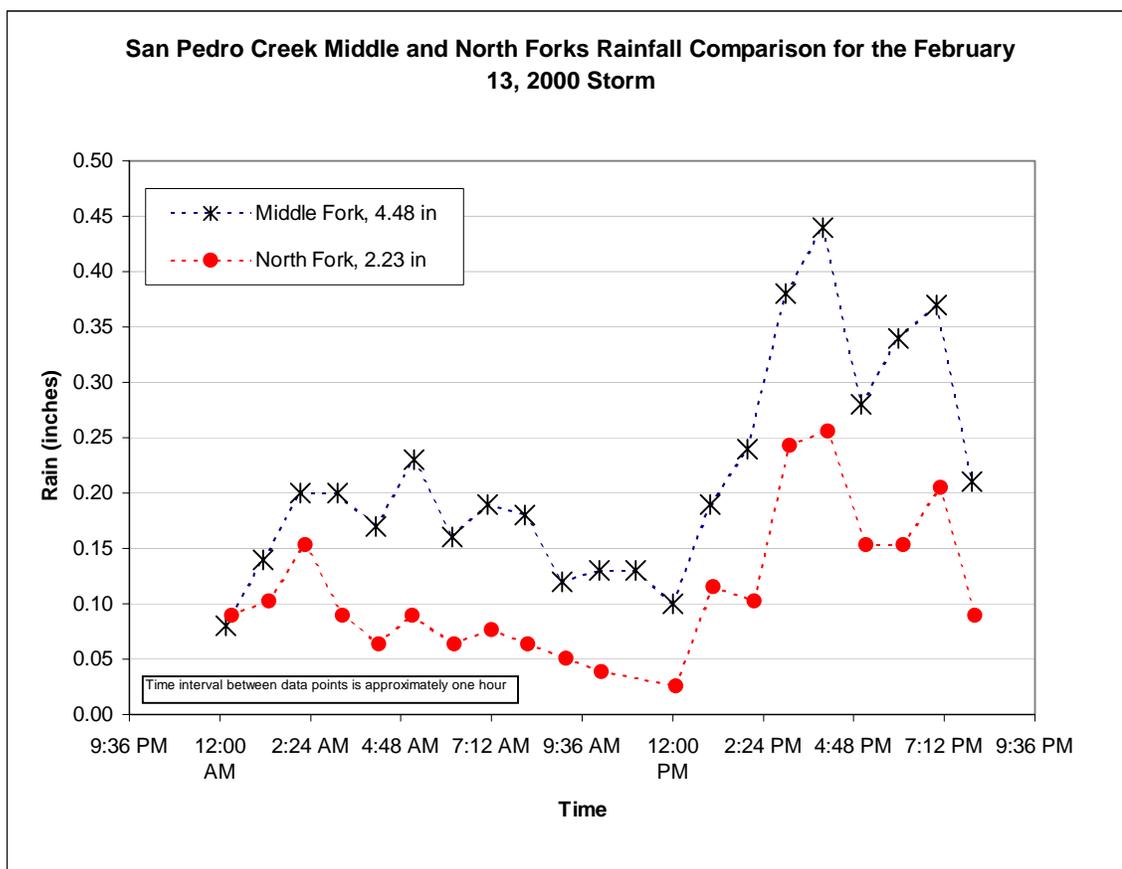
Figure 15. Rainfall Intensity and Duration for the February 13, 2000 Storm

Rainfall distribution on the 13th was similar to the earlier storm in that it was steady for most of the event, followed by a significant peak prior to ending. Specifically, rainfall was steady for about the first 12 hours, peaked over the next five, and ended four hours later (Figure 15).

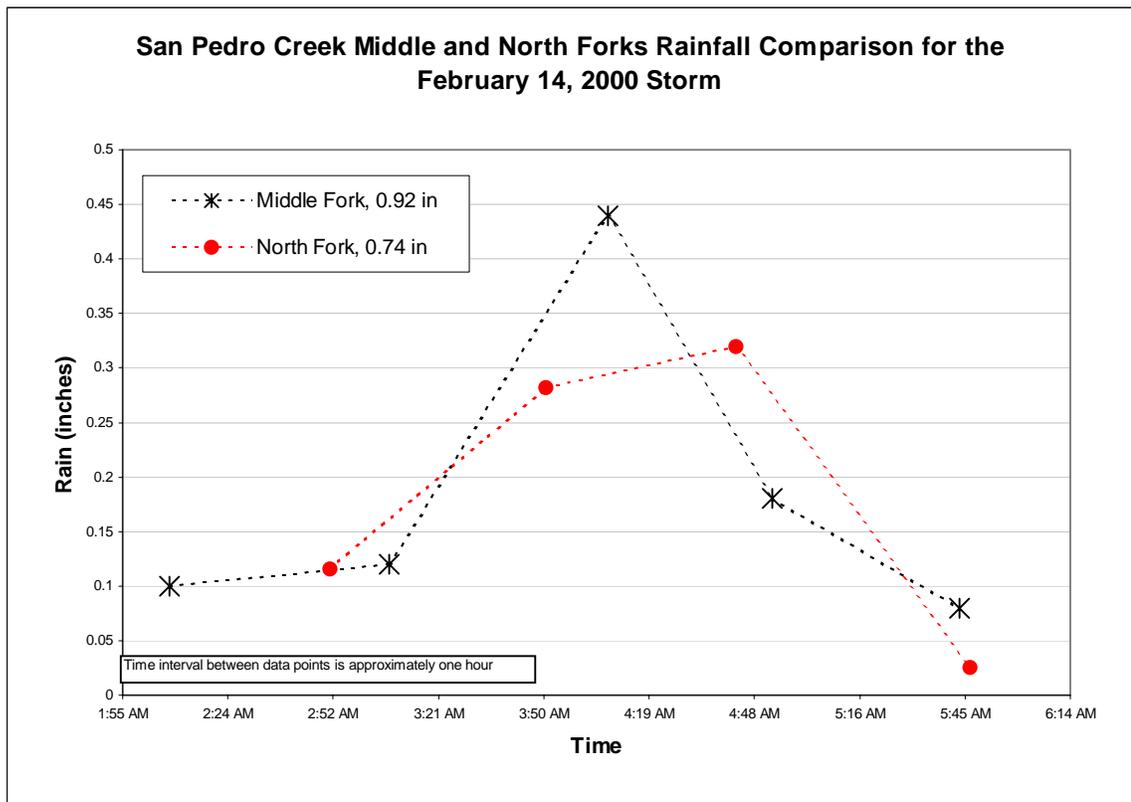
Figure 16. Rainfall Intensity and Duration for the February 14, 2000 Storm

The February 14 storm lasted 5 hours in the Middle Fork and only four in the North Fork, with rainfall totals of 0.92 inch (23.4 mm) and 0.74 inch (18.8 mm) respectively. In both storms, rainfall intensity was greatest at about the middle of the storm (Figure 16). This storm was much shorter than the two previous, resulting in much less overall rain. Peak rainfall intensity of the Middle Fork was very similar to the February 11 storm and February 13 storms. Peak rainfall intensity in the North Fork was about average the February 11th and 13th.

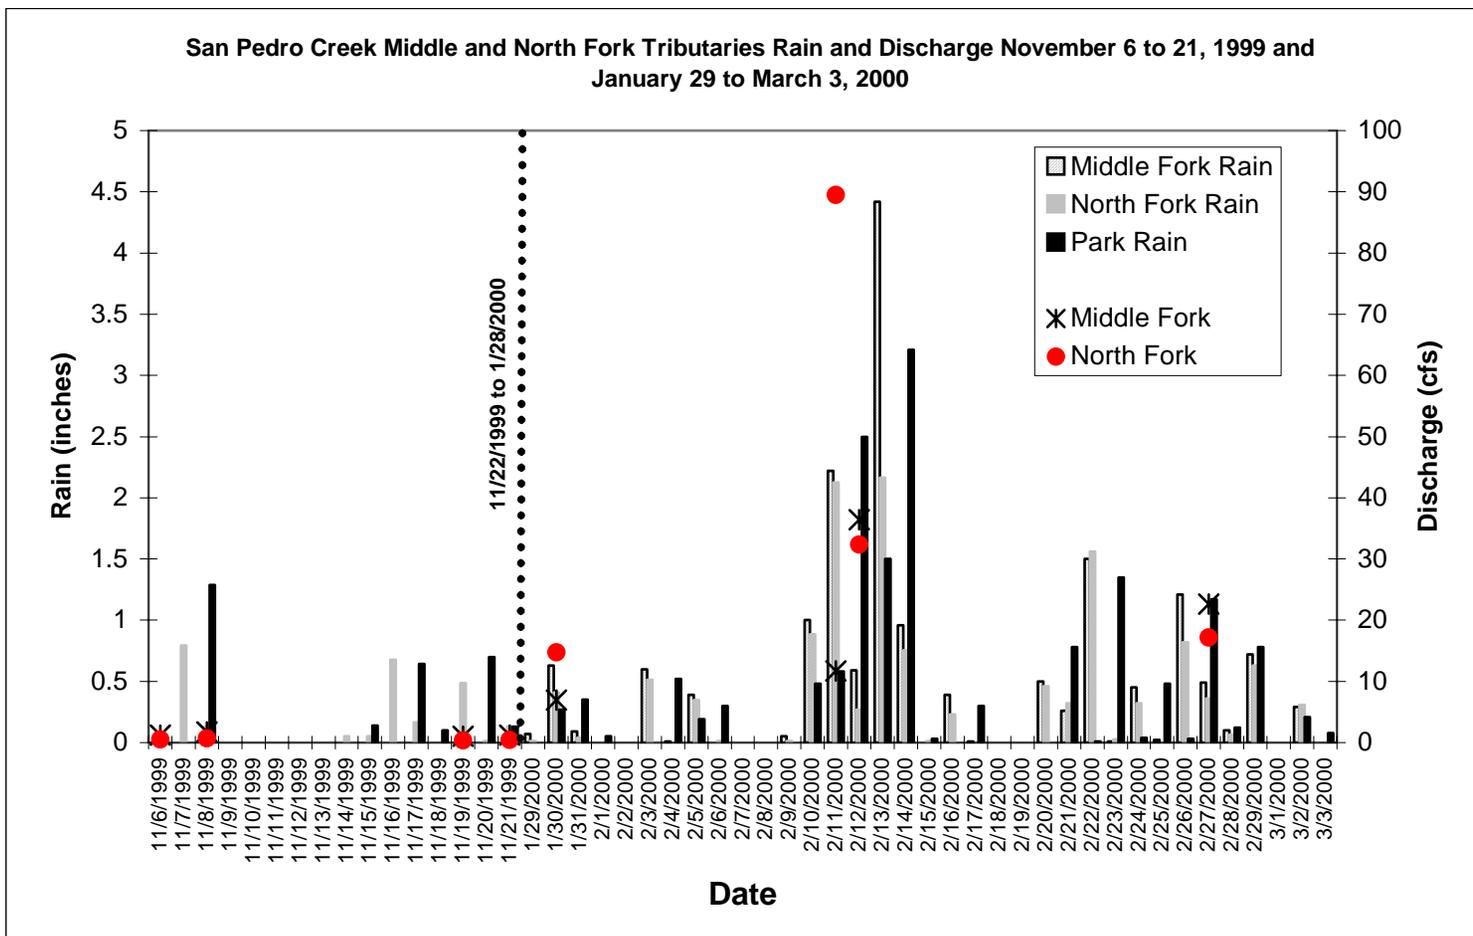
Figure 17. Daily Rainfall and Periodic Field Measured Discharge

to the increased soil infiltration potential following the dry season. Relatively dry soils are much more capable of absorbing the first few rains, preventing surface runoff or significant increases in groundwater inputs

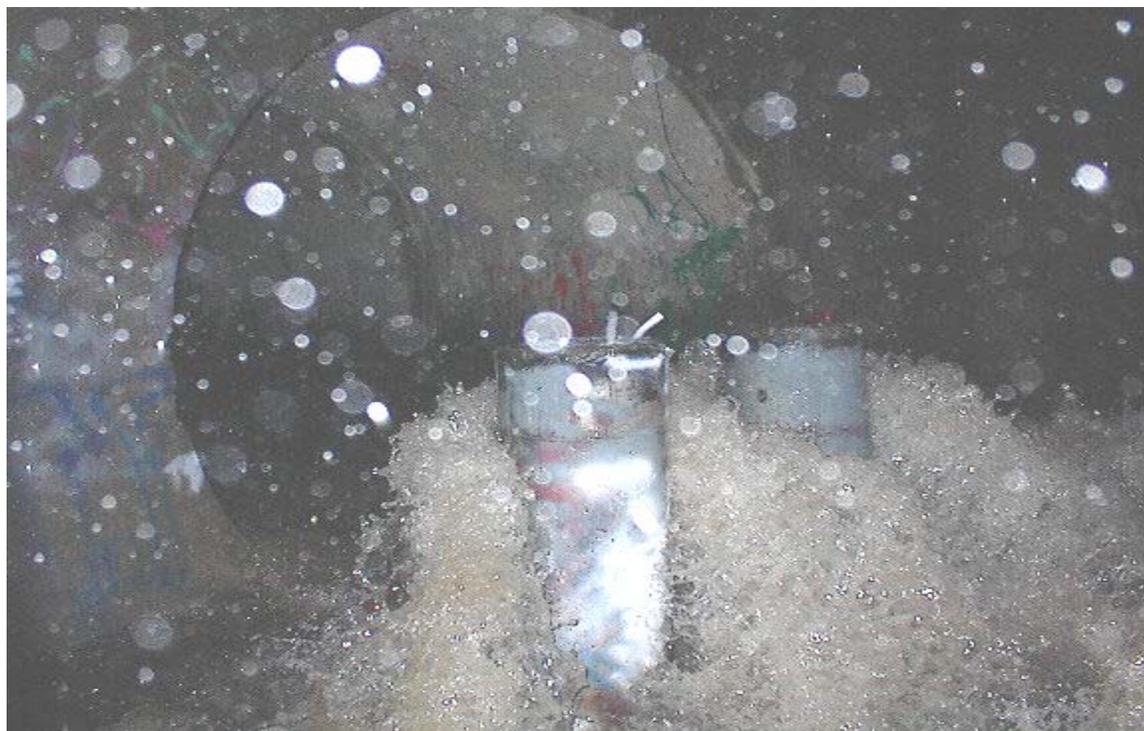
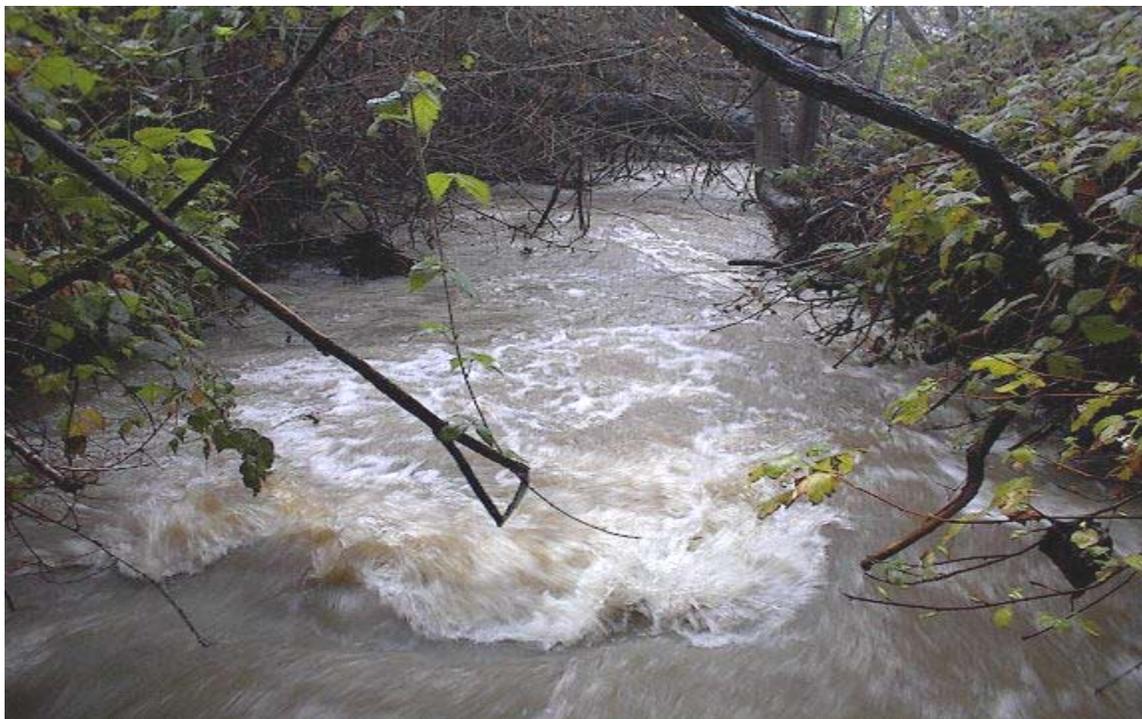
in the unurbanized Middle Fork. Photos 8 and 9 compare the energy and discharge of the North Fork and the Middle Fork during this event. The North Fork photo shows water backing up against the two remaining 4-foot tall reinforced-concrete energy dissipaters (three have fallen during earlier flows). Super critical flows can be seen in the form of a reverse wave (hydraulic jump) in the Middle Fork just downstream of the gage station. The Middle Fork may appear to have greater flows, but the photo was taken from in the channel; North Fork velocities were far too high to stand in.

Photo 8. North Fork Culvert flows During the February 11, 2000 Storm

Photo 9. Middle Fork Super Critical to Sub-critical Transition Flows During the February 11, 2000 Storm (view looking downstream)
