EFFECTS OF URBANIZATION ON STORM RESPONSE
IN THE NORTH FORK SAN PEDRO CREEK

A thesis submitted to the faculty of
San Francisco State University
In partial fulfillment of
The requirements for
The degree

Master of Arts
In
Geography

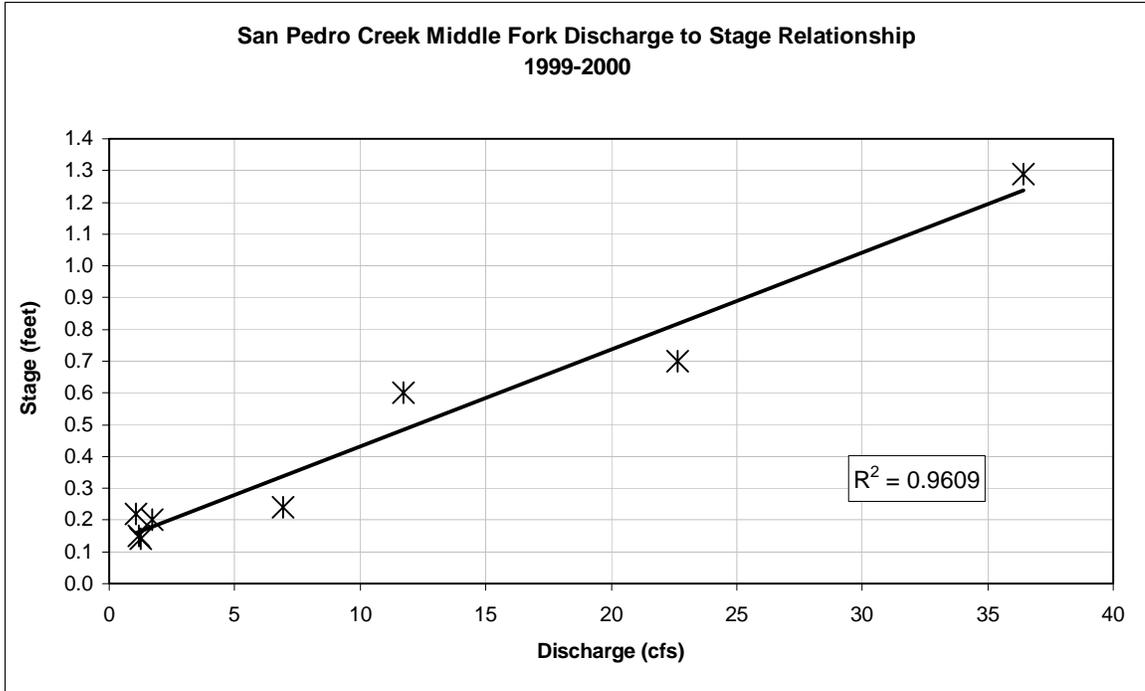
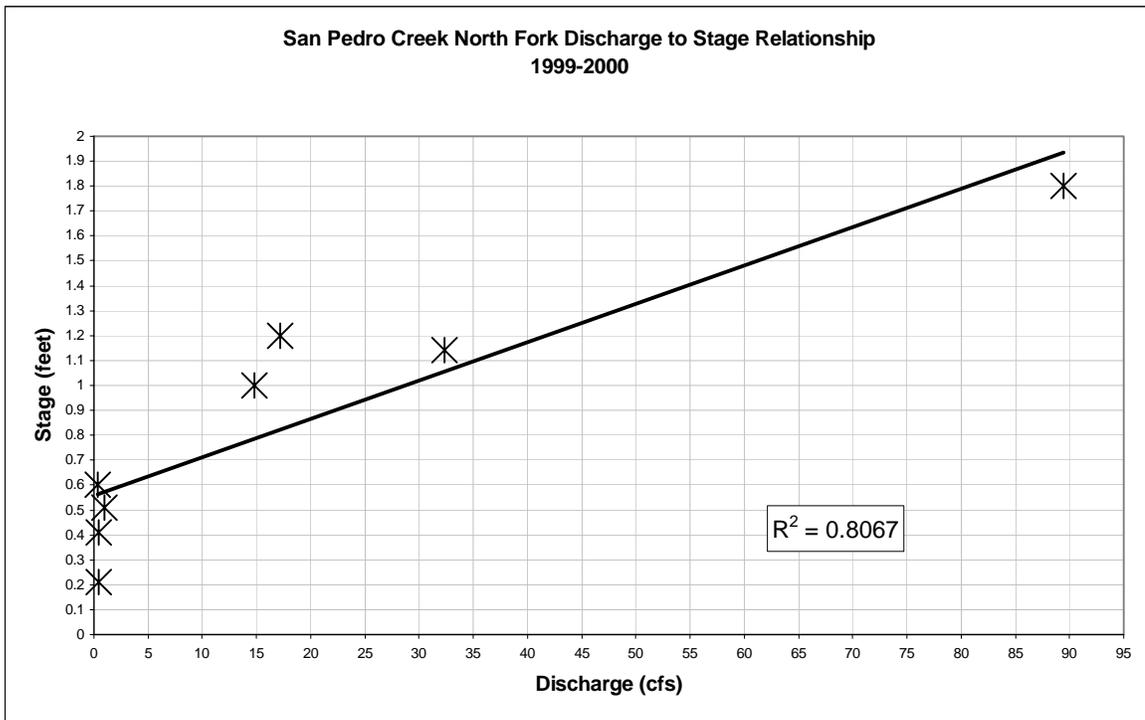
Figures 18 & 19. Middle & North Fork Relationship of Discharge and Stage

As described in the Methods section of this study, the relationship of measured discharge and stage was used to estimate discharge values for continuously logged stage (recorded in mA) measured at both gage stations. Discharge and stage were measured at the same time in the field and plotted to demonstrate correlations. For both locations, measured discharge increased with stage. Figures 18 and 19 show these relationships; this correlation yielded an r^2 of 0.96 in the Middle Fork and 0.81 in the North Fork. A weaker correlation in the North Fork may be caused by highly variable cross-sectional area and stage that can visibly change during the course of a reading. This is a direct result of increased “flashiness” in an urbanized system.

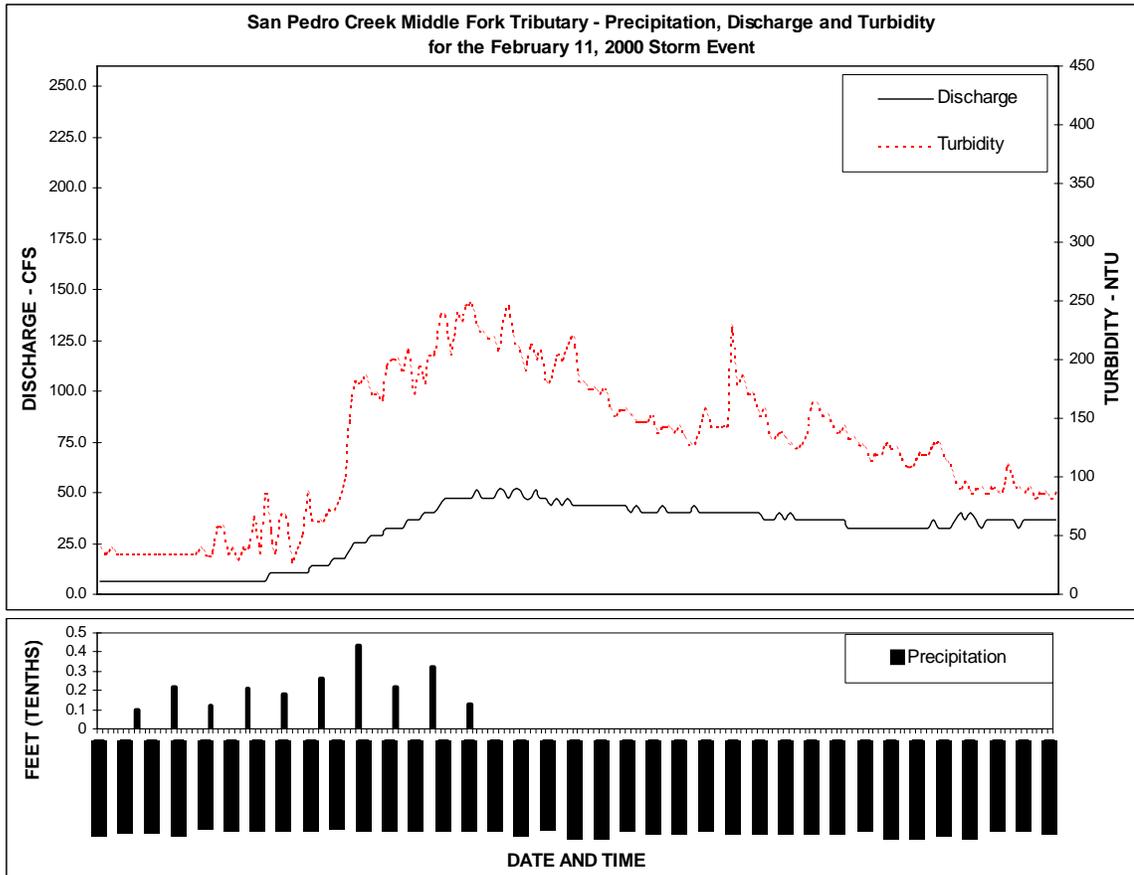
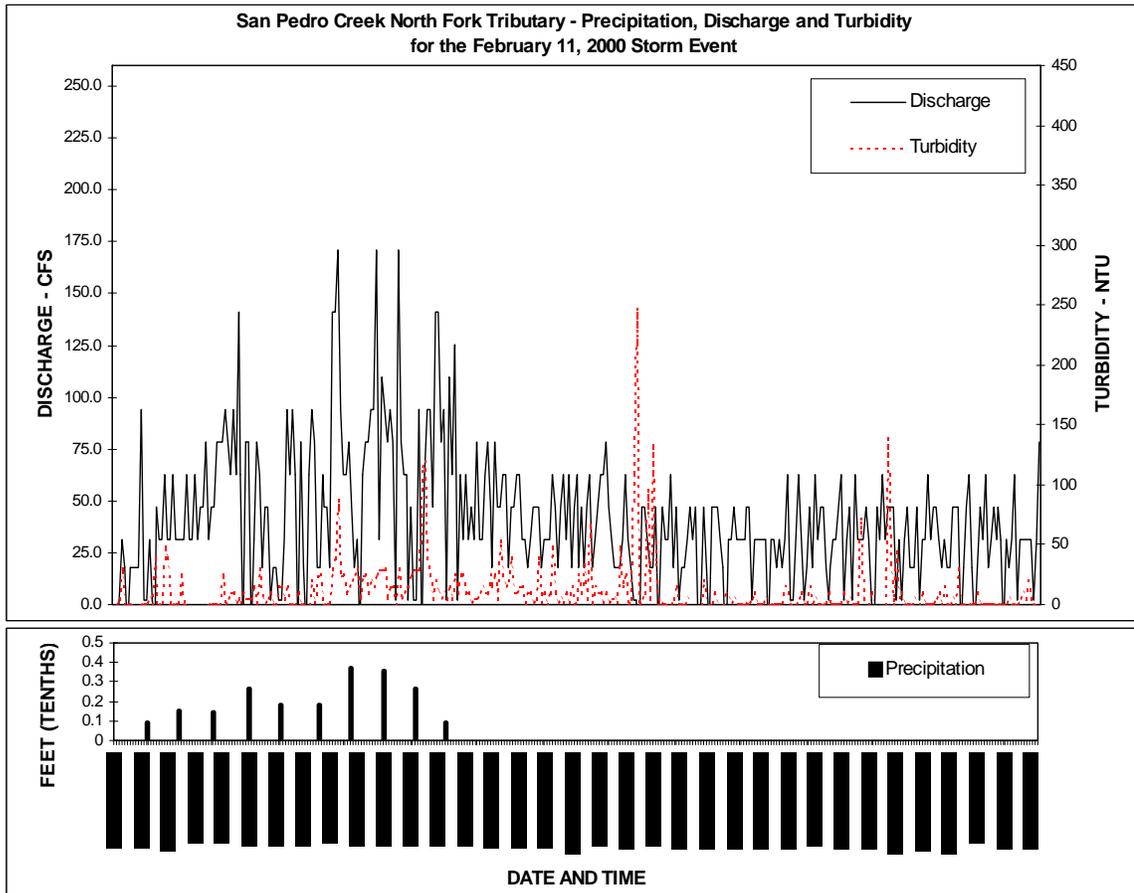
Response in turbidity was also very different between the two drainages. The relationship of turbidity to discharge in the Middle Fork was direct and consistent, showing a nearly parallel response between the two. The North Fork was somewhat erratic, more a function of supply, dilution, and concentration. Average turbidity in the North Fork was only 14.6 NTU while the Middle Fork averaged 127 NTU, or 9 times greater, demonstrating that sediment sources are greatly reduced by impervious surfaces and engineered concrete channels.

Figure 20. Middle Fork Rain, Discharge and Turbidity, February 11, 2000 Storm

Figure 21. North Fork Rain, Discharge and Turbidity, February 11, 2000 Storm

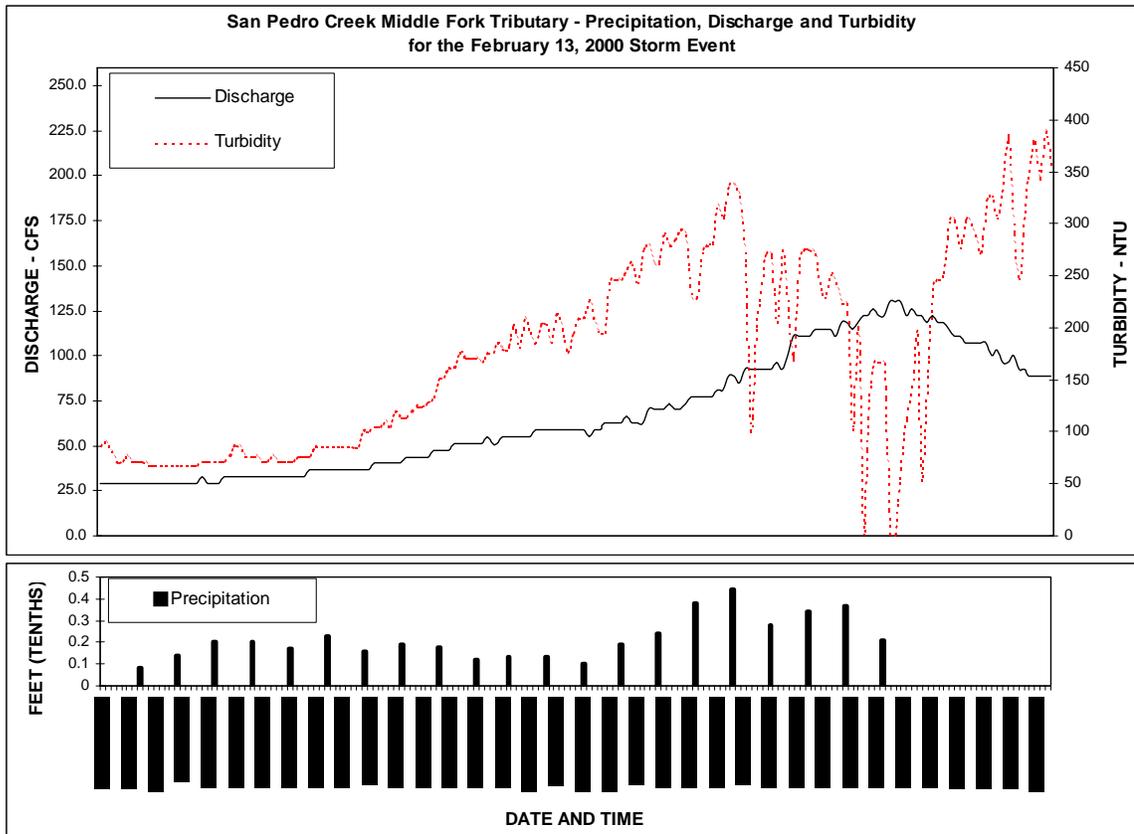
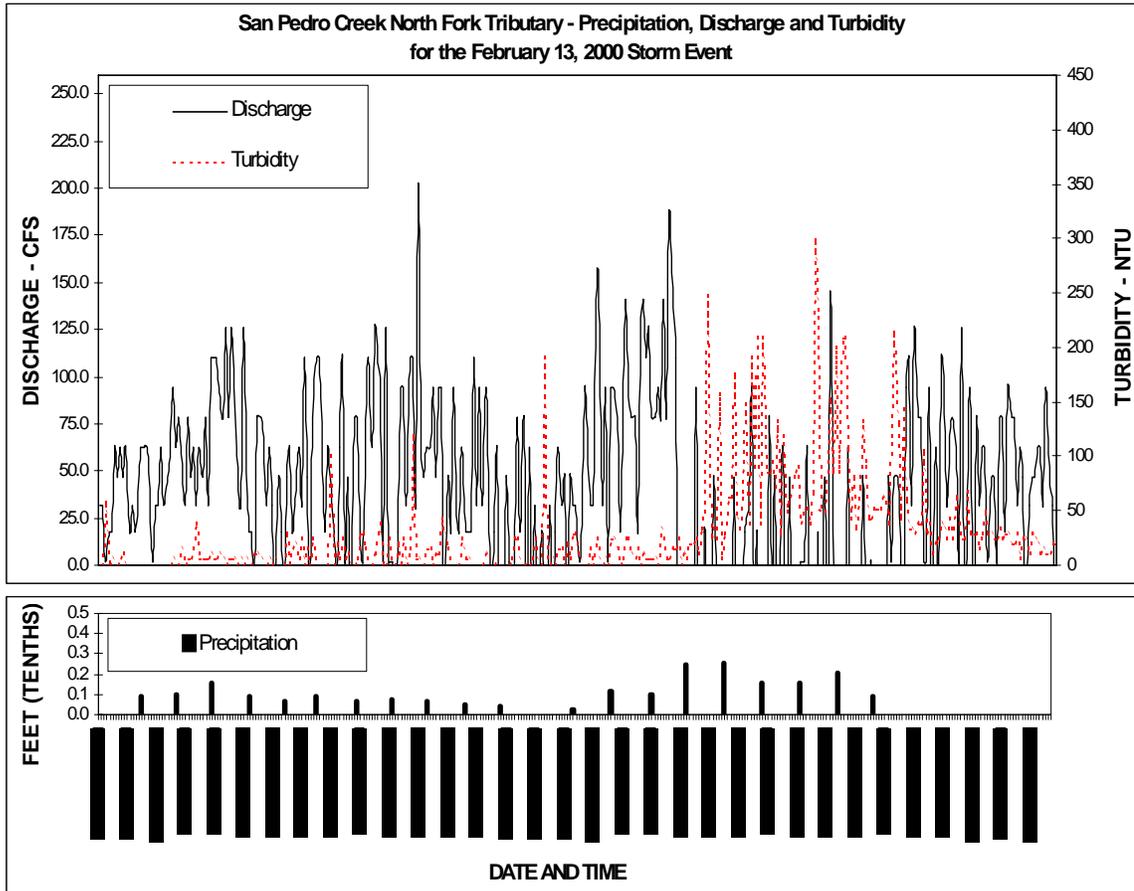
Peak and average turbidity in the Middle Fork were higher than the North Fork. Average turbidity was over 5 times greater demonstrating that sediment inputs from the earthen channel and natural watershed surfaces was much more substantial.

Figure 22. Middle Fork Rain, Discharge and Turbidity, February 13, 2000 Storm

Figure 23. North Fork Rain, Discharge and Turbidity, February 13, 2000 Storm

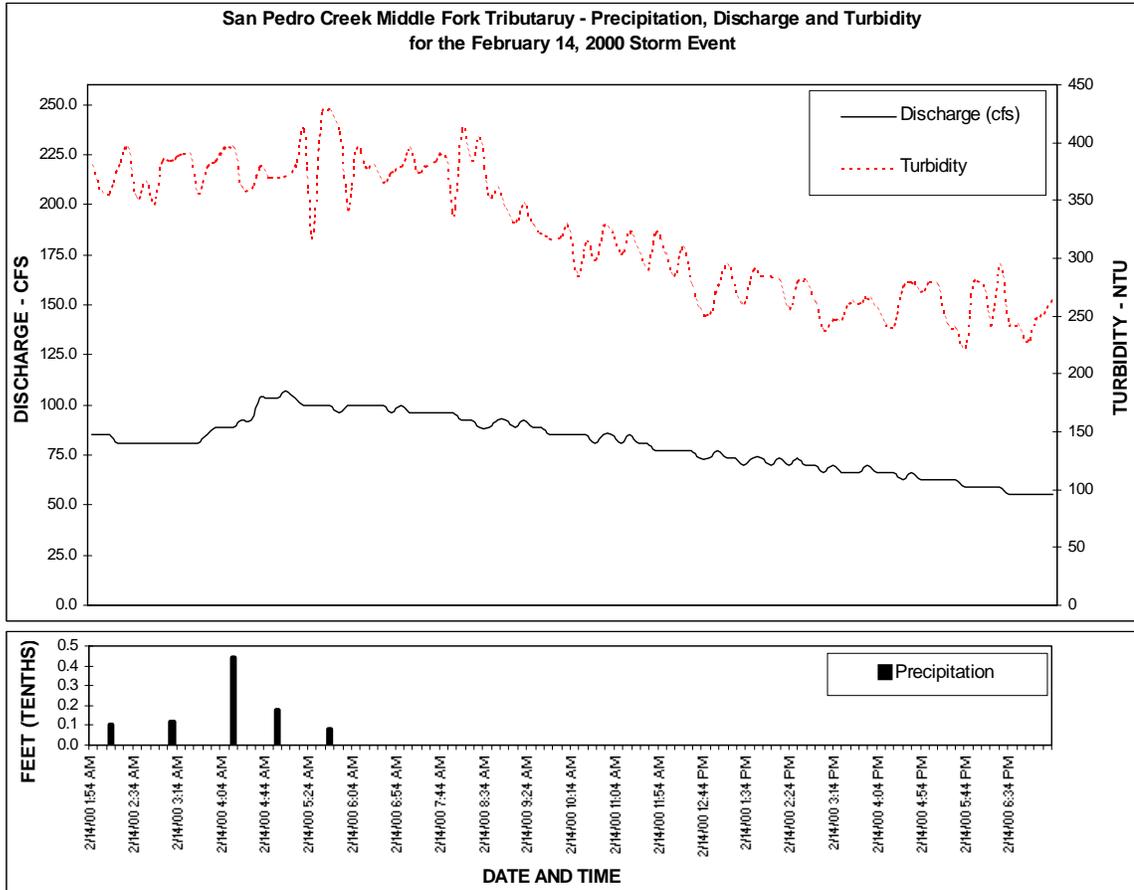
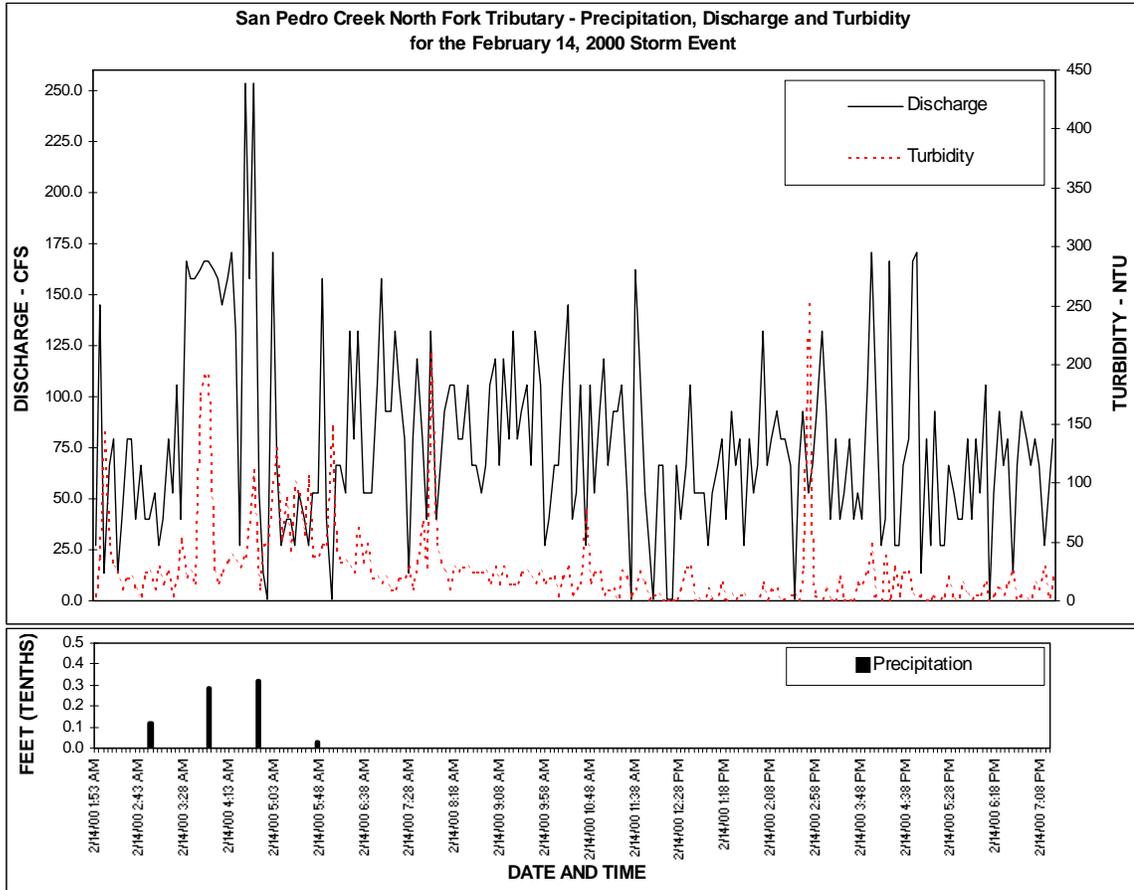
Peak and average turbidity remained lower in the urbanized drainage with a peak of 251 NTU and average of 19.9 NTU. The Middle Fork measured a peak of 427 NTU and an average of 321.7 NTU. Average turbidity was 16 times greater in the Middle Fork.

Figure 24. Middle Fork Rain, Discharge, and Turbidity, February 14, 2000 Storm

Figure 25. North Fork Rain, Discharge, and Turbidity, February 14, 2000 Storm

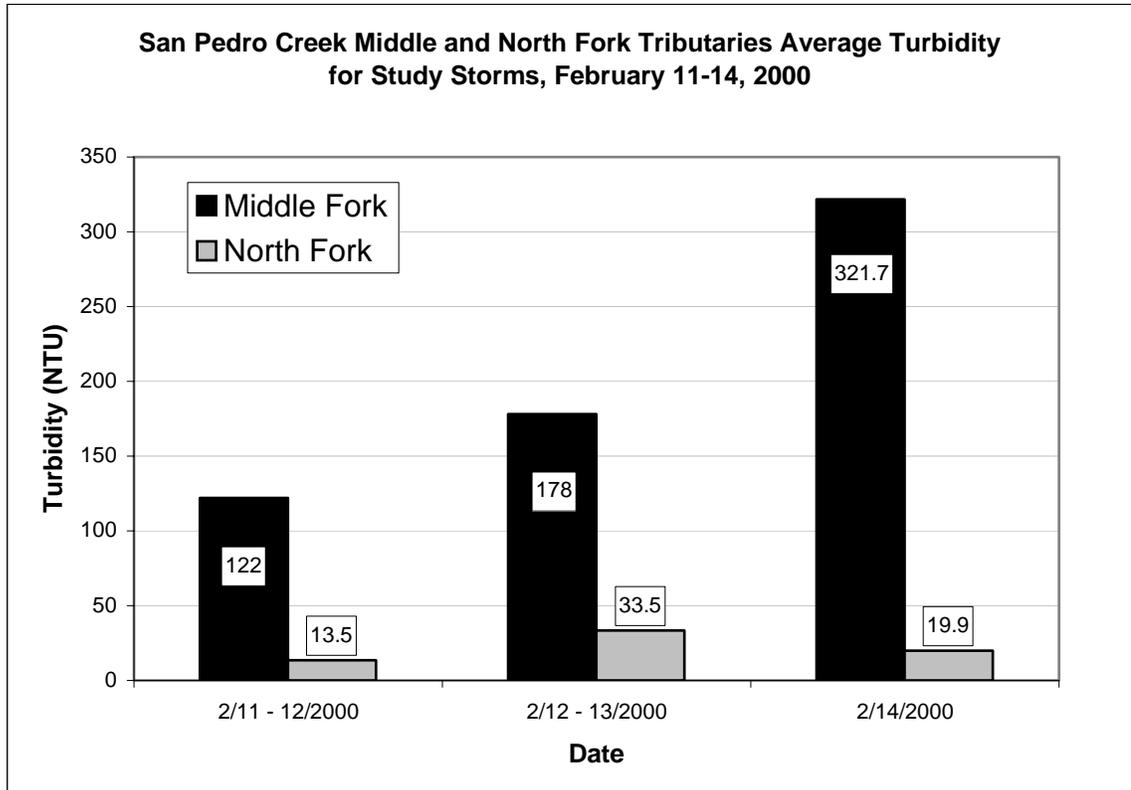
Figure 26. Average Turbidity for the Three Study Storms

Having established that the influence of urbanization has been a measurable alteration to the response of discharge and turbidity (a surrogate for sediment) the logical next step is to consider how the physical channel itself is affected.

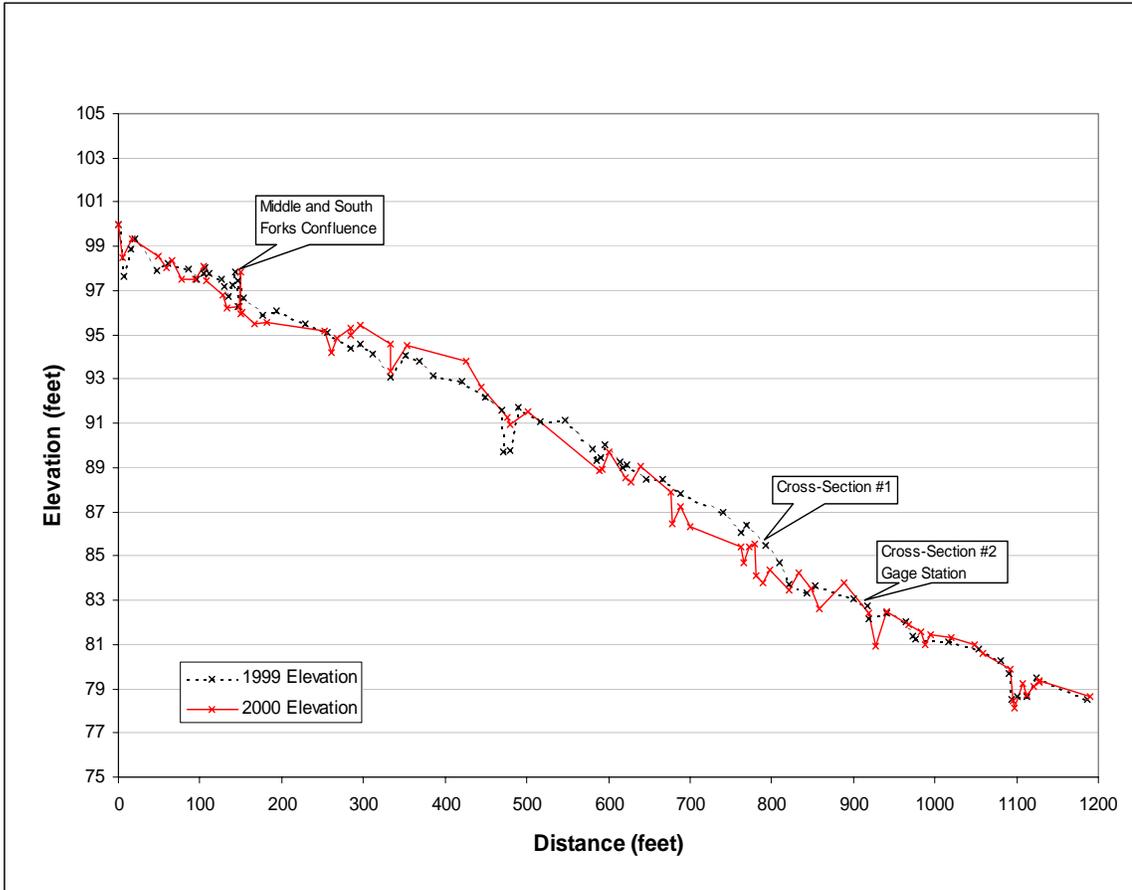
Figure 27, Middle Fork Longitudinal Profile, 1999 and 2000

An accurate determination of long-term trends in channel erosion and aggradation requires several years of observation similar to Leopold's research from 1953 to 1972 in the Watts Branch (Leopold 1973). This study included only two consecutive years of channel cross-section and profile surveys in the Middle and North Forks. As a result, observations from this data are limited to short-term, seasonal change. The 1,200 linear feet (365.8 m) Middle Fork Profile, beginning at Oddstad Boulevard and ending at the first upstream San Pedro Park bridge, experienced both incision and aggradation during the 2000 water year. Figure 27 shows the thalweg profile for 1999 and 2000 as well as the location of surveyed cross-sections and the stream gage station. According to the profile, this reach of the Middle Fork experienced localized incision and aggradation but was not particularly dominated by either. Minor deposition occurred just downstream of the Park bridge, downstream of the Middle and South Forks confluence, and in short sections near the stream gage station. Incision was evident up and downstream of the confluence, and for most of a 375 linear feet (114.3 m) section ending just downstream of cross-section #1. Overall, the bed did not exhibit a strong trend in either direction.

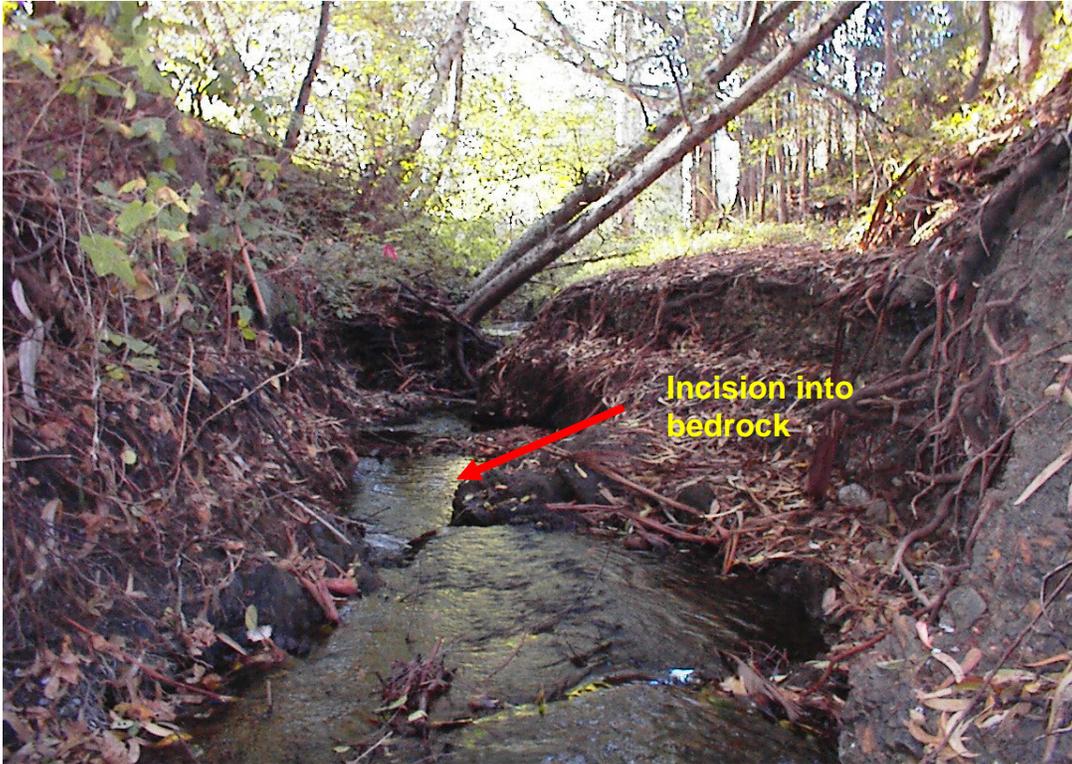
Photo 10. Middle Fork Cross-Section #1 - Showing Incision

Figures 28 and 29 show two surveyed cross-sections which confirm channel response to wet season flows during the study period. Cross-section #1, located about 100 feet (30.5 m) upstream from the gage station, was in a section of stream where the channel appeared to be incising through sandstone and conglomerate bedrock. Active channel incision at the cross-section is evident in Photo 10. Large storms reported in 1956, 1962, and 1982 (Collins et al. 2001) moved large amounts of sediment into the channels, covering the bed with alluvial deposits. Tree cores taken from young alders growing on a gravel deposit at the upstream end of the Oddstad Bridge showed them to be 18 years old, indicating they colonized the gravel bar following the 1982 storm. The Middle Fork appears to be incising through these deposits at this location. The area of vertical and lateral incision shown in the cross-section is consistent with incision shown at the same location on the profile and in the area of incision shown in the photo.

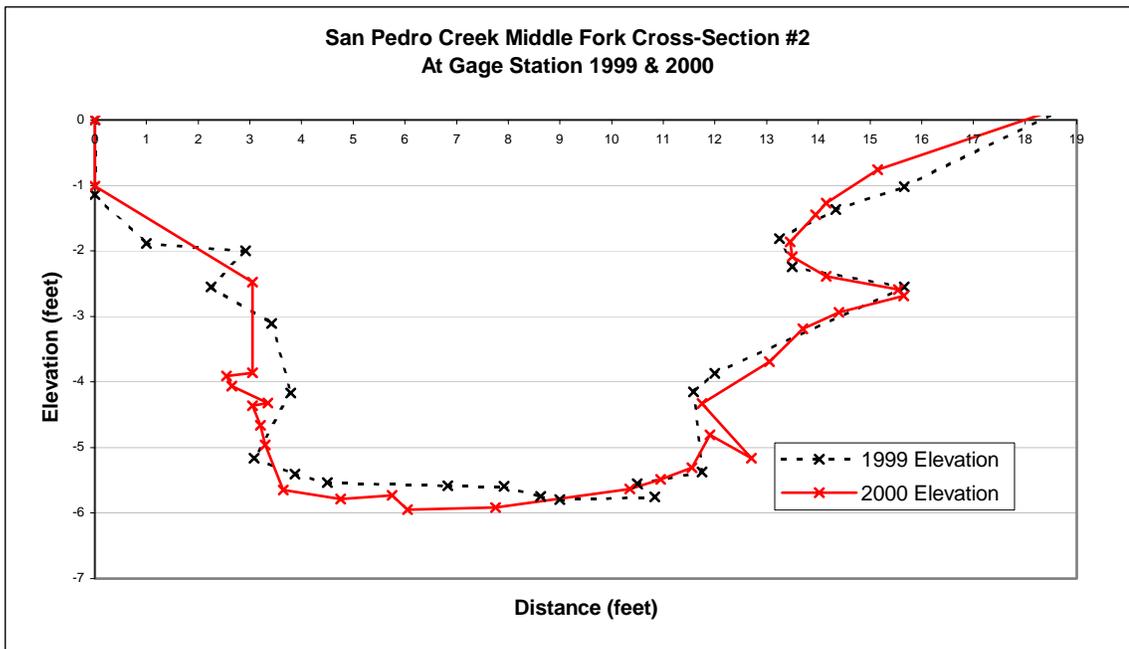
Figure 29. Middle Fork Cross-Section #2, Stream Gage Station, 1999 and 2000

Cross-section #2 at the stream gage station was relatively stable during the 2000 water year. Only minor bank erosion and bed incision (on the order of a few inches) occurred. A small gravel bar continued to develop immediately upstream of the gage station as seen in Photo 11, perhaps due in part to minor flow obstruction from the gage itself. Like cross-section #1, channel change at cross-section #2 at the stream gage is also consistent with the profile and photo.

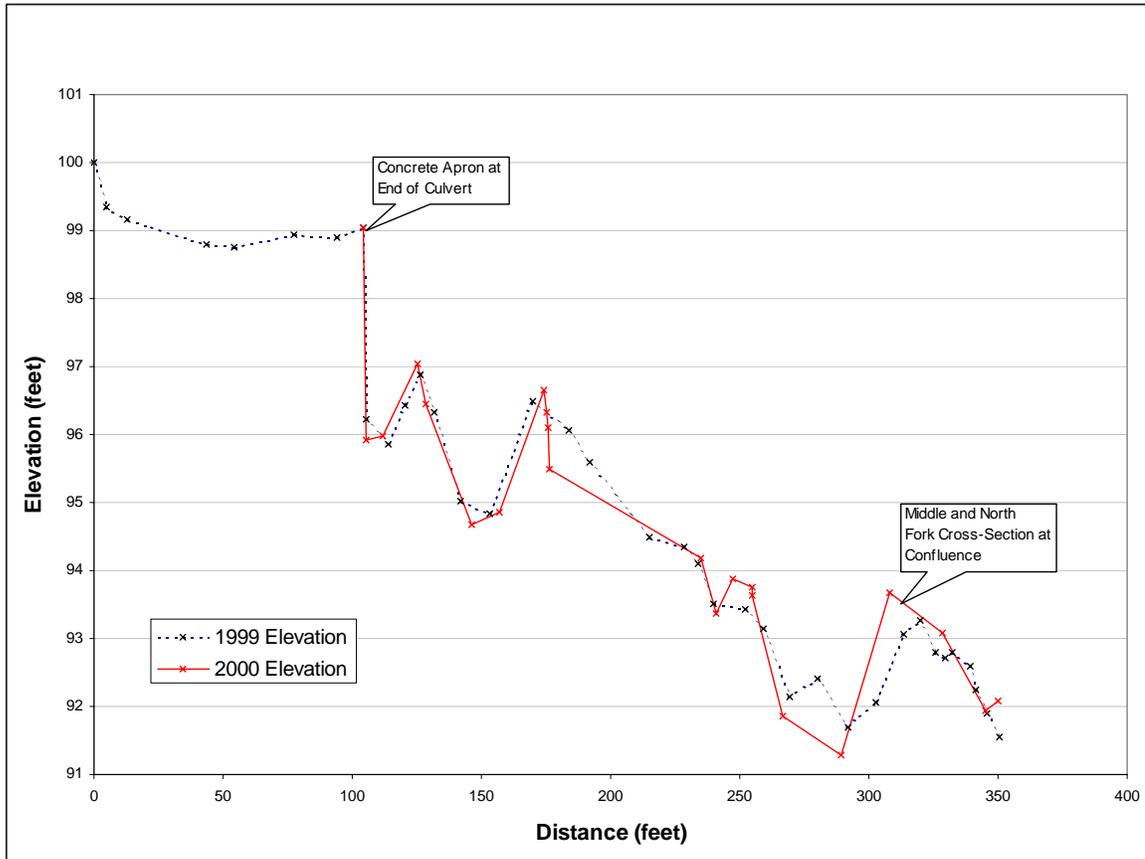
Figure 30. North Fork Longitudinal Profile, 1999 and 2000

The North Fork longitudinal profile was surveyed for 350 linear feet (106.7 m). Of that, only the downstream 250 feet (76.2 m) are earthen channel; much of this is armored with concrete rubble of undetermined origin. The upper 100 feet (30.5 m) are in the 8 feet (2.4 m) diameter concrete pipe. The entire reach length begins at the stream gage station and ends just downstream of the confluence with the Middle Fork as shown in Figure 30. This short reach of the North Fork experienced both incision and aggradation during the 2000 water year. All pools and a 25 feet (7.6 m) long riffle show some deepening with a range of 0.2 foot to 0.7 foot (0.06 m to 0.2 m). Aggradation was less both longitudinally and vertically with a few localized sections exhibiting accretions of 0.3 foot to 0.6 foot (0.09 m to 0.18 m). The most notable deposition was at the location of the one North Fork cross-section (Figure 31), which captures both the Middle and North Fork at their confluence

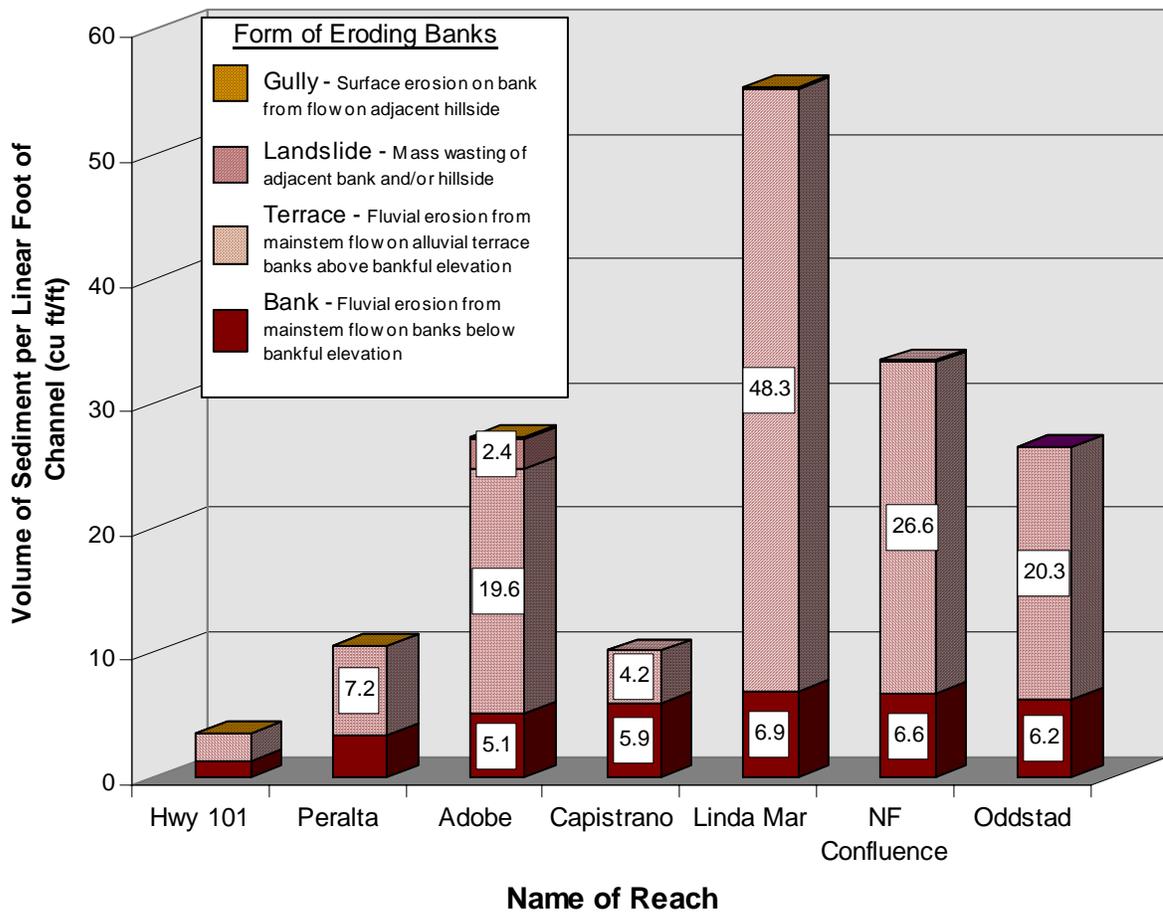
Figure 32. Bank Erosion Volume Per Linear Foot (Collins et al. 2001)

**SAN PEDRO CREEK 2.6 MILE STUDY REACH, 1999
Bank Erosion Volume per Linear Foot for Each Reach
Over the Last 217 Years**
