MODELING GEOMORPHIC EFFECTS ON EELGRASS BEFORE AND AFTER  
RESTORATION, NISQUALLY DELTA, WASHINGTON

Master of Arts  
In  
Geography: Resource Management and Environmental Planning

Anna Elizabeth Davenport

May 2012

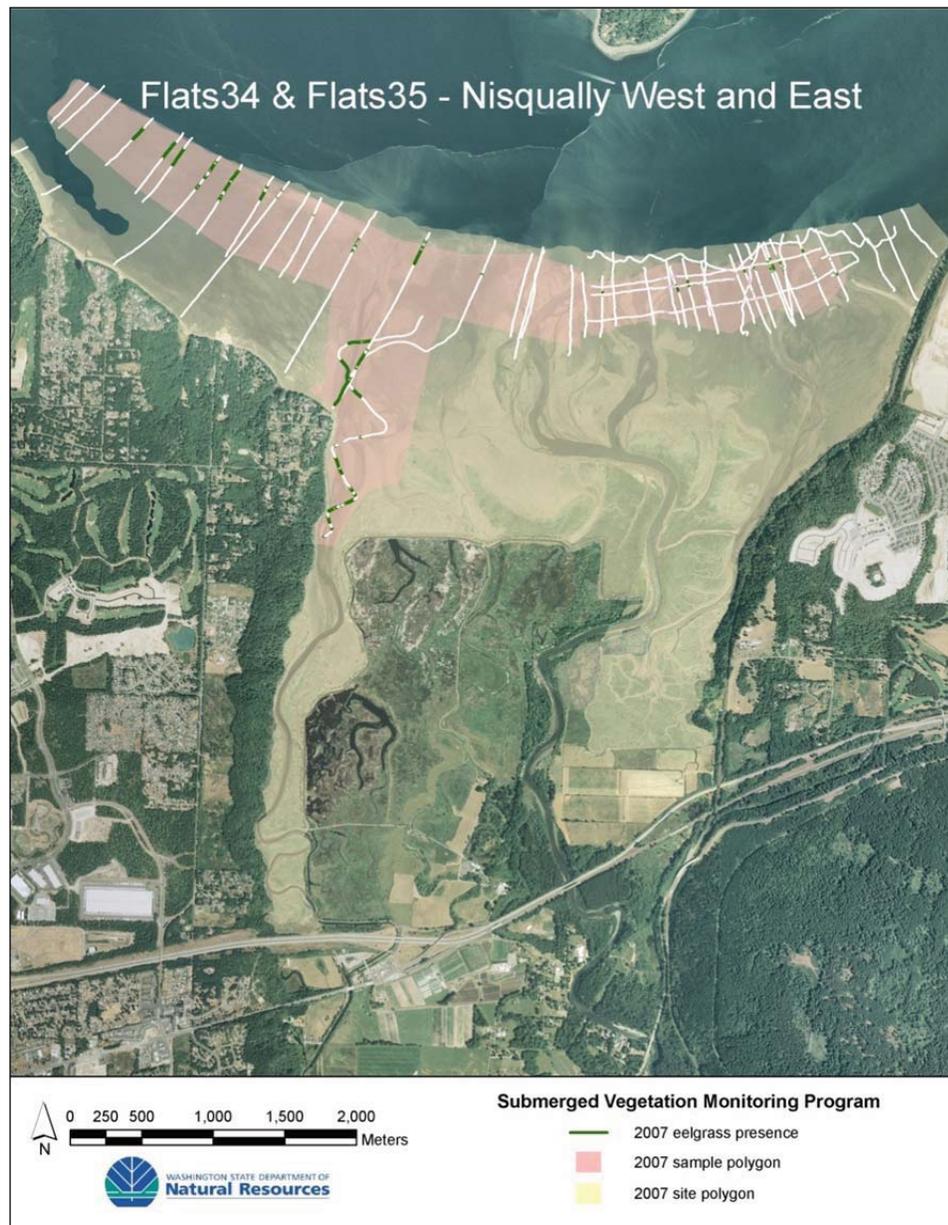
Figure 3. Map of sites Flats34 and Flats35 showing eelgrass presence and absence in 2007 within Nisqually tidal flats used to determine study site. Map: Washington State Submerged Vegetation Mapping Program 2011

Nisqually Delta East and West sites were used as a basis for where to focus on eelgrass distribution for classification within the delta front (Figs. 3 and 4). These maps indicate eelgrass presence or absence for areas in Puget Sound through both video transect lines and polygons incorporating presence data. The area outside of the former dike is covered by the eelgrass bed sites Flats34 and Flats35. These site maps provided a basis for establishing the extent of the study area within the Nisqually Delta based on where eelgrass was present in the past. Areas were then analyzed within the study site extent using remotely sensed high resolution false-color infrared aerial photography. Flats34 and 35 are due to be sampled for eelgrass video transects again later this year (Jeff Gaeckel pers. comm. April 6th 2010). The results will also yield predictions for where distributions could expand in the future. These could then be compared with the 2012 SVMP sampling to gauge the validity of eelgrass distribution predictions gained through the classification and field sample analysis methodology of this research. Results will also provide key areas in which to focus further eelgrass research along the delta front. Areas of eelgrass farther out towards the Nisqually Reach in deep water that cannot be mapped using aerial photos will be mapped using sonar later this year (pers. comm. Andrew Stevens November 1<sup>st</sup> 2011) and by providing advance knowledge of where eelgrass is located at present, the mapping in the Nisqually Reach has the potential to create a complete assessment of eelgrass distribution throughout the Nisqually Delta front.

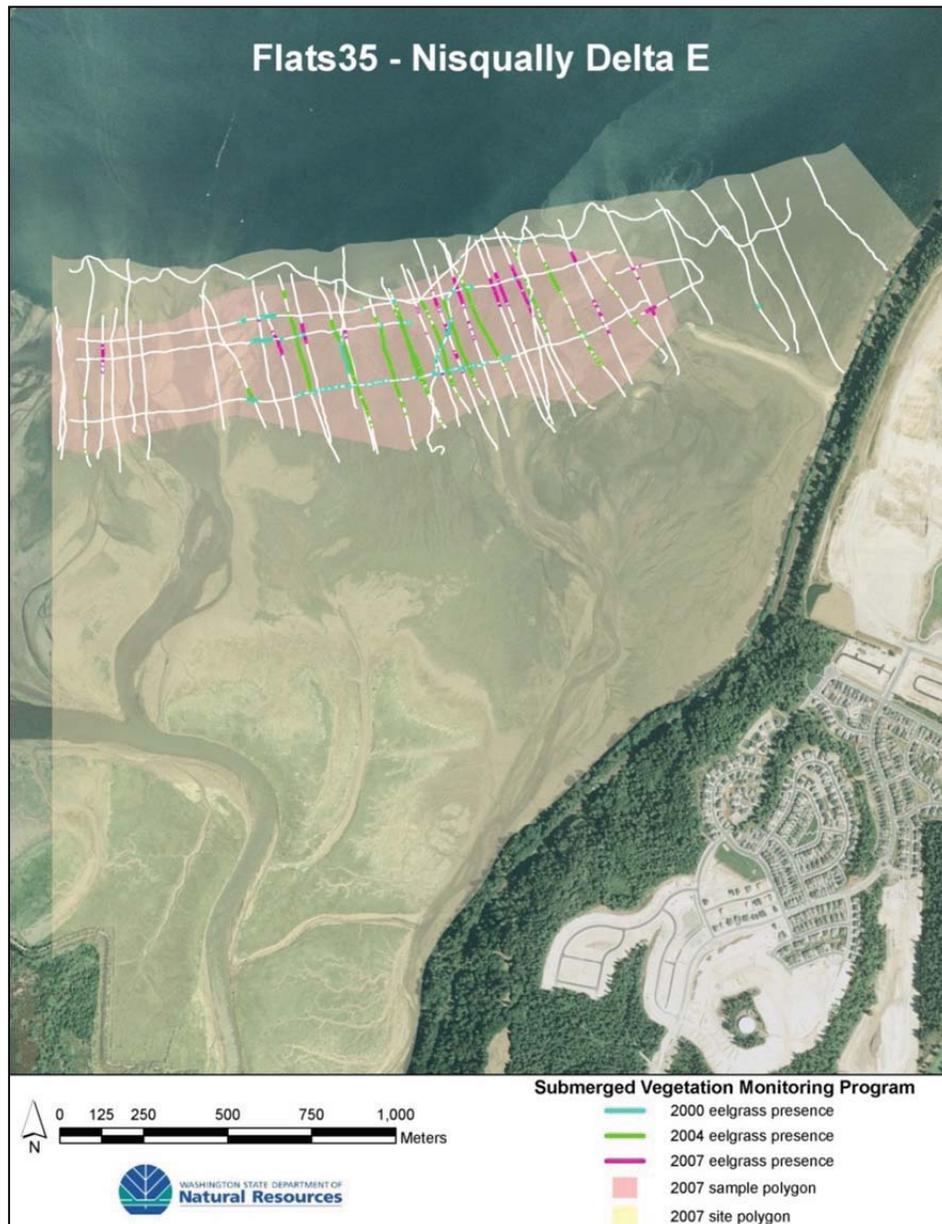
Figure 4. Map of inset of Flats 35 showing eelgrass presence and absence within Nisqually tidal flat used to determine study site. Map: Washington State Submerged Vegetation Mapping Program 2011
