GEOMORPHOLOGY AT THE CONFLUENCE  
OF STREAM RESTORATION AND FLOOD CONTROL

A Thesis submitted to the faculty of  
San Francisco State University  
In partial fulfillment of  
the requirements for  
the Degree

This study assesses the geomorphologic response of a stream management project integrating ecological restoration principles with flood control. Damaging floods on the coastal stream San Pedro Creek in Pacifica, California, led to replacement of the straightened and incised natural channel with a constructed meander and vegetated floodplain. The intention was to mitigate flooding and increase habitat for species such as the federally-listed threatened Central California steelhead (*Oncorhynchus mykiss*). Longitudinal profile data show a degradation and aggradation oscillation. Smaller scale meanders have begun to form on the straight reaches between larger designed meanders. Headcutting backwaters at an inflection point initiated a chute cut-off. Preliminary flood modeling demonstrates less than a 50-year flood protection level. These results suggest that the stream reach is not stabilizing as designed, but is instead adjusting according to geomorphological principles. Specif

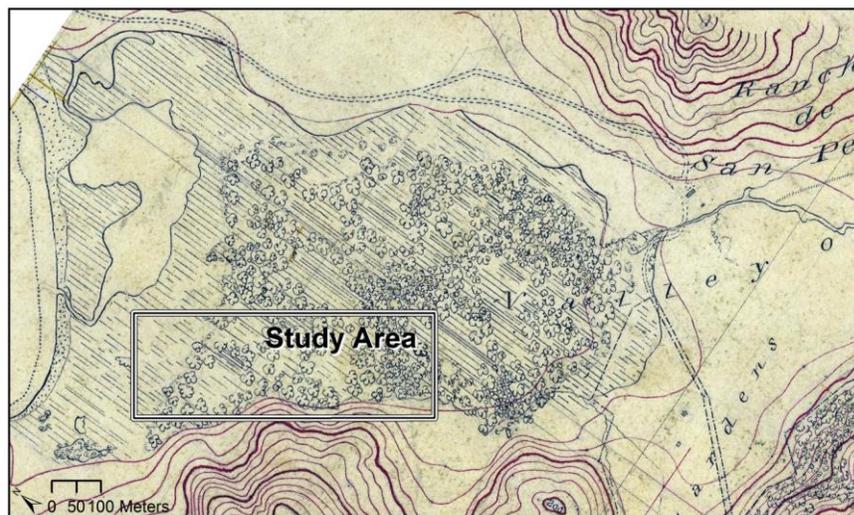
Figure 1: The stream study area overlays an 1866 T-sheet. By 1896 the stream was straightened and by 1915 the willow grove and wetland area were drained (Culp 2002).

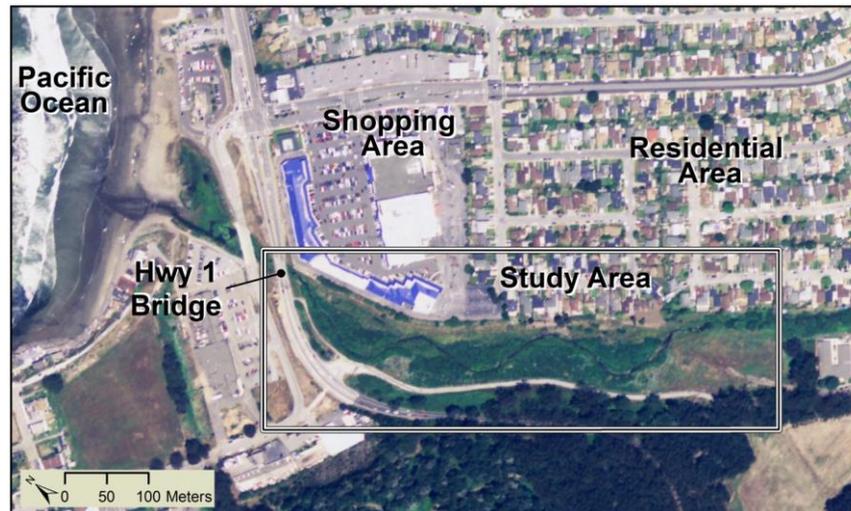
Figure 2: The study area in 2005. Shopping and residential areas are to the north and the creek passes beneath Highway 1 before draining into the Pacific Ocean.

0.04 km<sup>2</sup>. The remainder of the historic wetland and lake are now business and residential areas (Figure 2).

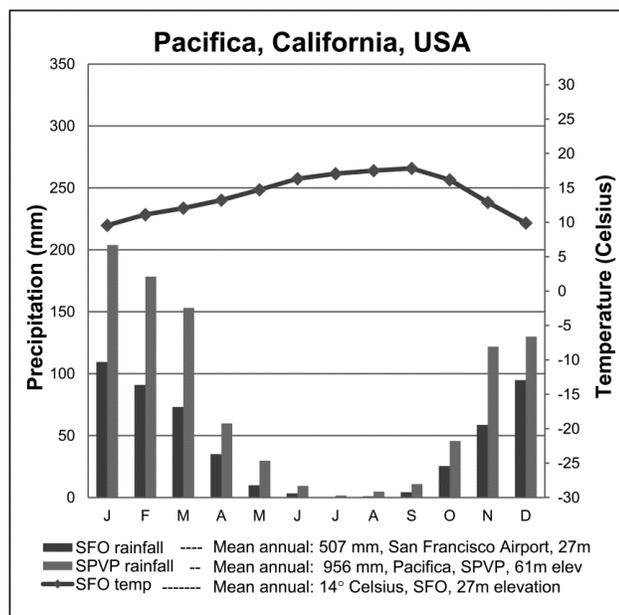
Figure 3: Climograph for Pacifica, California. Data courtesy of San Pedro Valley Park and wrcc.dri.edu.

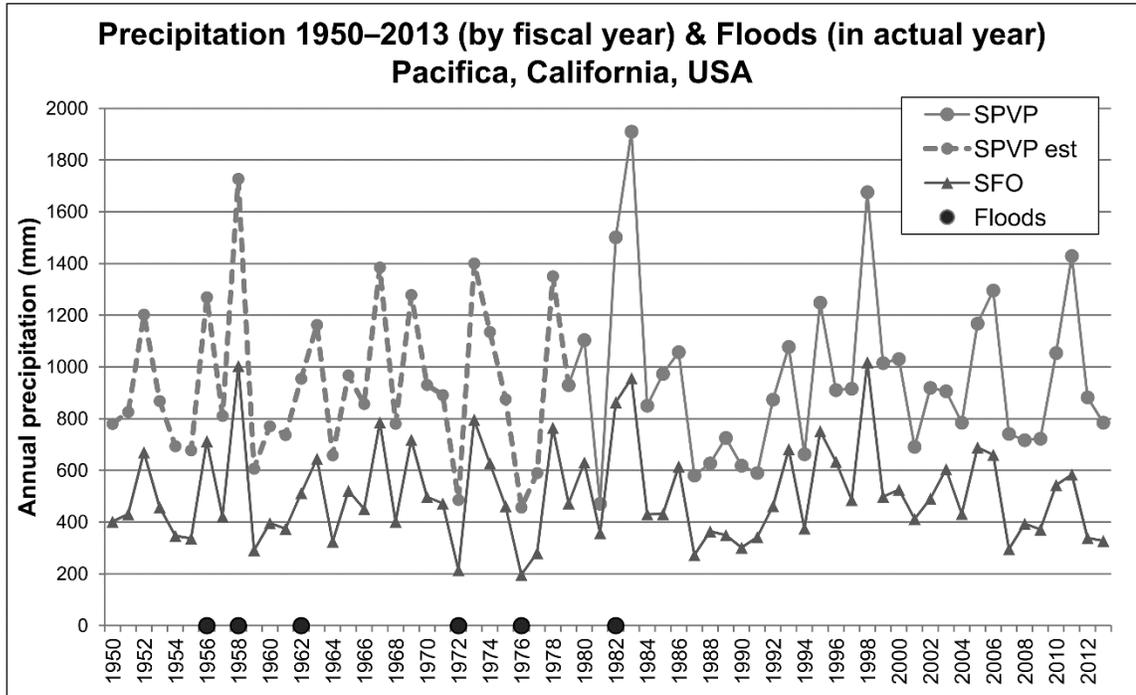
Figure 4: Annual precipitation 1950–2013. Dashed SPVP value calculation described in the Results Section. (Data courtesy of San Pedro Valley Park and wrcc.dri.edu.)

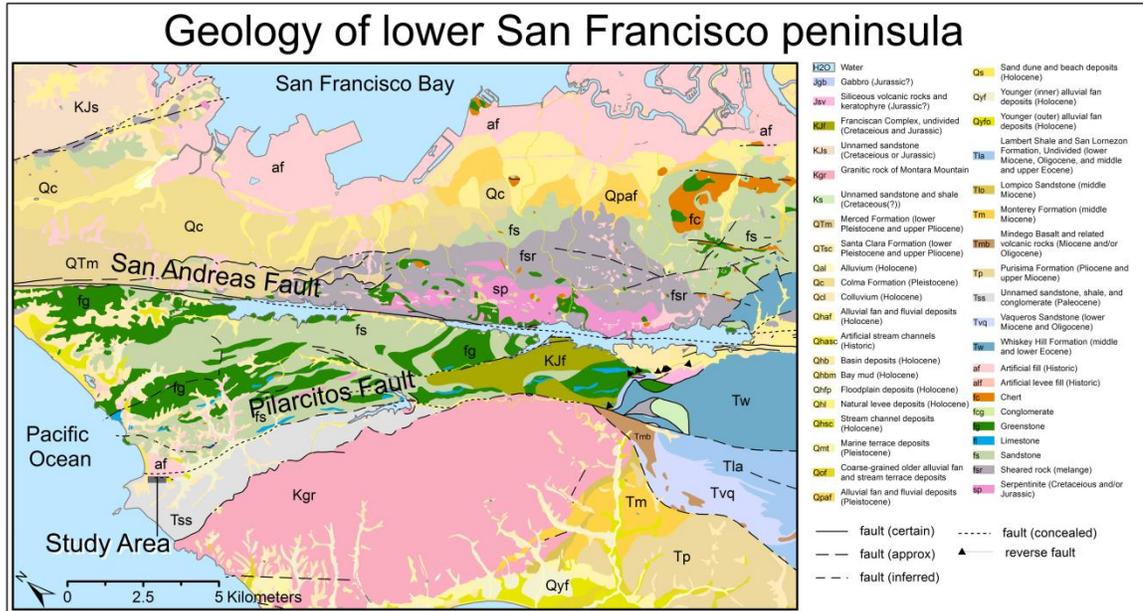
Figure 5: Geology of lower San Francisco peninsula and San Mateo County. Modified from Brabb, Graymer, & Jones (1998). Please see original map for the details of geological units.

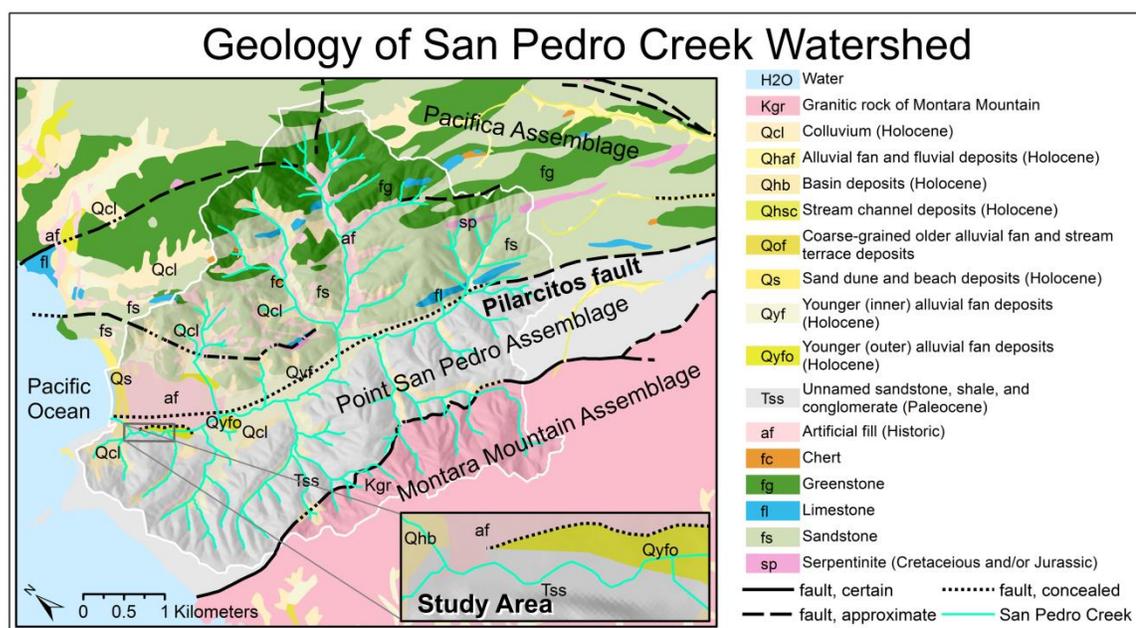
Figure 6: Geology of San Pedro Creek watershed. Modified from Brabb, Graymer, & Jones (1998). Please see original for the details of geological units.

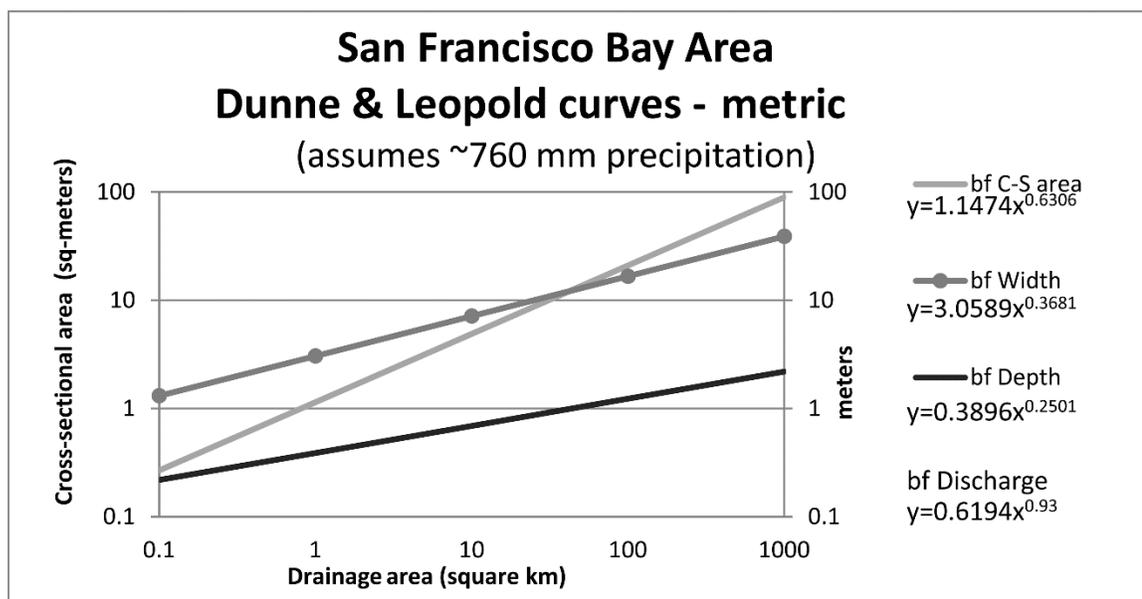
Figure 9: Bankfull dimensions by drainage area based on equation approximations of the regional curves presented in graphs from Dunne & Leopold (1978). The bankfull discharge equation for the SF Bay area was included in their text and is included in the legend above.

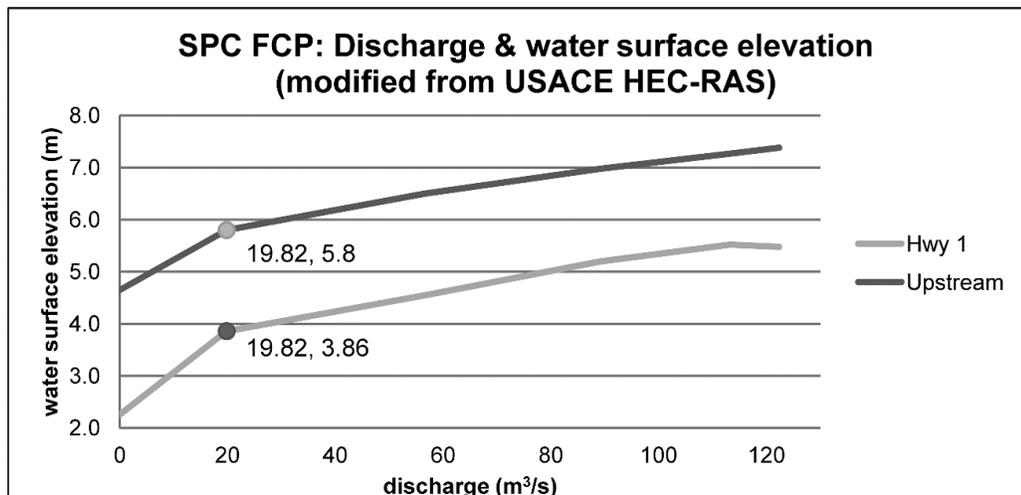
Figure 10: Discharge and water surface elevation downstream and upstream of the study area. Elevations based on the vertical datum NAVD88. Note that 19.82 m<sup>3</sup>/s is the 2-year flood return interval discharge value.

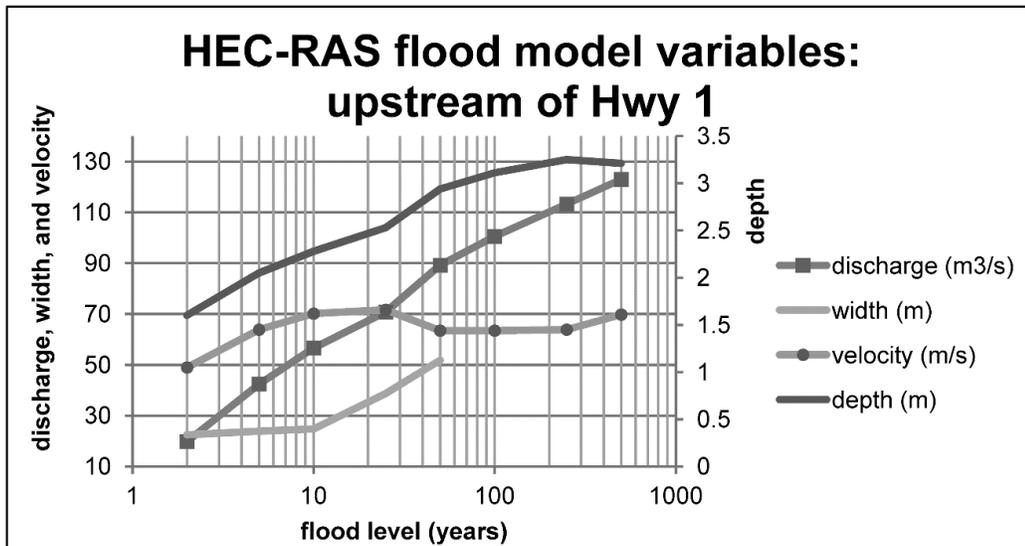
Figure 11: Model variables upstream of Highway 1. Notes: Model discharge (Q) is the same at each cross-section for one flood return interval value. An approximate equation for Q is  $y = 18.569 \cdot \ln(x) + 11.708$ . However this does exaggerate the 2-year return interval flood value of 19.8 to 24.6 m³/s.

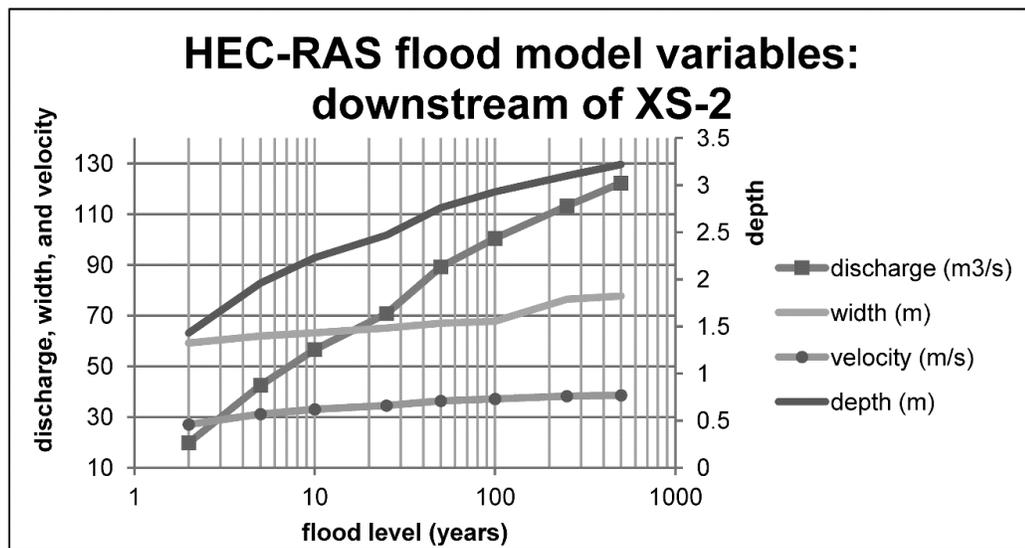
Figure 12: Model variables near cross-section 2 (CS2/X-S2), discussed later in this paper, taken from USACE's HEC-RAS flood model.

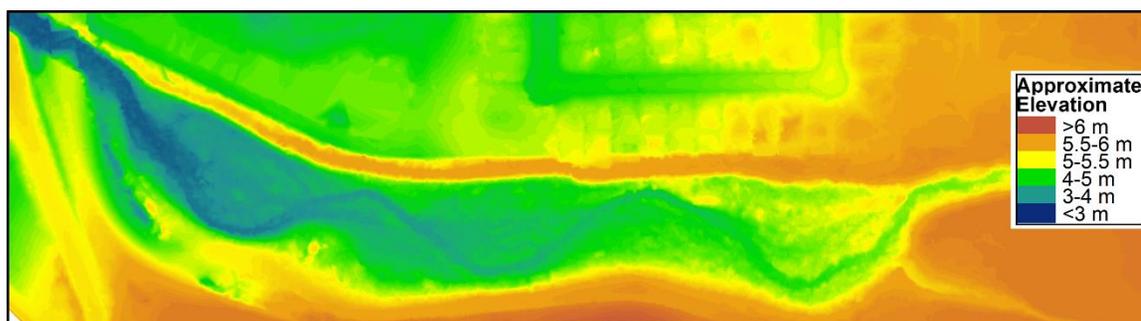
Figure 13: High resolution LiDAR flow in 2011 by Towill.

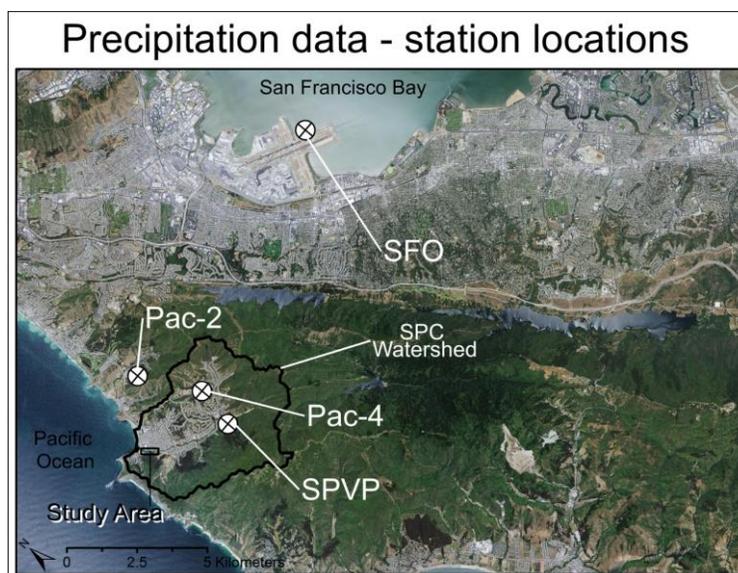
Figure 14: Precipitation data station locations. SPVP and Pac-4 stations are more indicative of precipitation in the SPC watershed than Pac-2 or SFO, which are outside the watershed.

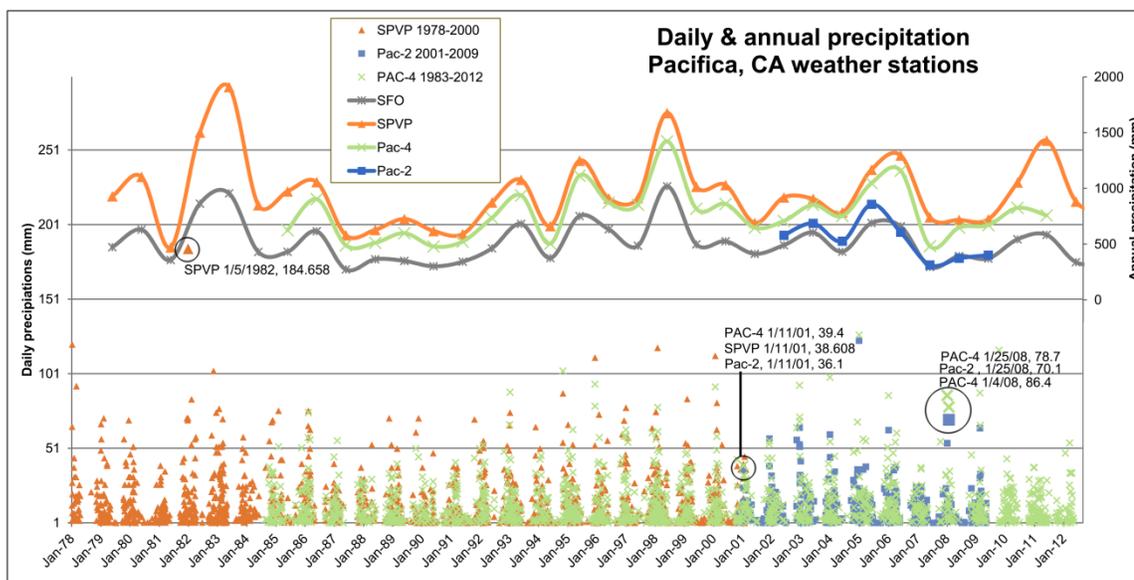
Figure 15: Daily rainfall 1978–2012 at three local Pacifica stations is compared to their annual precipitation and annual precipitation from SFO (daily SFO not shown). Data courtesy of San Pedro Valley Park and wrcc.dri.edu.

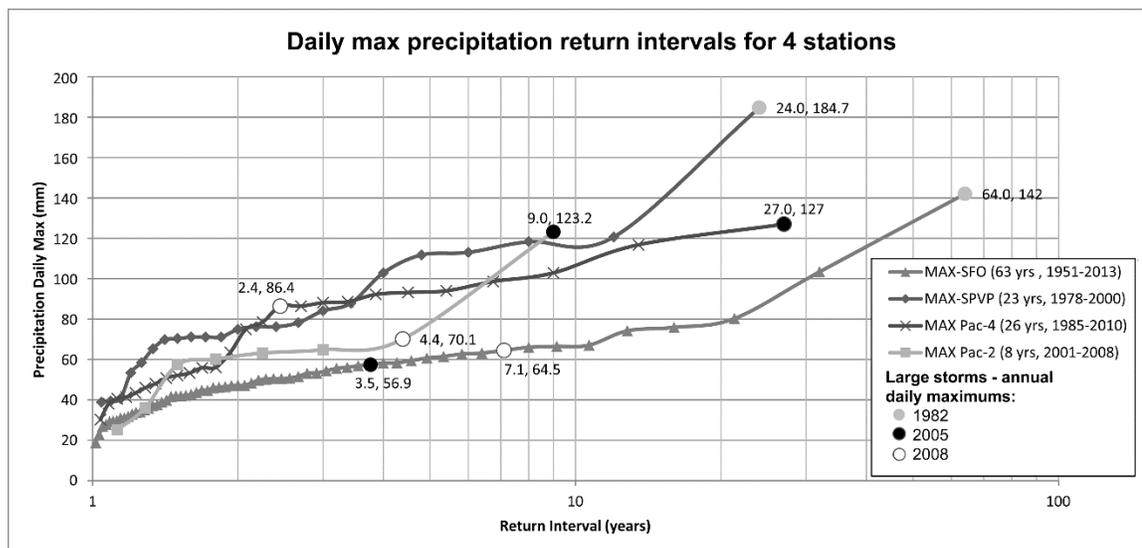
Figure 17: Annual maximum daily precipitation return intervals for four precipitation data sets, including three in Pacifica and one at SFO. Same day largest storms for 1982, 2005, and 2008 are labelled with return interval (years) and precipitation (mm). Data courtesy of San Pedro Valley Park and wrcc.dri.edu.

Return intervals for the storms in 1982, 2005, and 2008 are then calculated using the trendlines (Table 3). It is interesting to note that the 2008 storm in Figure 17, found in all but the SPVP dataset, ranges from a 2.4 to 4.4 year return in Pacifica and 7.1 year return at SFO. Calculating 2008 return intervals using the trendlines gives 2.9 to 4.3 in Pacifica and 5.5 at SFO (Table 3). These same three stations also captured the 2005 storm, which was the largest-on-record storm for the two Pacifica stations at 9- and 27-year return intervals. However, the SFO return interval was only 3.5 years. This may be an artifact of fewer years of data or demonstrative of a particular wind direction during the storm. The trendline return interval calculations for 2005 maximum event are 11.4 to 16.4 years in Pacifica and 3.8 years at SFO. Finally, the 1982 storm, captured by SFO and SPVP, has return intervals of 64 and 24, respectively, being the maximum event on record. However, the trendline calculations return 246.4 years for SFO and 37.7 years for SPVP. This is not surprising, given the steep slope of the SPVP trendline and the low slope of SFO. Nevertheless, it shows the difficulty in assessing return intervals with limited and varying years of precipitation data.

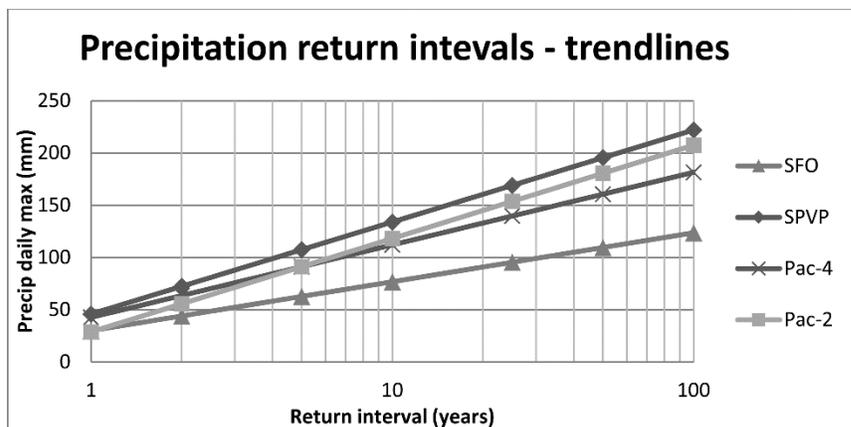
Figure 18: Precipitation return interval trendlines with points at return intervals for years 1, 2, 5, 10, 25, 50, and 100.

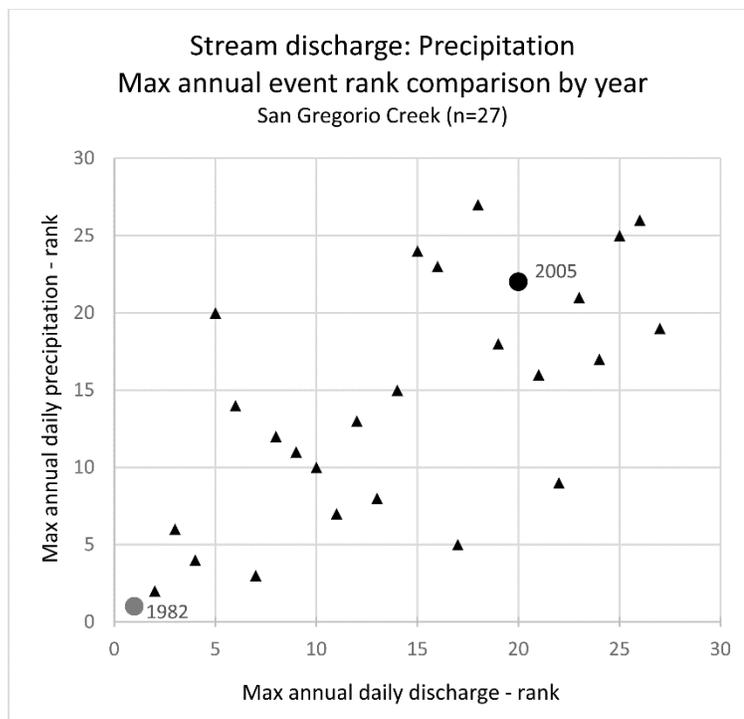
Figure 19: San Gregorio Creek discharge and precipitation correlation. Annual peak daily discharge ranked by magnitude is compared to the same year's annual maximum daily precipitation ranking by magnitude. Stream gauge data from [nwis.waterdata.usgs.gov](http://nwis.waterdata.usgs.gov) and precipitation data from [weather-warehouse.com](http://weather-warehouse.com).

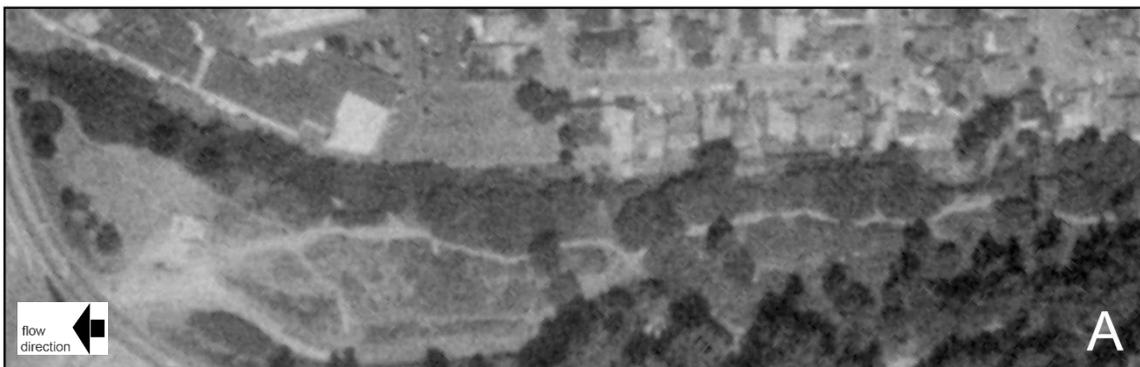
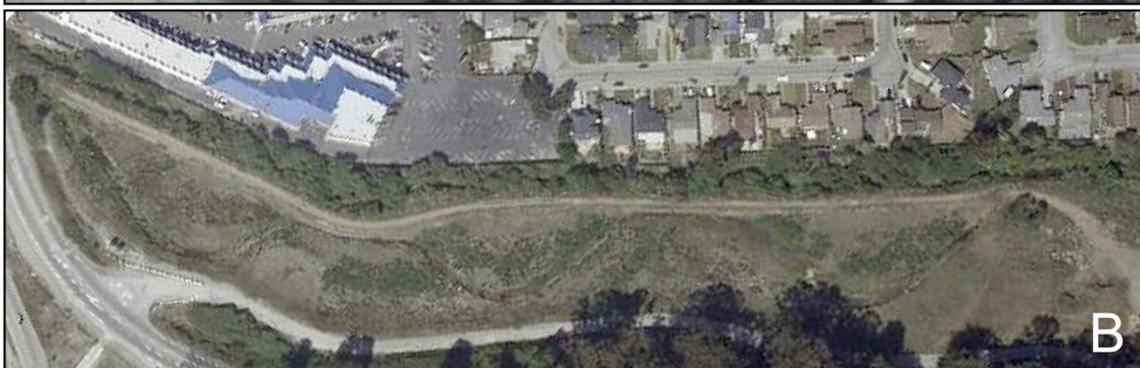
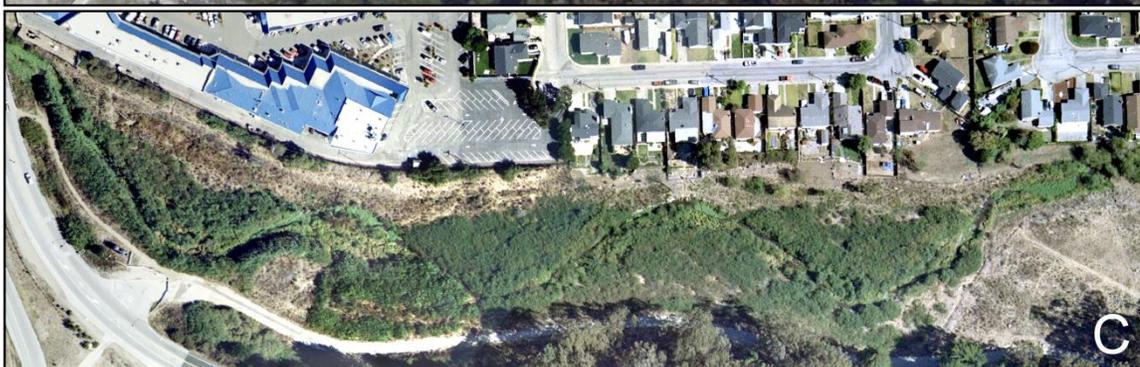
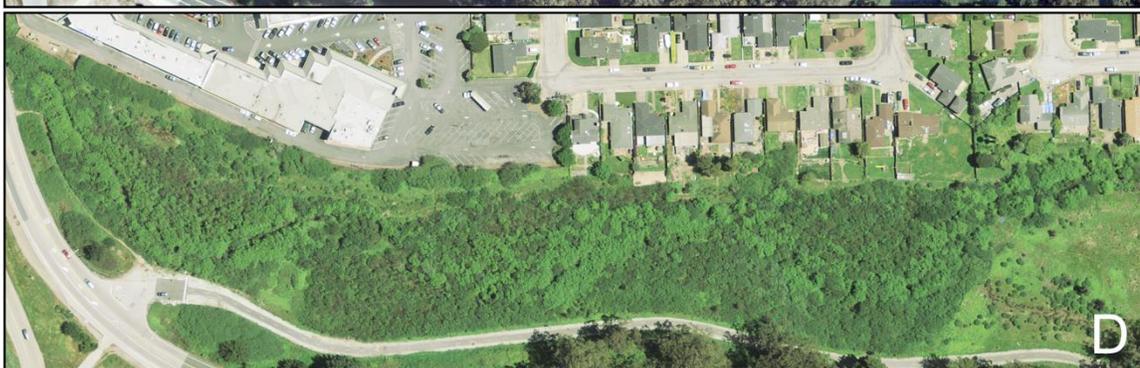
Figure 20 (previous page): USGS high-resolution aerial orthoimagery of the stream reach over time. **A: 1993** (DOQQ 30 cm resolution), **B: 2002** (MrSID 30 cm maximum resolution), **C: 2005** (seamless 15 cm resolution), and **D: 2011** (seamless 30 cm resolution)

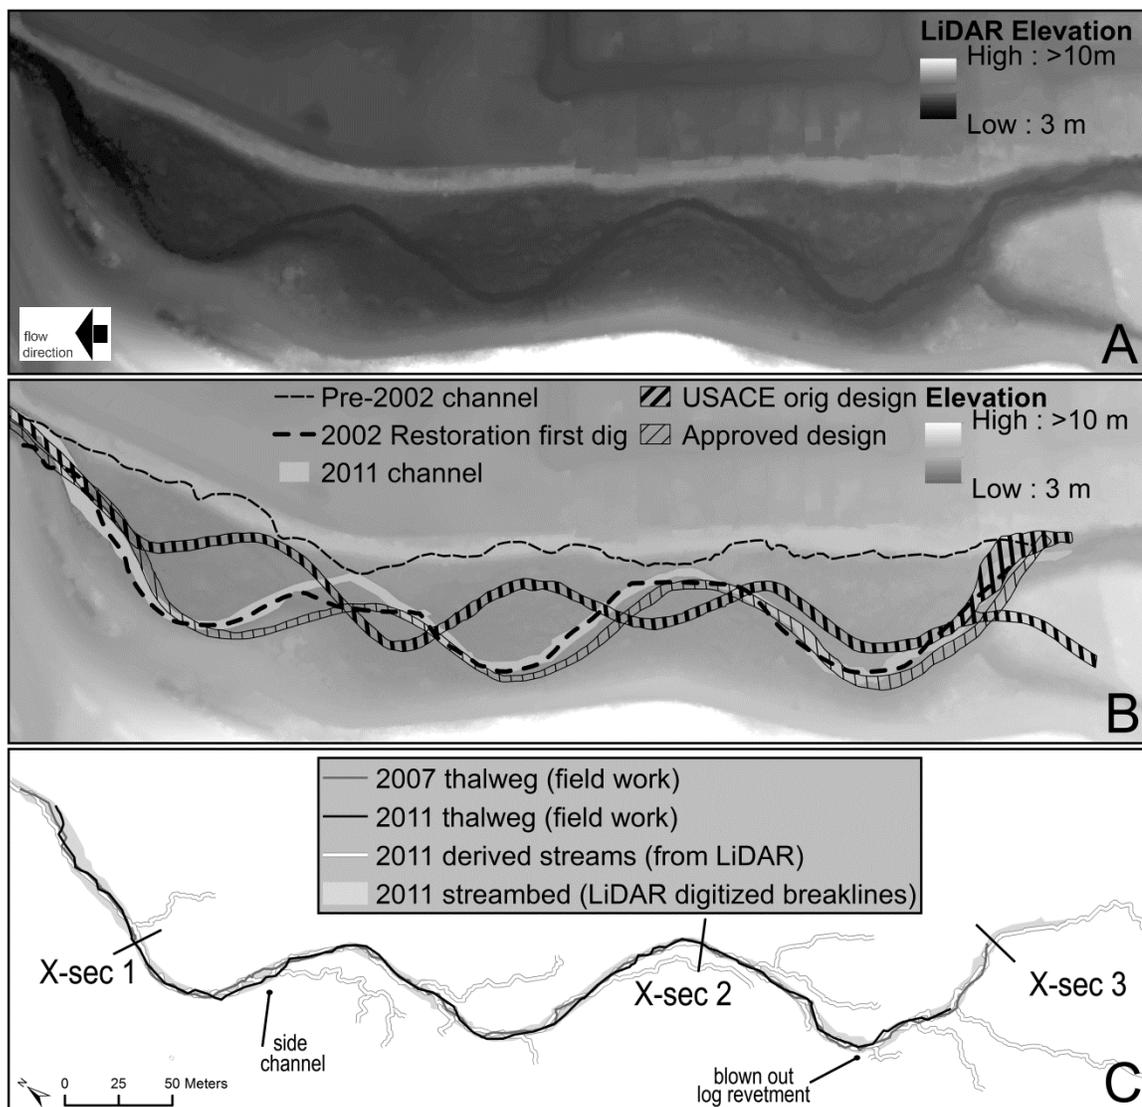
Figure 21: Planviews comparing LiDAR and other data sources. A: LiDAR planview of the stream reach, B: Planviews digitized from sketches and orthoimagery, and C: Planviews of fieldwork (2007 and 2011) and LiDAR derived streams, along with digitized stream channel breaklines. The culvert draining in to the study area from the lower right, shows clearly in A.

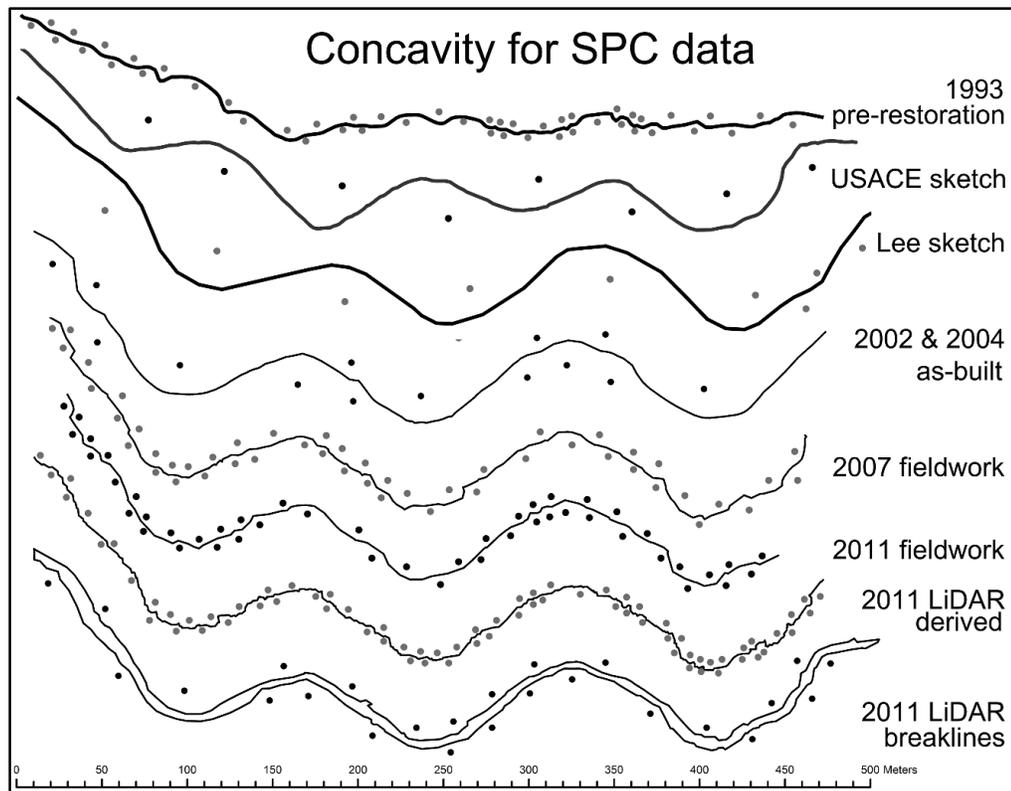
Figure 22: Concavity changes were noted visually and indicated with points. Each data source is labelled at right.

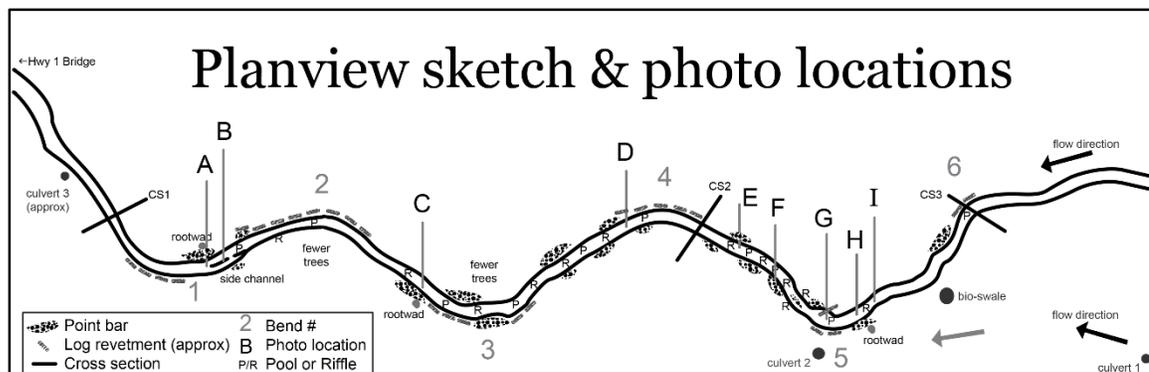
Figure 23: Planview sketch and locations of photographs (“A”, “B”, “C”, etc.) discussed later.

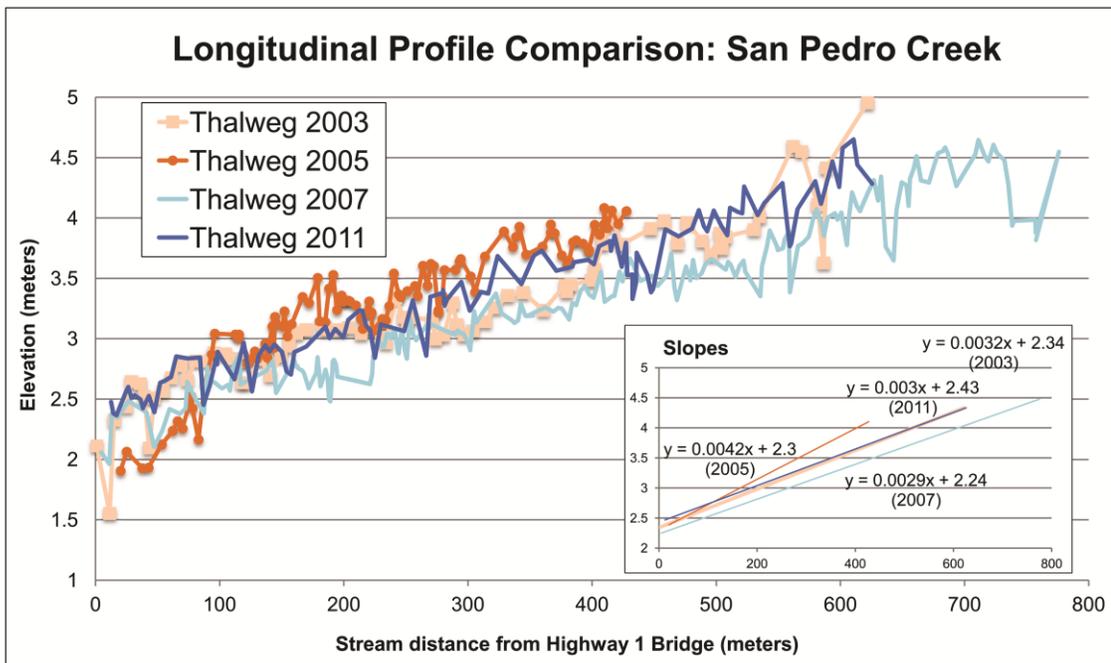
Figure 24: Longitudinal profile comparison I: Fieldwork in 2003, 2005, 2007, and 2011, with inset trendlines.

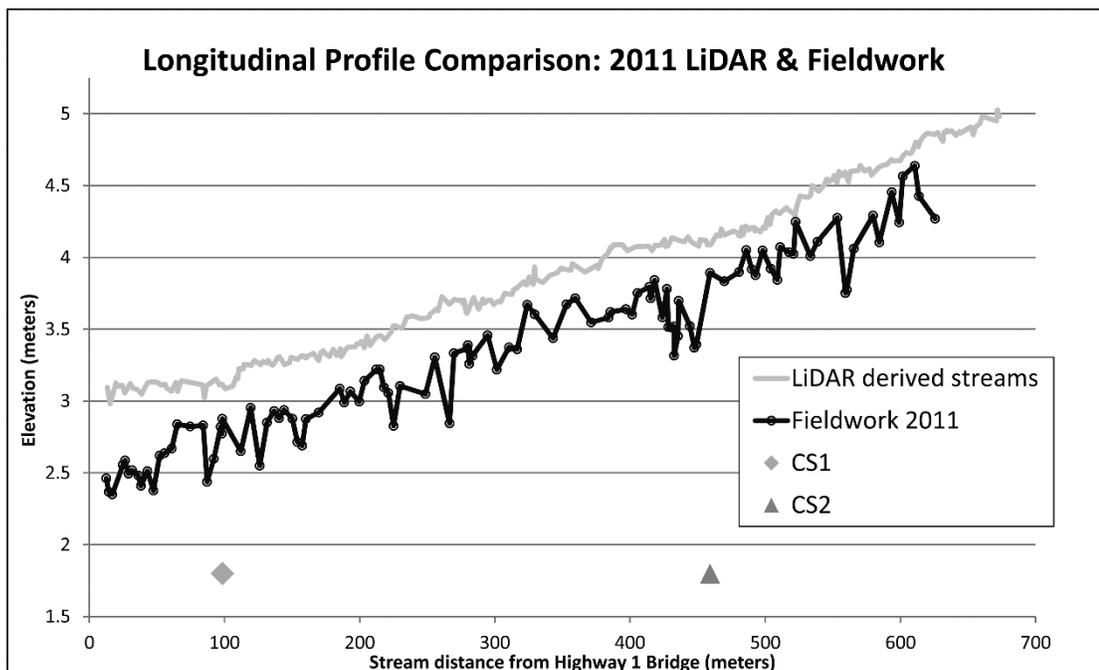
Figure 25: Longitudinal profile comparison II: LiDAR derived streams from March 2011 is compared to the fall 2011 data. Approximate location of CS1 and CS2 are shown.

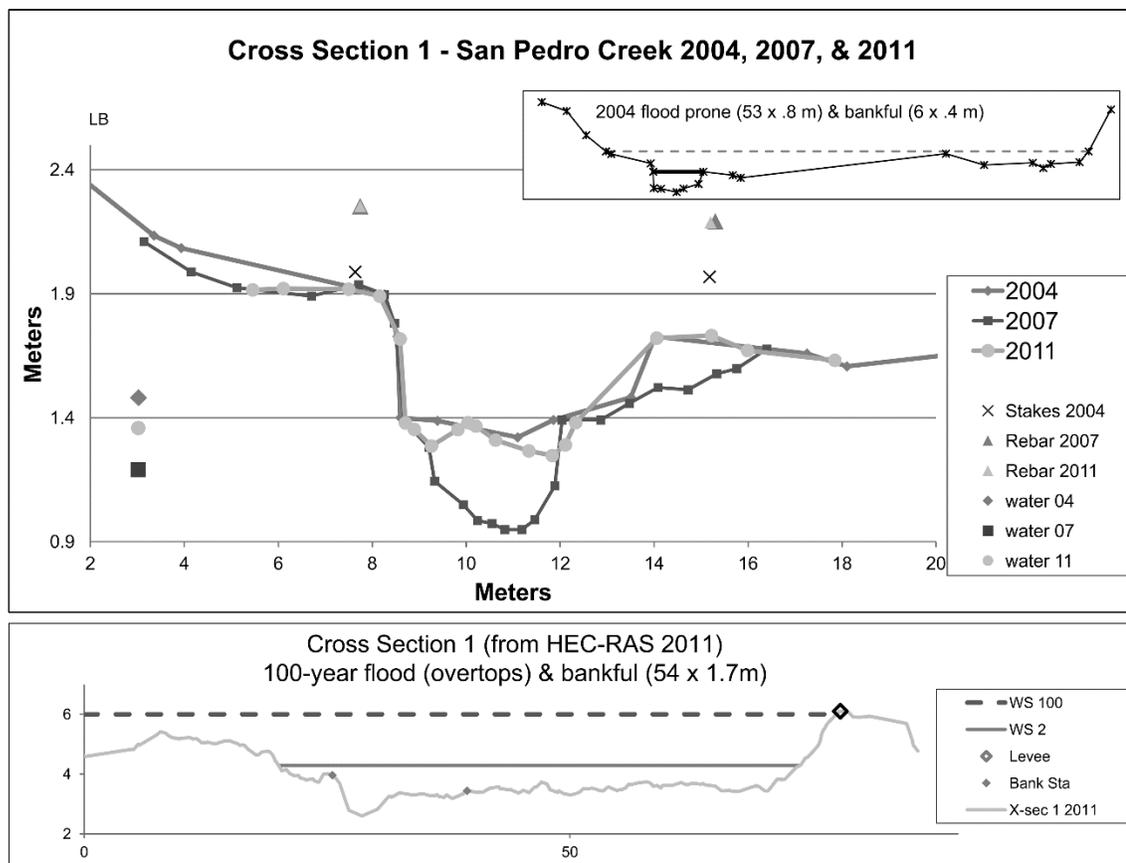
Figure 26: Cross-section 1 (CS1) showing data from 2004, 2007, and 2011, along with USACE HEC-RAS data from 2011 (lower graph). The above graph shows water levels near the y-axis for each year and includes cross-section benchmarks stakes and rebar. The lower graph shows water level for 2 year and 100 year flood levels (WS 2 and WS 100) as well as bankfull field indications (Bank Sta). See Figure 21C and Figure 23 for cross-section location.

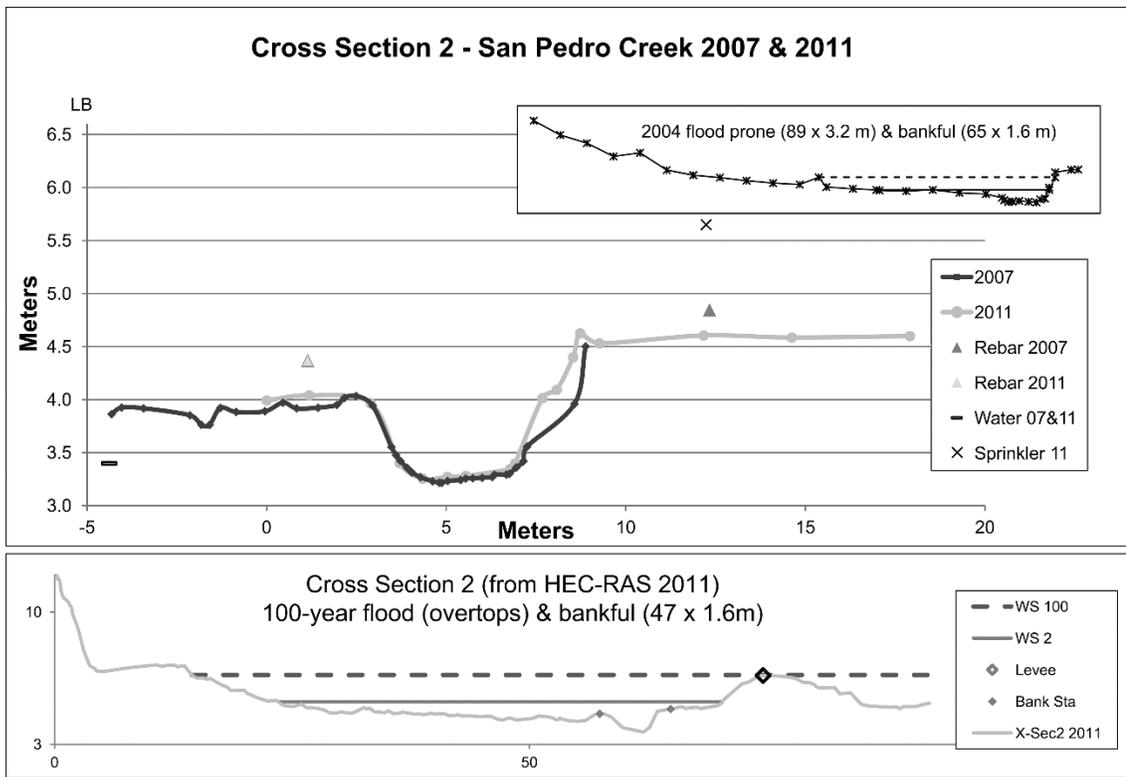
Figure 27: Cross-section 2 (CS2) showing data from 2007 and 2011, along with USACE HEC-RAS data from 2011. The above graph shows water level near the y-axis and includes cross-section benchmarks rebar and sprinkler. The lower graph shows water level for 2- and 100-year flood levels (WS 2 and WS 100) as well as bankfull field indications (Bank Sta). See Figure 21C and Figure 23 for cross-section location.

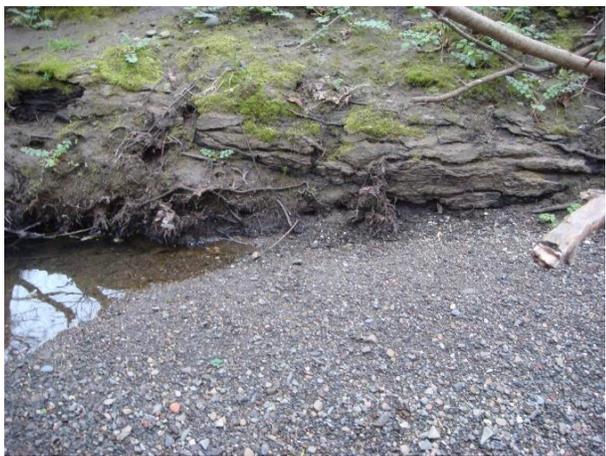
Figure 28: Either bedrock or erosion-resistant Quaternary clays located downstream of CS2 at photo location "D".

CS2 (Figure 27), on the other hand, maintains its streambed elevation. This is due to pre-restoration erosion-resistant materials, either Quaternary clays or bedrock exposed in the streambed (Figure 28). Clays would be explained by 1989 soil boring that found peat or peaty clay 1.8–3 m below the surface in three boring holes on SPC FCP, providing evidence of previous wetlands on the site (Lee 1999). Note that the water levels for 2007 and 2011 at CS2 are identical. However, up on the left bank shows erosion under the rebar, while the right bank shows some aggradation similar to that in CS1 from 2007 to 2011.

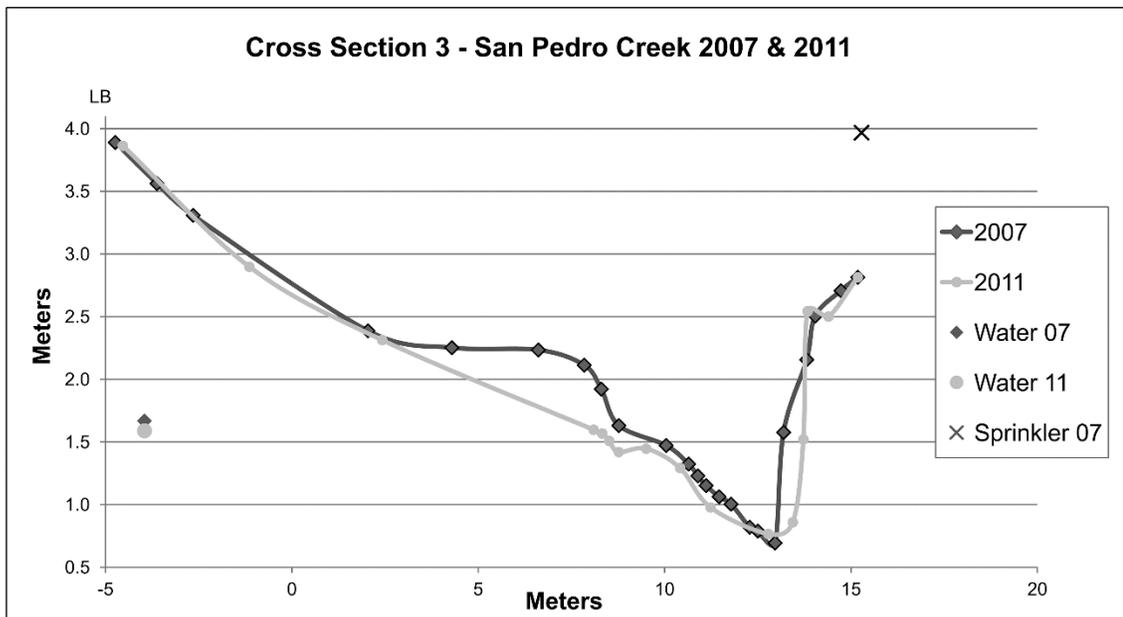
Figure 29: Cross-section 3 (CS3) comparison for 2007 and 2011. The graph shows water level for each year near the y-axis and includes benchmark sprinkler. See Figure 21C and Figure 23 for cross-section location.

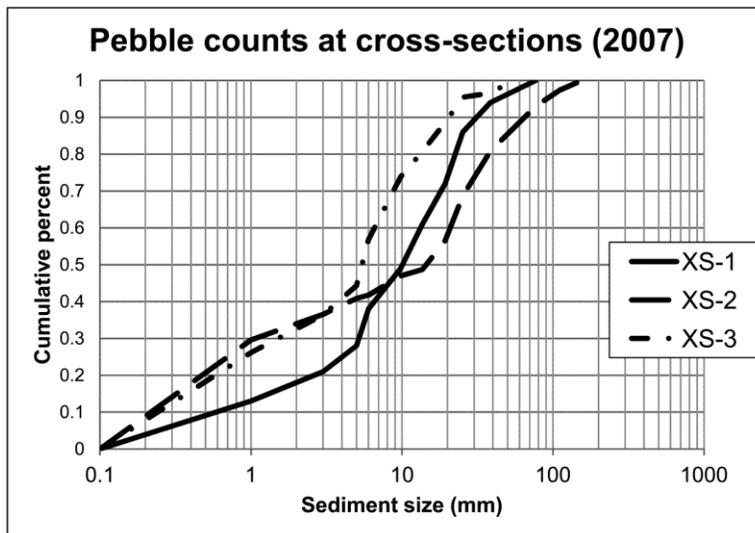
Figure 30: Pebble counts for 2007 at the cross-sections only. XS-1 is CS1 or cross-section 1. Similarly XS-2 is equivalent to CS2 and XS-3 is equivalent to CS3.

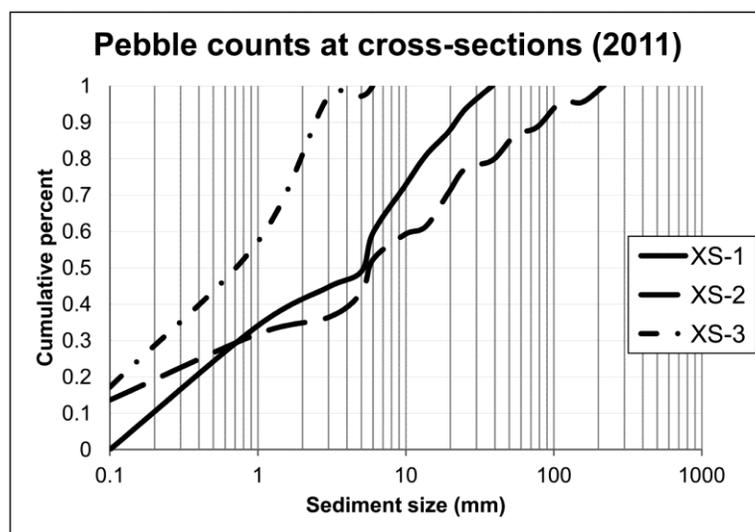
Figure 31: Pebble counts for 2011 at the cross-sections only. XS-1 is CS1 or cross-section 1. Similarly XS-2 is CS2 and XS-3 is CS3.

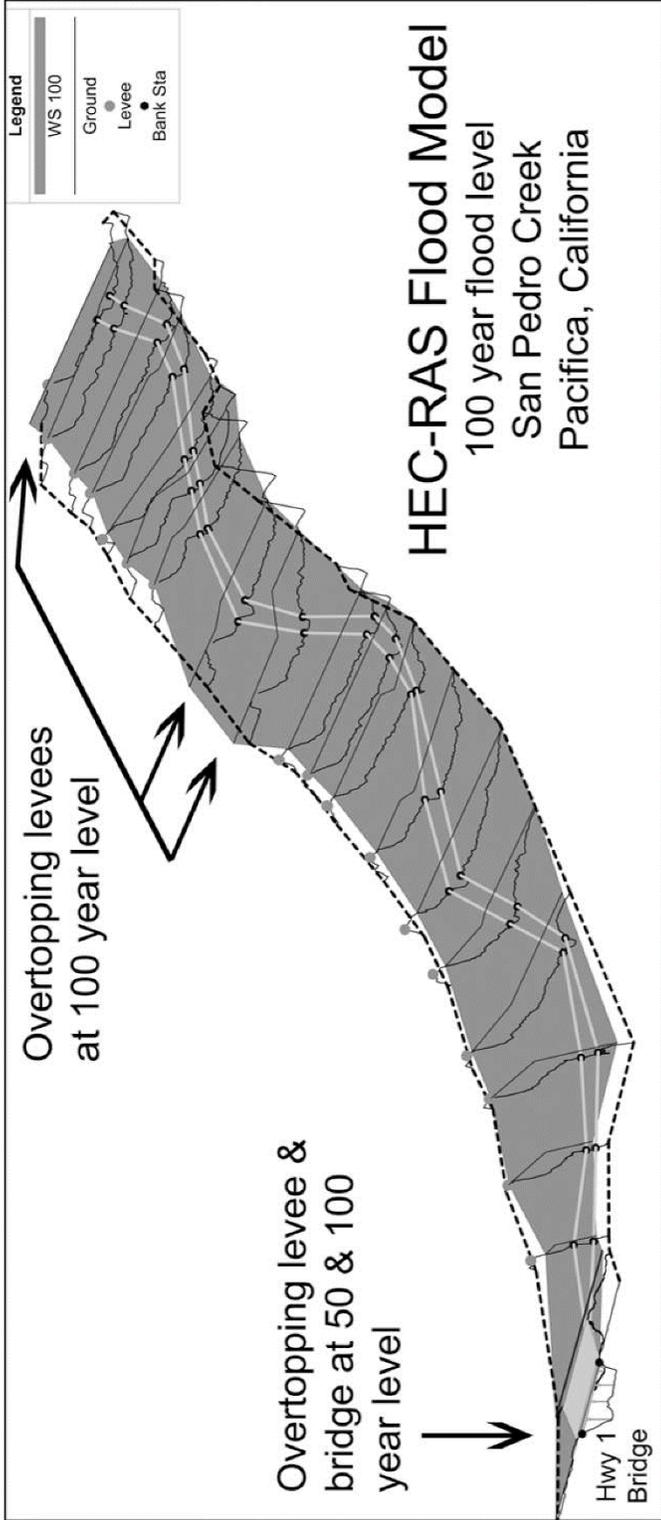
Figure 32: HEC-RAS model result for 100-year flood level. Water surface (WS) overtops levees at Highway 1 for the 50- and 100-year flood return levels with the as-is bridge and proposed Manning's n values. The berm near CS2 and the berm at the upstream extent of the model both overtop for the 100-year flood level for the proposed Manning's n values and both the as-is bridge or the new bridge. Left bank overtopping near CS1 and elsewhere are not visible in this diagram but are also present for both bridge scenarios.

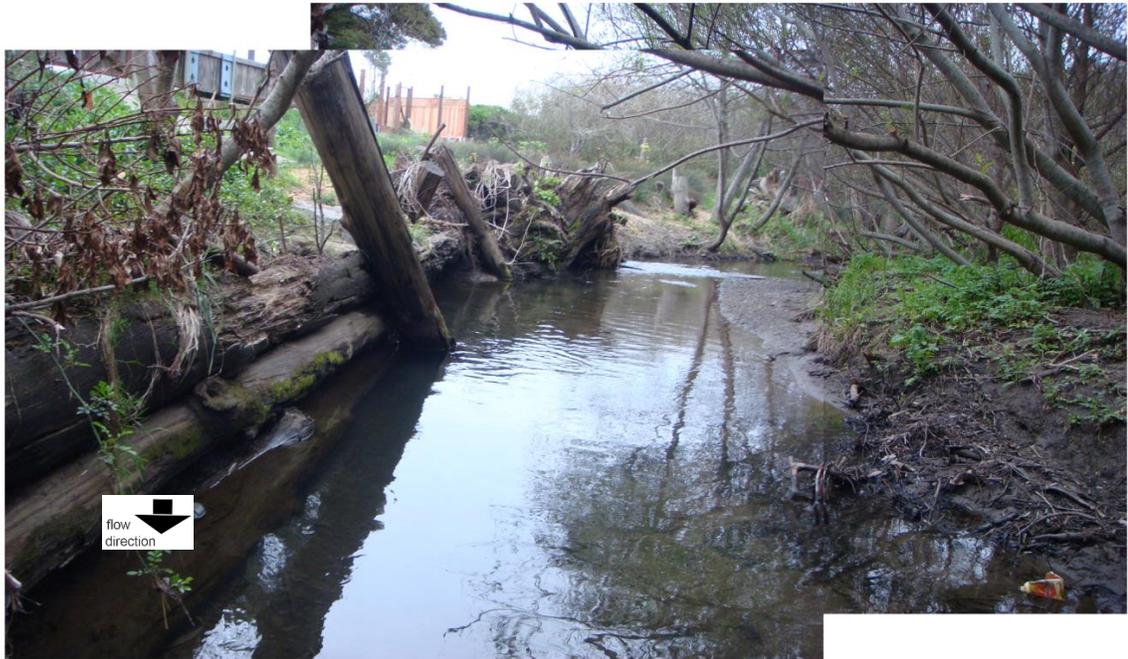
Figure 33: 2013 photo looking upstream towards CS2.

The two middle arrows (of the four in Figure 32) are near the residential area of CS2 shown in Figure 33. The location of CS2 on the reach is shown in Figure 23. Residential fences are visible at the top left and log revetments line the right bank until midframe where the revetments are set back from the stream, covered by material eroded down from above. This area, along with the Highway 1 reach, the leftbank, and the upstream end, are the primary area of concern for flood hazard as predicted by the HEC-RAS flood model.
