GEOMORPHOLOGY AT THE CONFLUENCE  
OF STREAM RESTORATION AND FLOOD CONTROL

A Thesis submitted to the faculty of  
San Francisco State University  
In partial fulfillment of  
the requirements for  
the Degree

This study assesses the geomorphologic response of a stream management project integrating ecological restoration principles with flood control. Damaging floods on the coastal stream San Pedro Creek in Pacifica, California, led to replacement of the straightened and incised natural channel with a constructed meander and vegetated floodplain. The intention was to mitigate flooding and increase habitat for species such as the federally-listed threatened Central California steelhead (*Oncorhynchus mykiss*). Longitudinal profile data show a degradation and aggradation oscillation. Smaller scale meanders have begun to form on the straight reaches between larger designed meanders. Headcutting backwaters at an inflection point initiated a chute cut-off. Preliminary flood modeling demonstrates less than a 50-year flood protection level. These results suggest that the stream reach is not stabilizing as designed, but is instead adjusting according to geomorphological principles. Specif

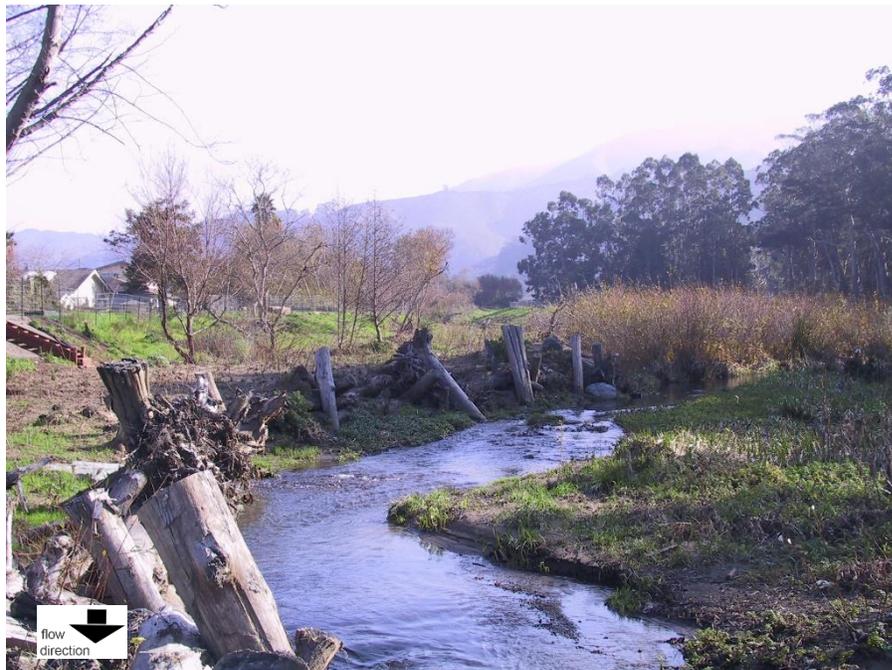
Figure 34: 2004 same view of CS2 as previous figure showing the convex and cut banks both lacking the young willows visible in the right middleground. Photo courtesy of Matt Graul.

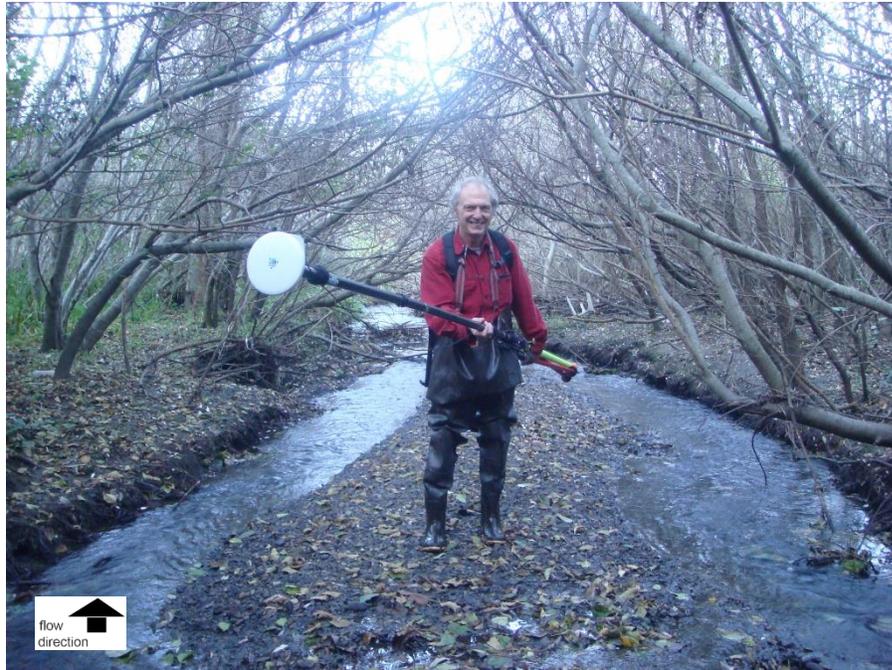
Figure 35: 2011 mid-channel bar with split thalweg at photo location "E", looking towards CS2. By 2013, the thalweg flowed against the left bank only, with backwater pools along the right bank.

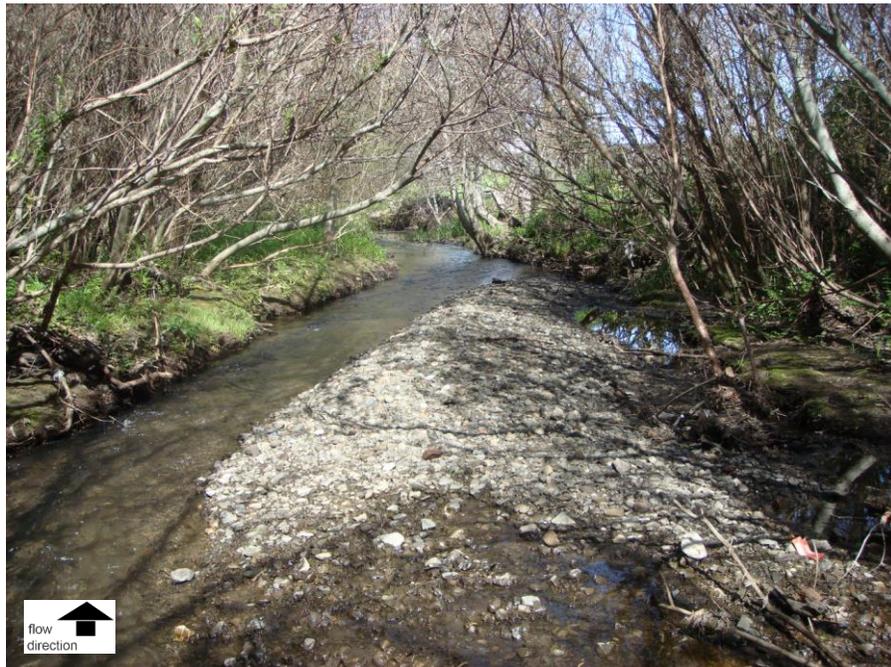
Figure 36: 2014 repeat photograph of location "E". The thalweg flows against the left bank. Right of the bar has filled in with coarse and fine sediment, while sustaining small side pools.

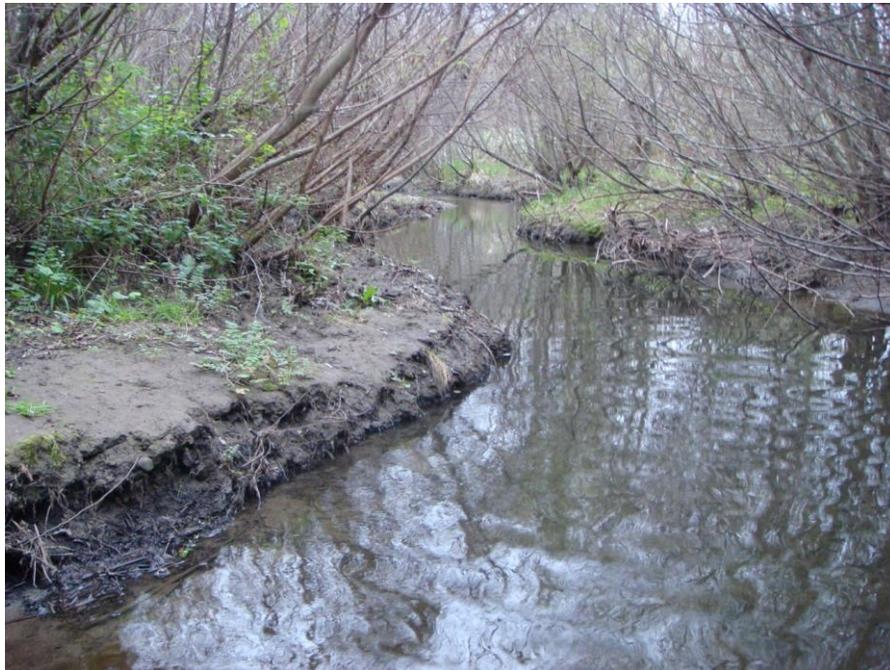
Figure 37: 2013 meander form with muddy banks looking upstream from location “I”. Form maintained from the 2005 Figure 21B, into the 2011 LiDAR Figure 21A.

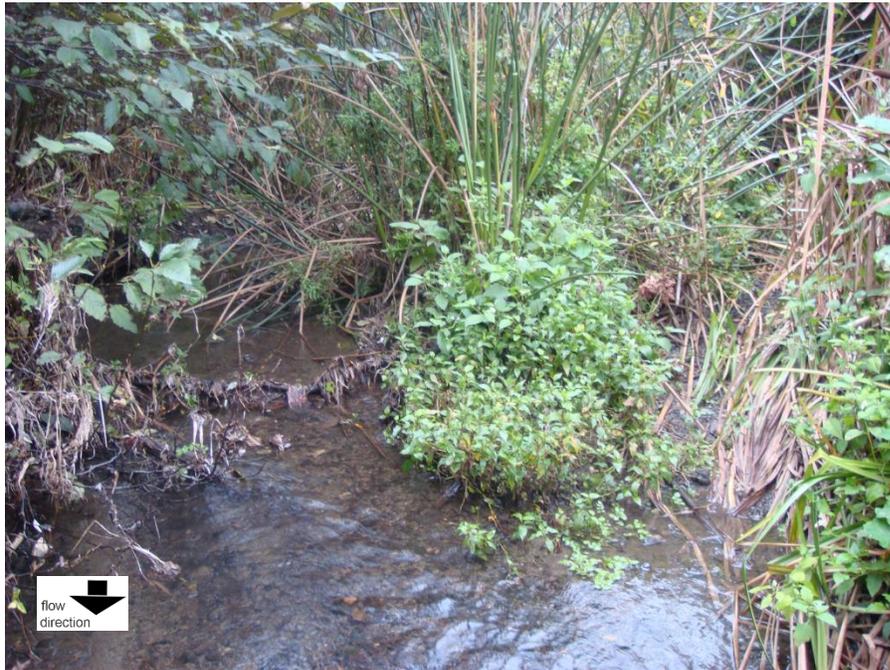
Figure 38: 2007 backwater eddy and headcut located at "A". Main channel is along the right bank and the backwater eddy veers upstream on the left bank (lower right of photo).

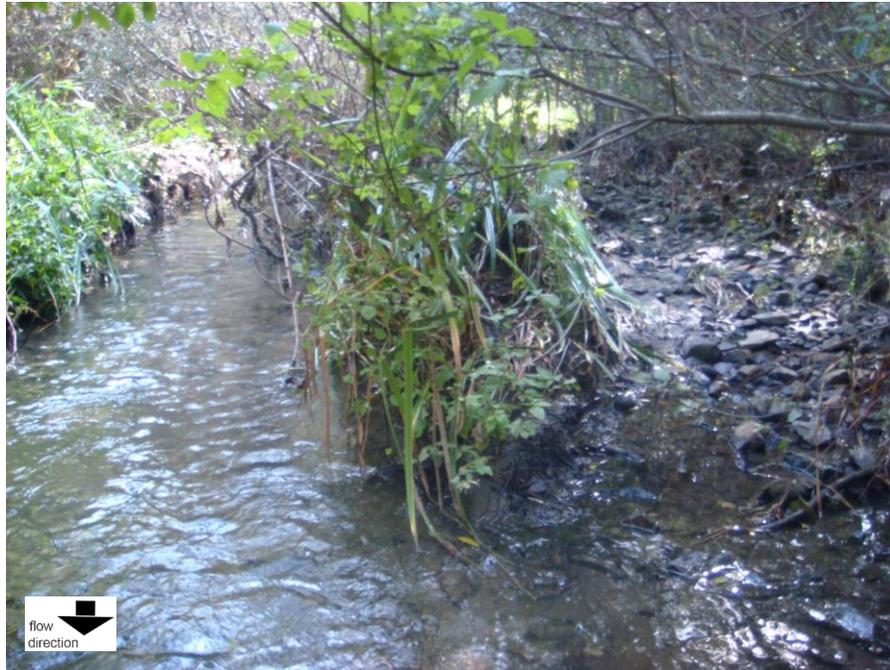
Figure 39: 2011 Repeat photography of location "A" with a more defined headcut on the bank.

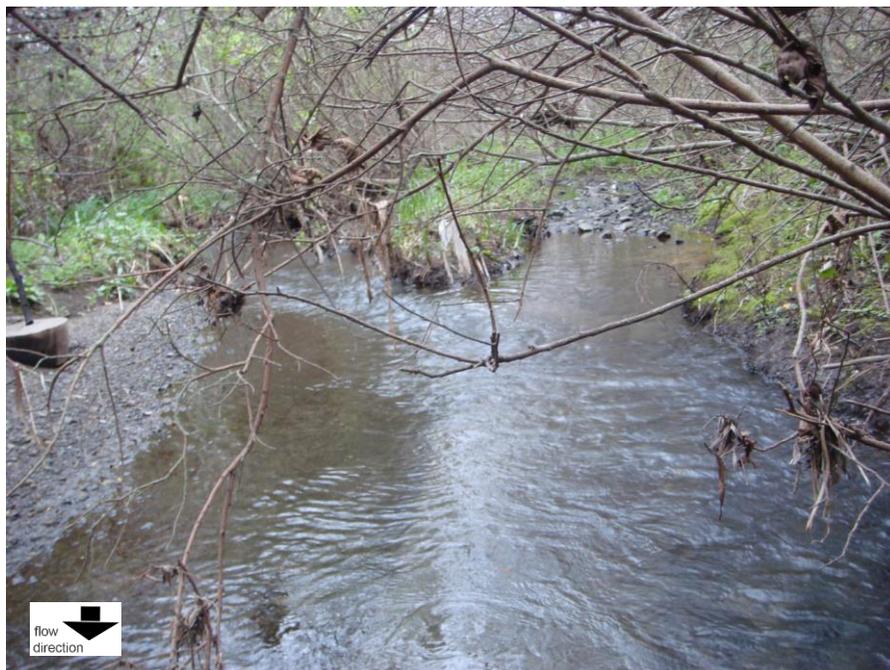
Figure 40: 2013 Repeat photography of location "A". Headcutting backwater has a slightly longer upstream pool length.

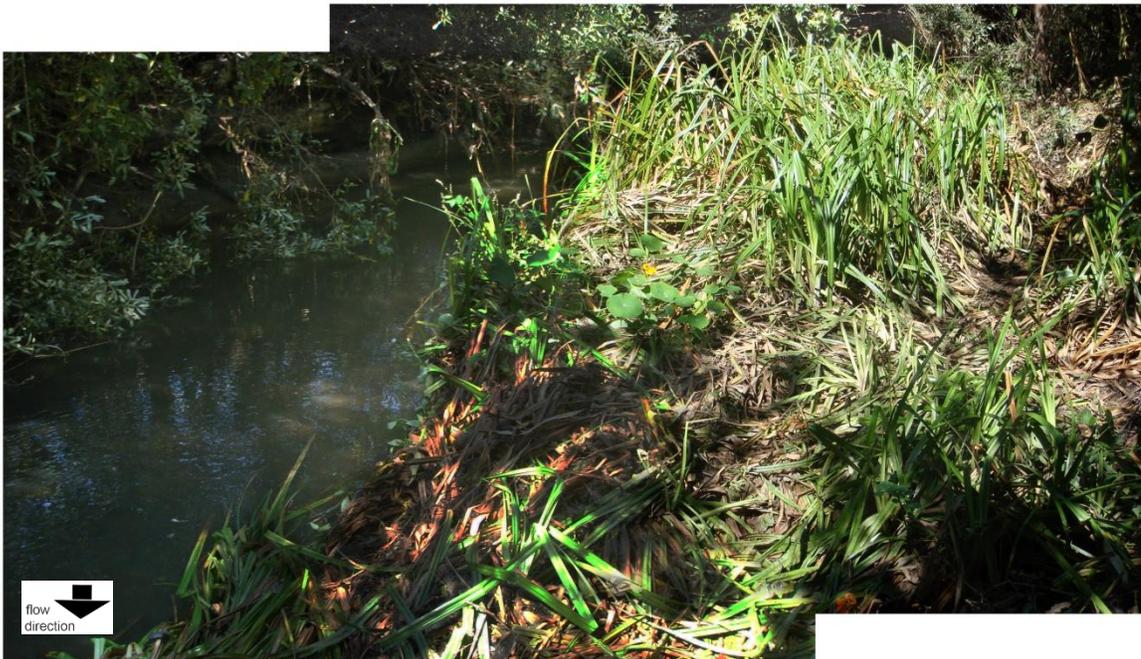
Figure 41: Upstream of “A” at location “B” in 2007 showing the invasive Jubata grass still folding down due to water flows (along right of photo).

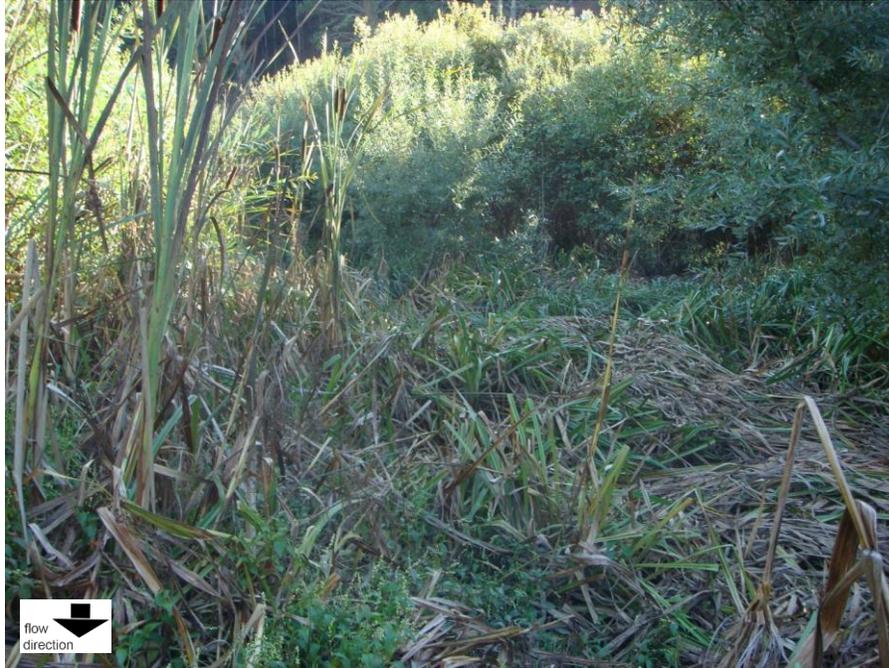
Figure 42: Looking across to the left bank from the channel at “B” in 2007 shows vegetation downed by water and large trees planted far from the water’s edge.

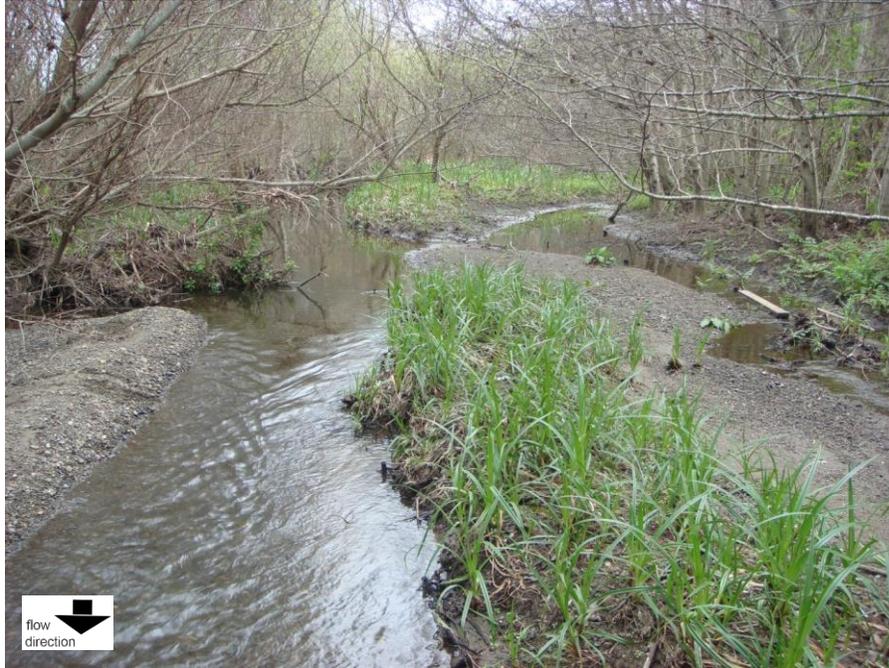
Figure 43: 2013 photo looking upstream from location "B" showing chute cut-off upstream of "A".

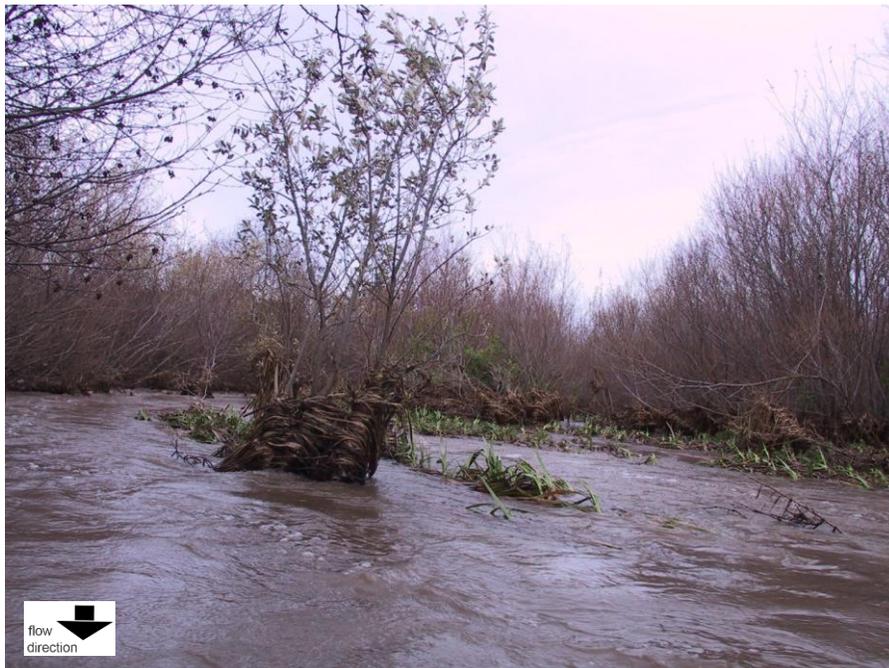
Figure 44: 2008 repeat photograph from location "B" during a maximum daily precipitation event. The middle trees are the same as those in the middle background of Figure 43. Photo courtesy of Jerry Davis.

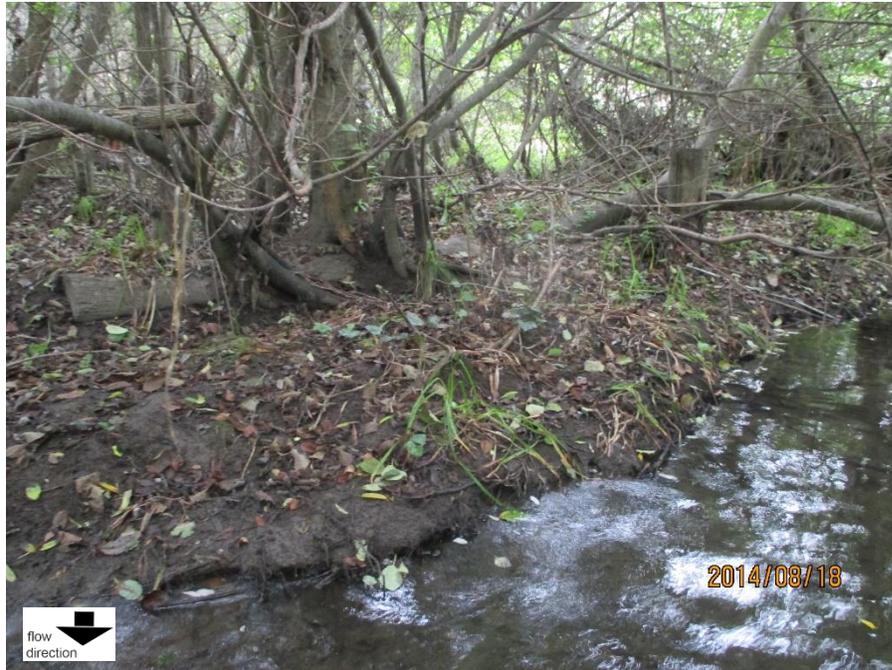
Figure 45: Log revetments and vertical logs merged into the right bank at location "B".

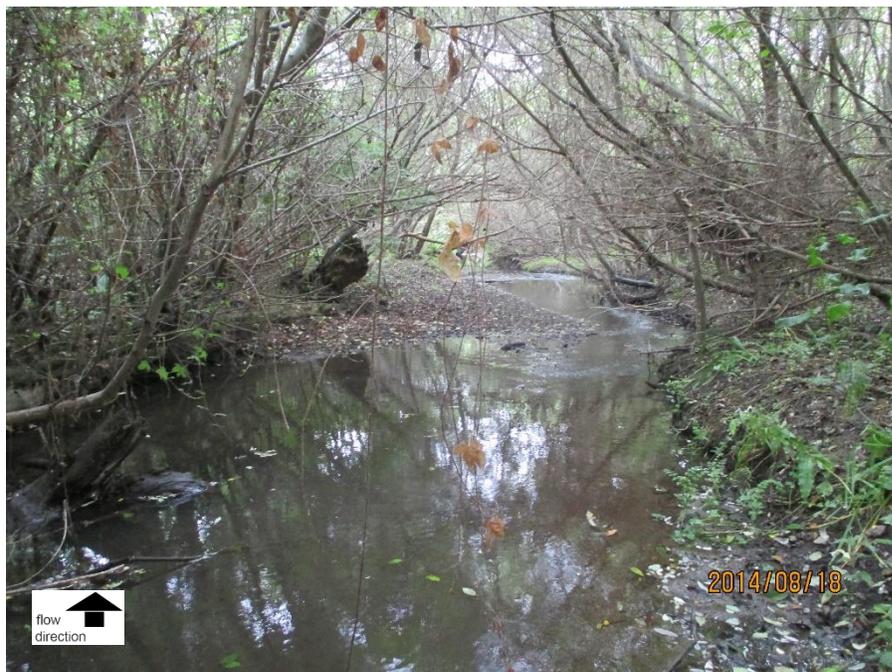
Figure 46: Rootwad back up behind a point bar at location "C".

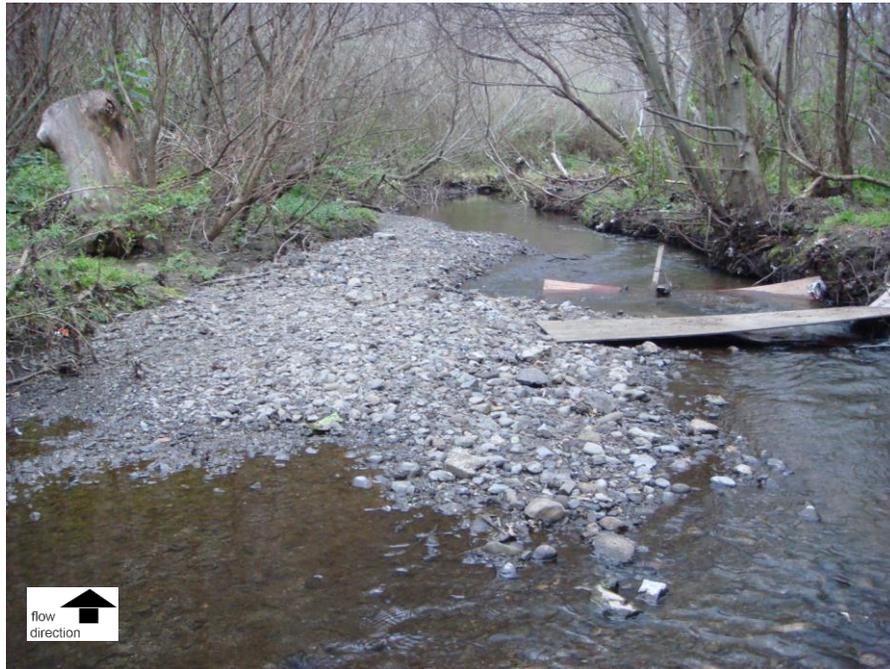
Figure 47: 2013 rootwad at location "H" indicates the original left bank, now behind a point bar.

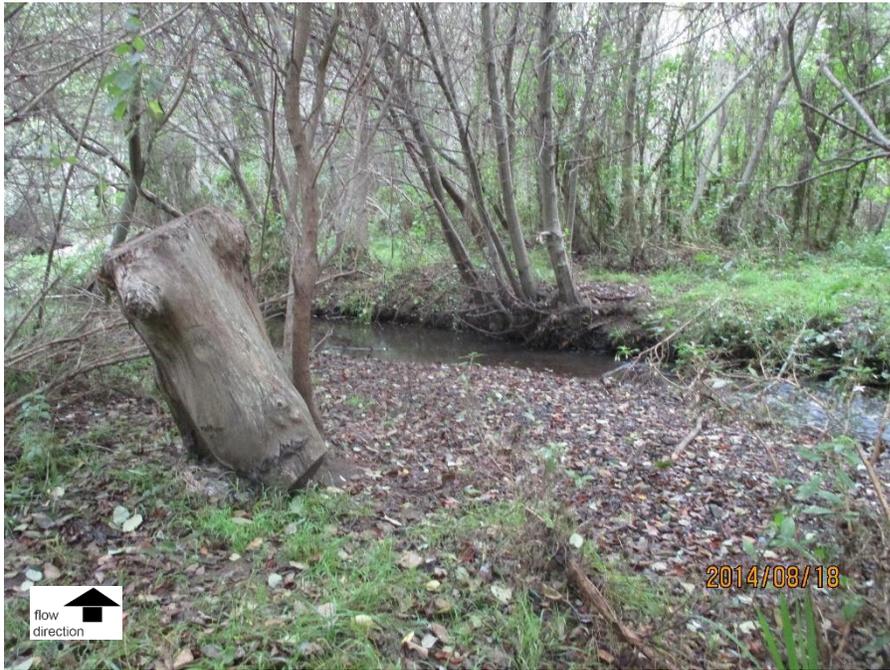
Figure 48: Mid-2014 rootwad at location "H", from the left bank looking towards the stream.

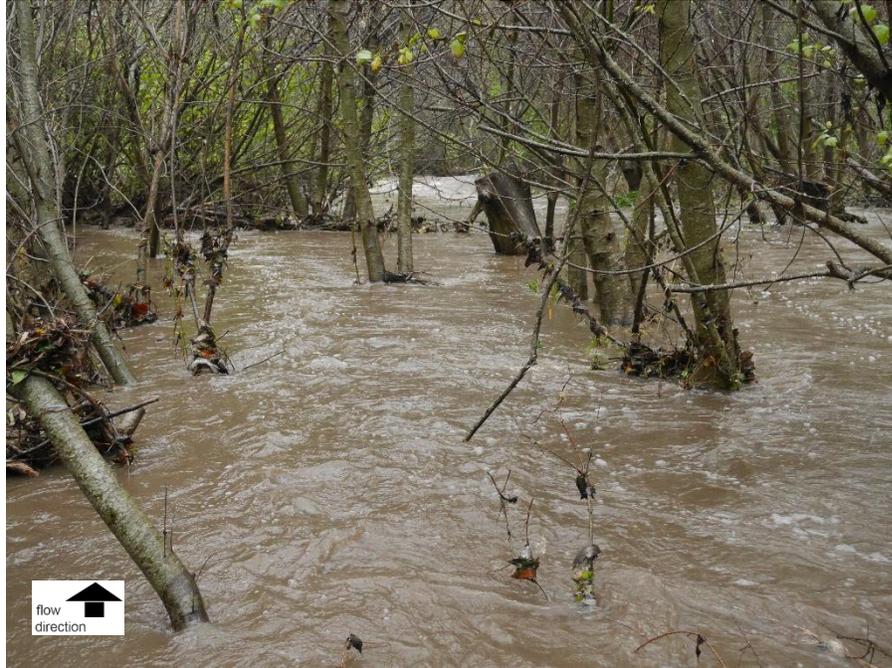
Figure 49: Late-2014 rootwad (middle background) at location “H”, during a flood event. (Photo courtesy of Jerry Davis.)

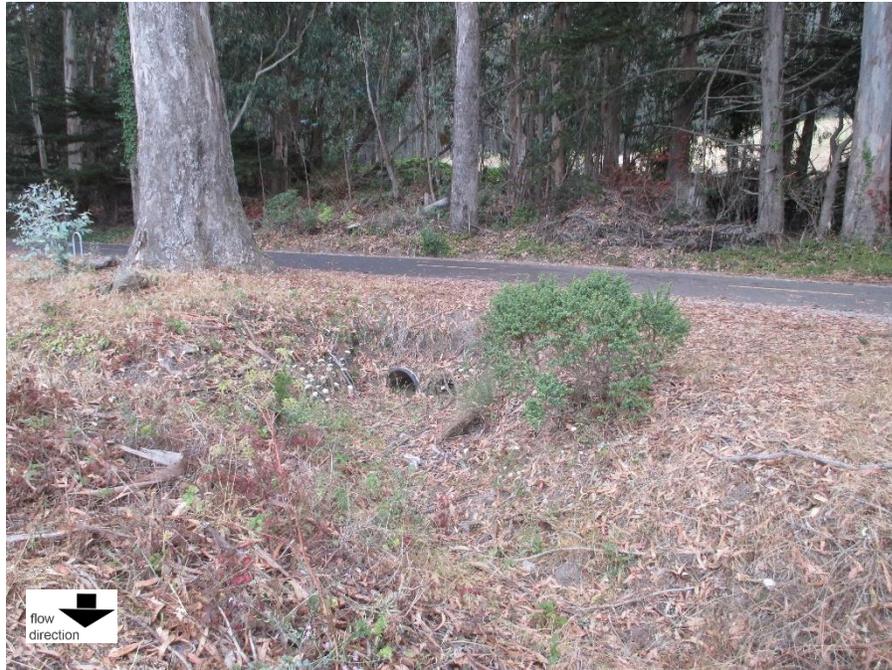
Figure 50: “Culvert 1” drains under the decommissioned road at the lower right of the study area. The ditch continues along the road and ends before meeting the floodplain vegetation.

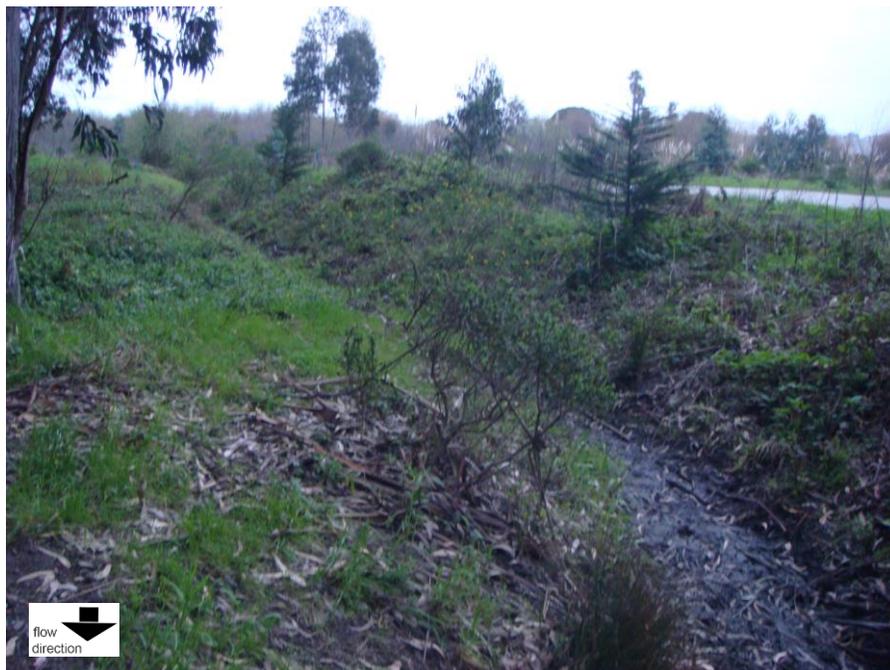
Figure 51: Looking up the ditch that drains from “culvert 1” into the study area. The ditch shows in the LIDAR elevation model (Figure 21A) coming in from the lower right corner.

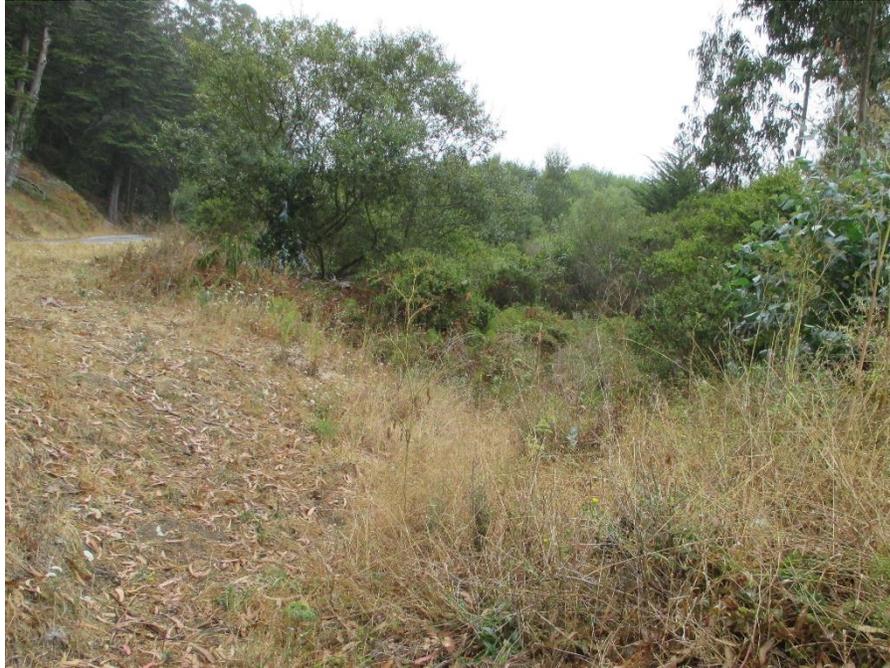
Figure 52: The ditch draining "culvert 1" ends here in what may function as a bioswale.

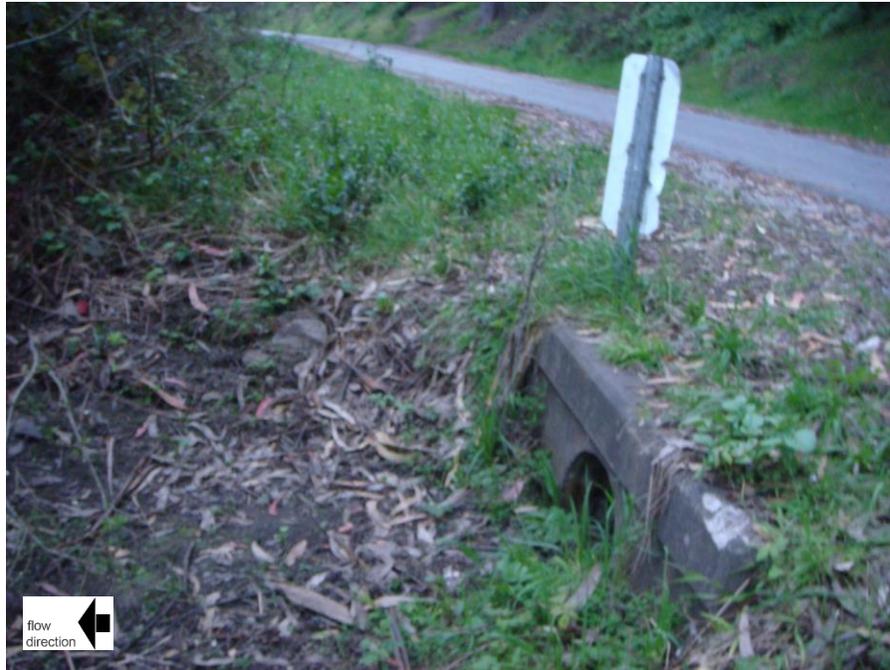
Figure 53: A second culvert, “culvert 2”, draining under the decommissioned road into the floodplain area.

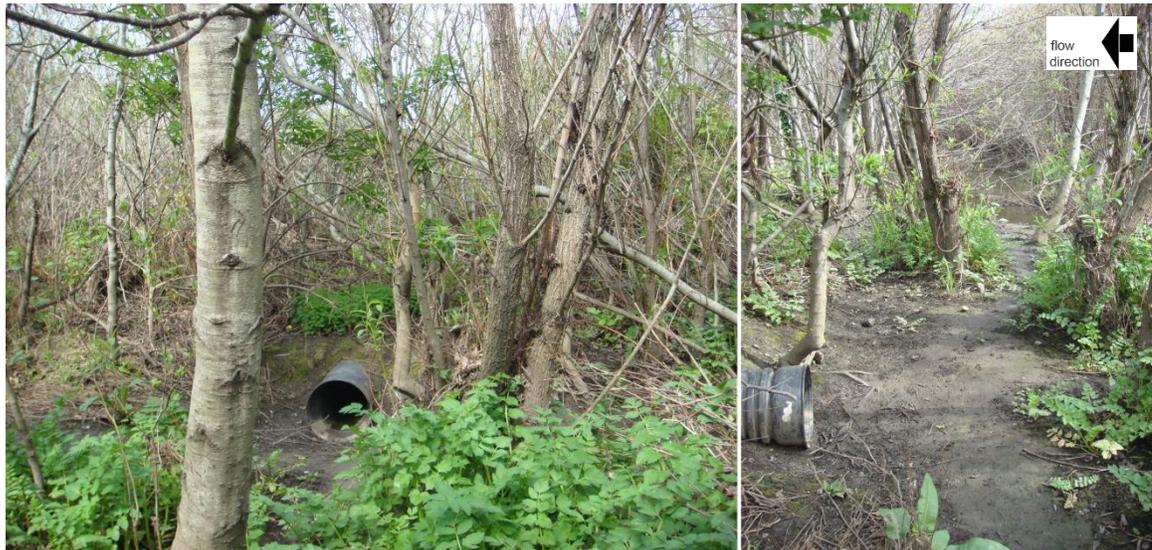
Figure 54: A third pipe, “culvert 3”, draining into the floodplain near the Highway 1 end of the decommissioned road.

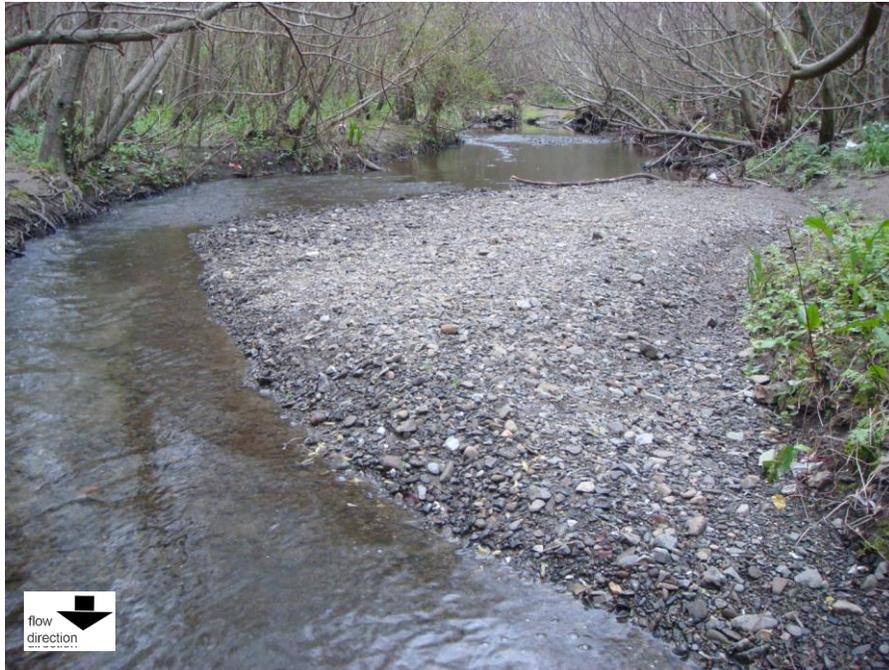
Figure 55: A cobble and pebble bar in early 2013 at location “F”. Vegetation has colonized the bar in the foreground. A relatively uniform particle size overlays a heterogeneous bedload. The thalweg undercuts the right bank and exposes tree roots.

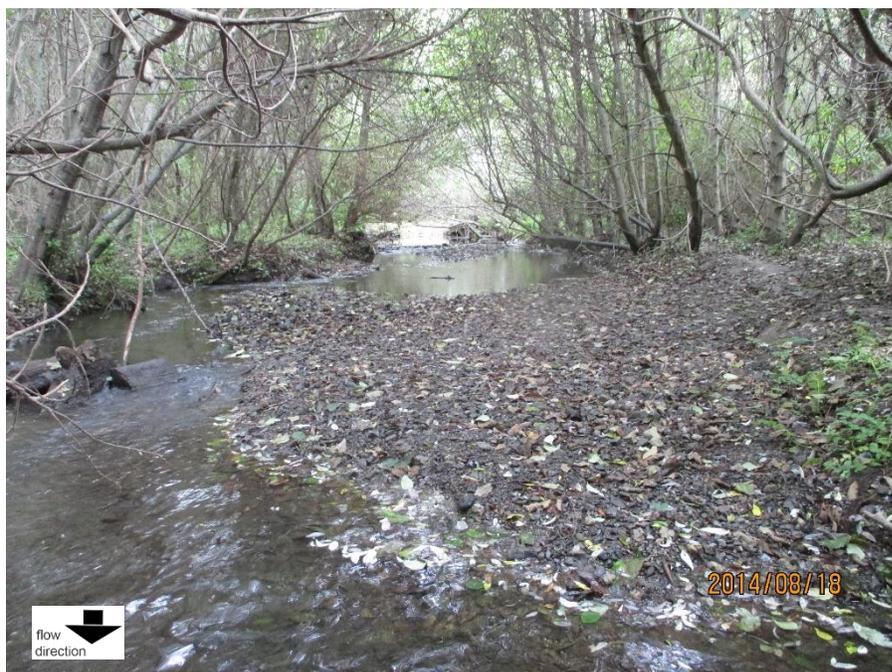
Figure 56: August 2014 point bar at location “F”, looking upstream.

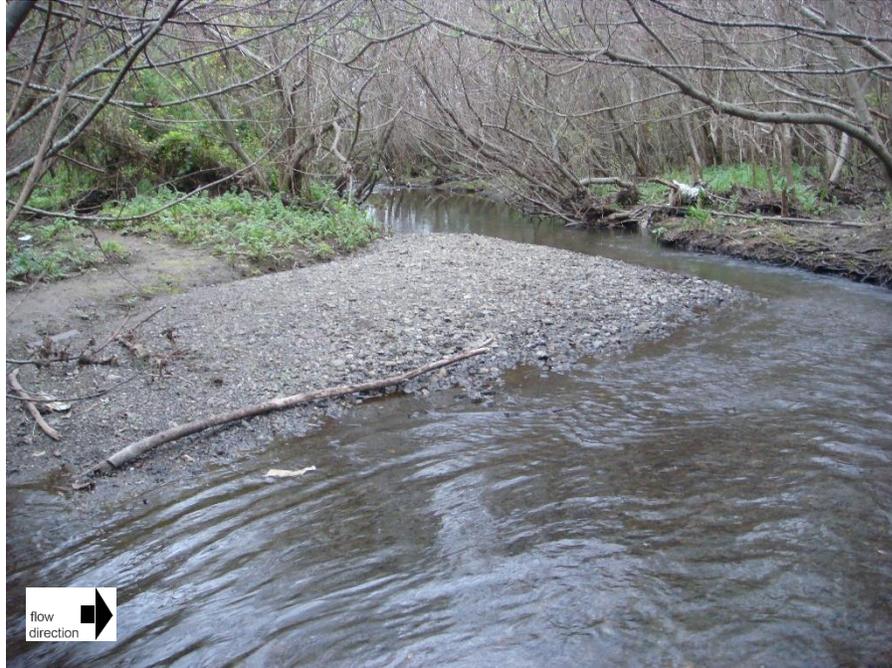
Figure 57: March 2013 point bar at location “F”, looking downstream.

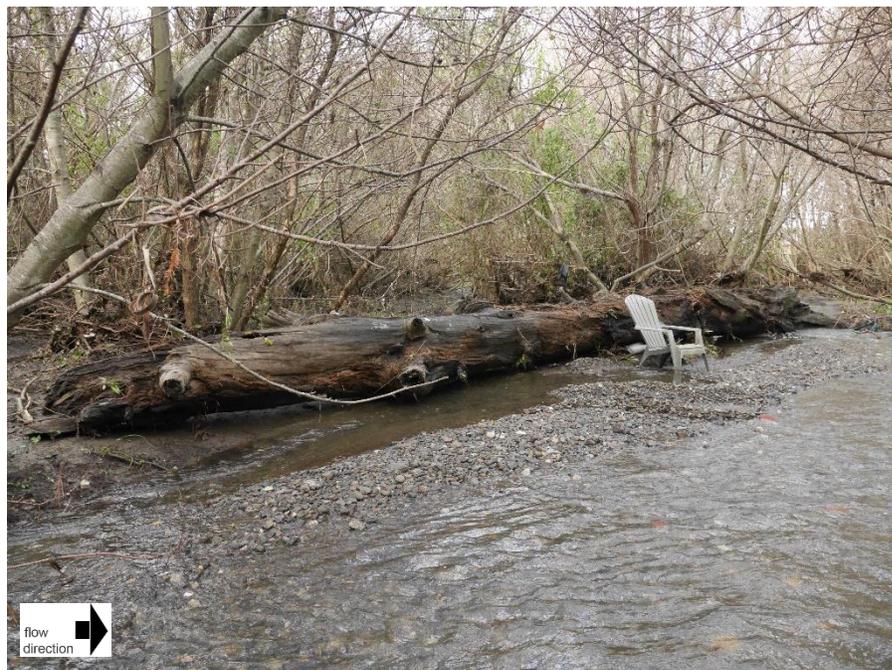
Figure 58: December 2014 point bar at location “F” recruits a large blown out log revetment after a storm event. The blown-out log revetment has settled into the bar and is already developing an undercut. Photo courtesy of Jerry Davis.

Figure 63: Late 2014 flood event shows the blown out log revetment at location “F” (also shown in Figure 58 after the waters recede). It was transported from location “H”. Photo courtesy of Jerry Davis.

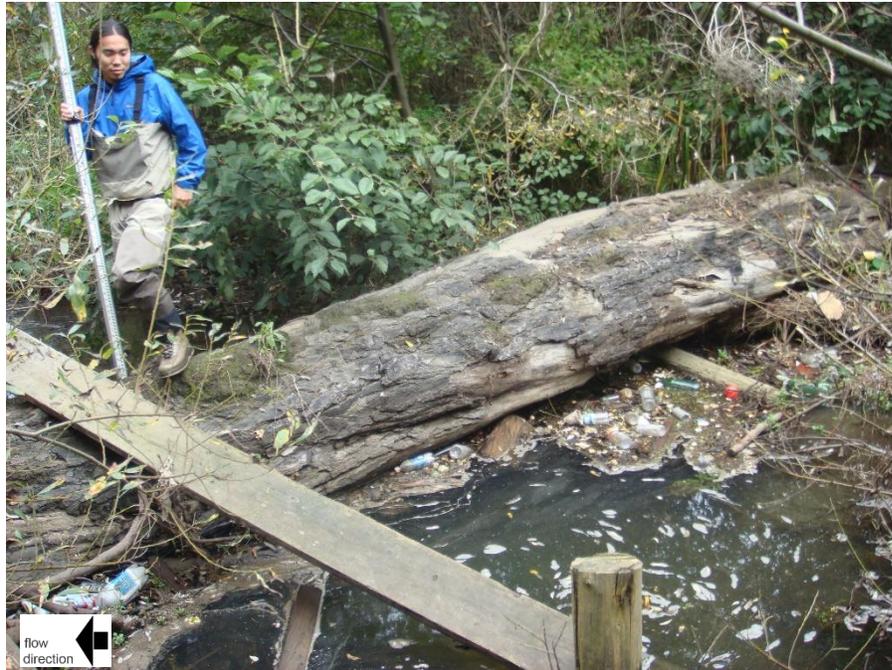
Figure 59: 2007 blown log revetment at location “G” spans the width of the stream, trapping trash and debris and causing a deep scour pool beneath it.

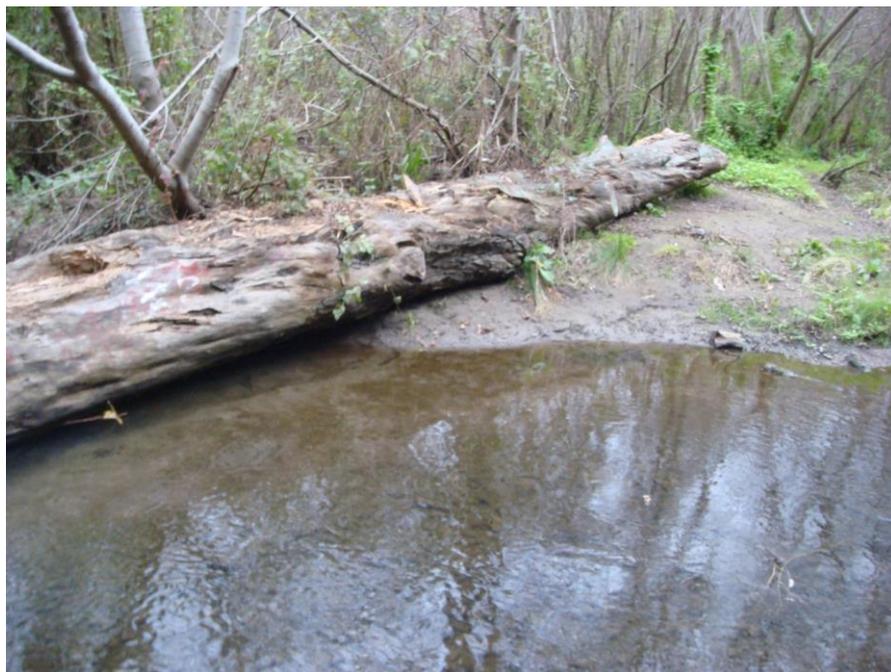
Figure 60: Blown out revetment at “G” opened up downstream by 2011 extending only halfway across the width of the stream, clearing the debris and reducing the scour pool depth.

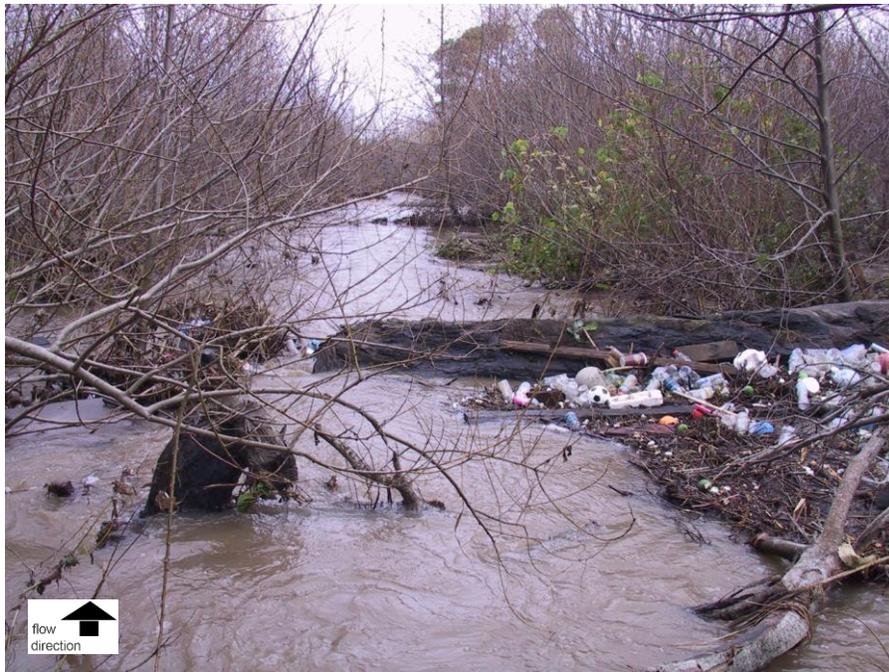
Figure 61: Early 2008 flood event shows the blown revetment at location "G". Note the rootwad in the lower left foreground, also in other photos in this series. Photo courtesy of Jerry Davis.

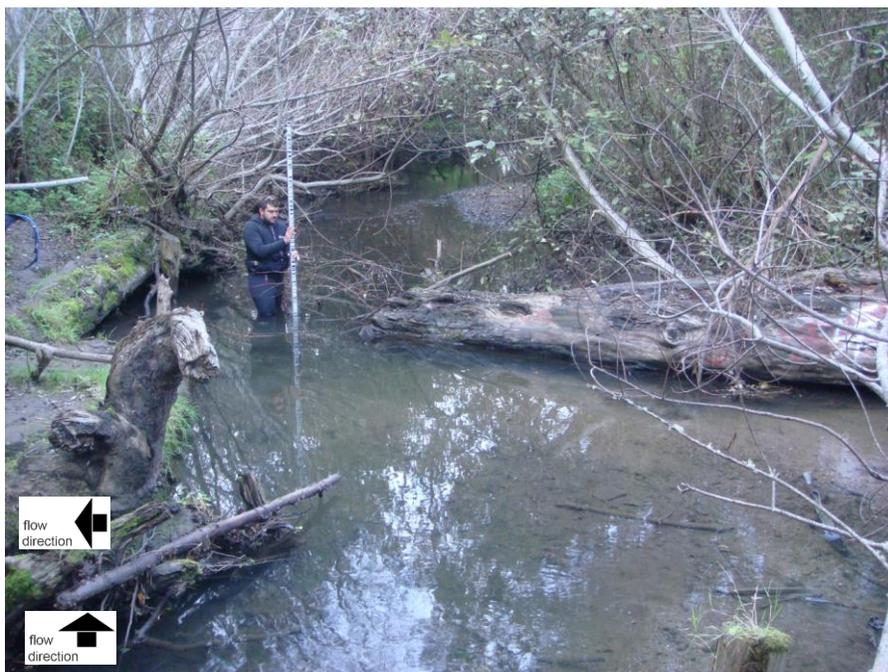
Figure 62: Looking downstream at the revetment at location "G" in 2011. In 2007, there was no gap between the left bank and the blown out log revetment across the stream.

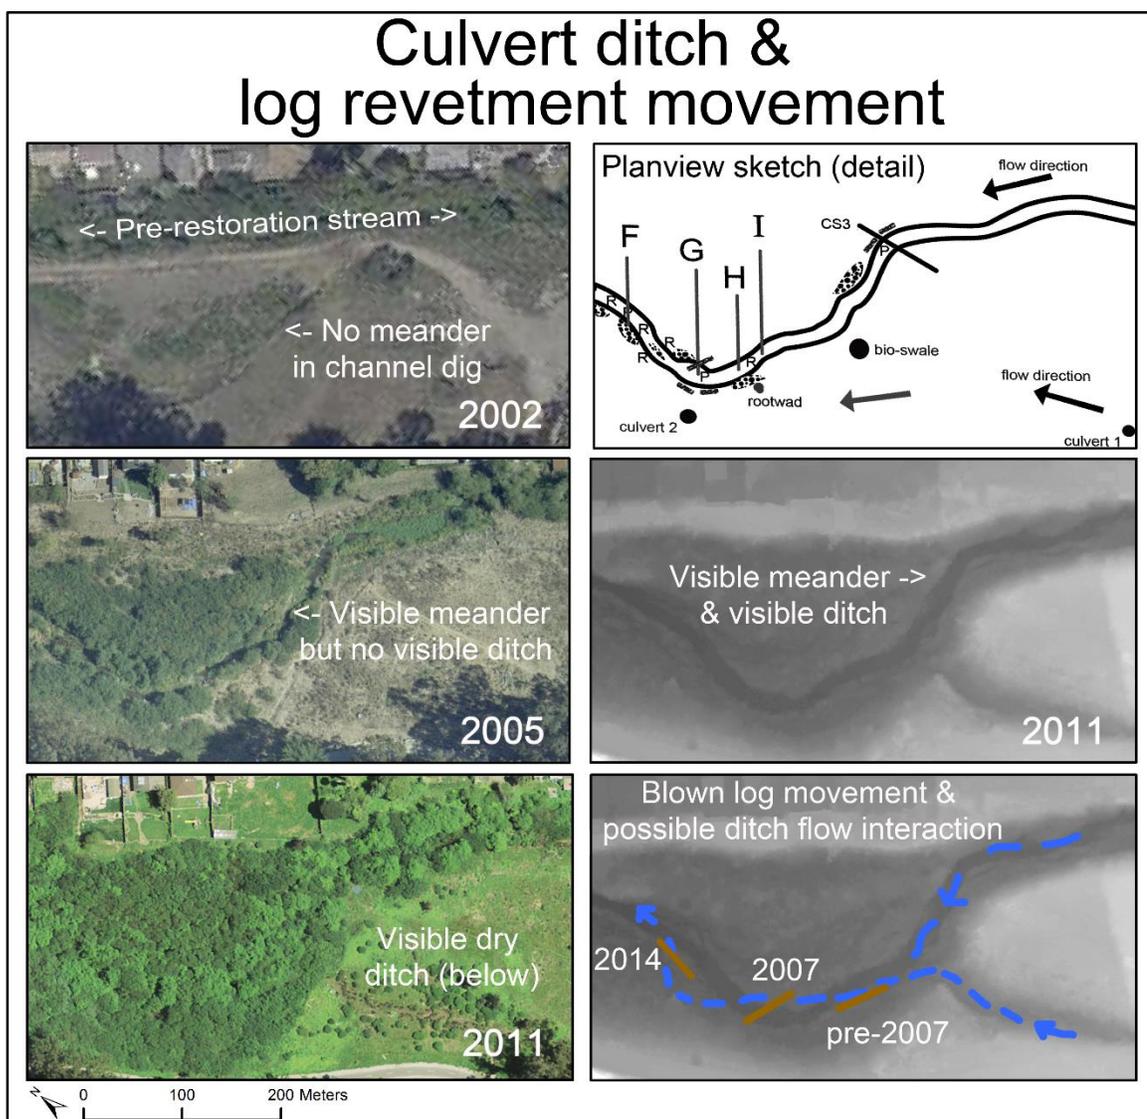
Figure 64: Hypothesis for the log movement (brown) and culvert flow (blue) over time.

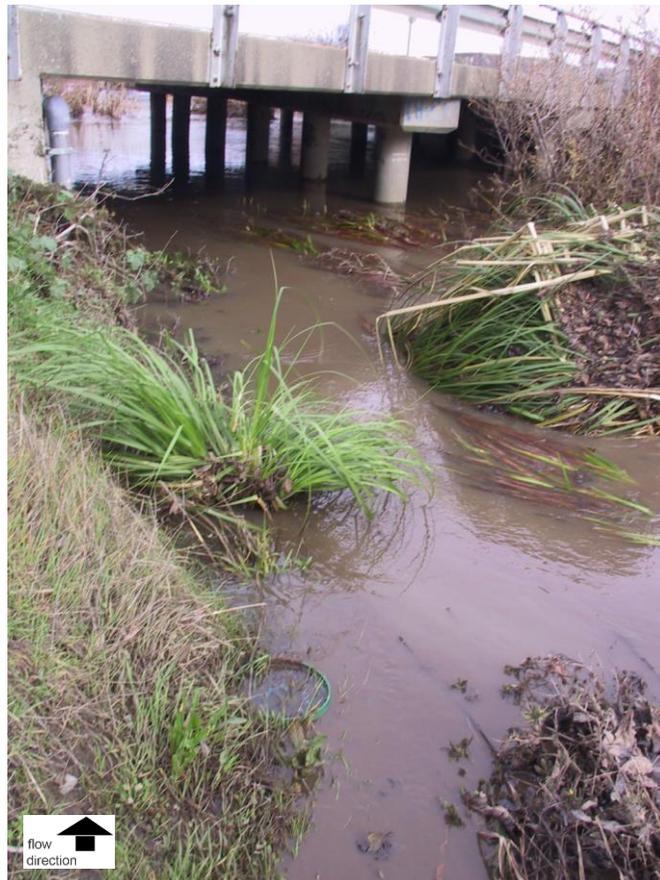
Figure 65: 2008 peak flood event, looking downstream at the Highway 1 Bridge. There is no garbage/debris accumulation here. Photo courtesy of Jerry Davis.

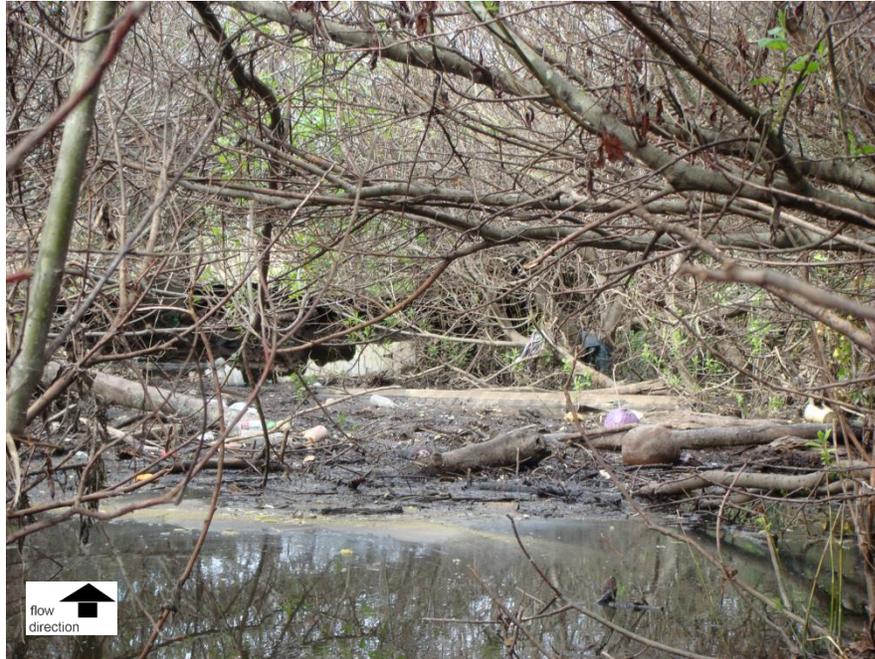
Figure 66: Looking downstream at the Highway 1 Bridge in 2013, with more overhanging vegetation – and a lot more trash blocked by woody debris.

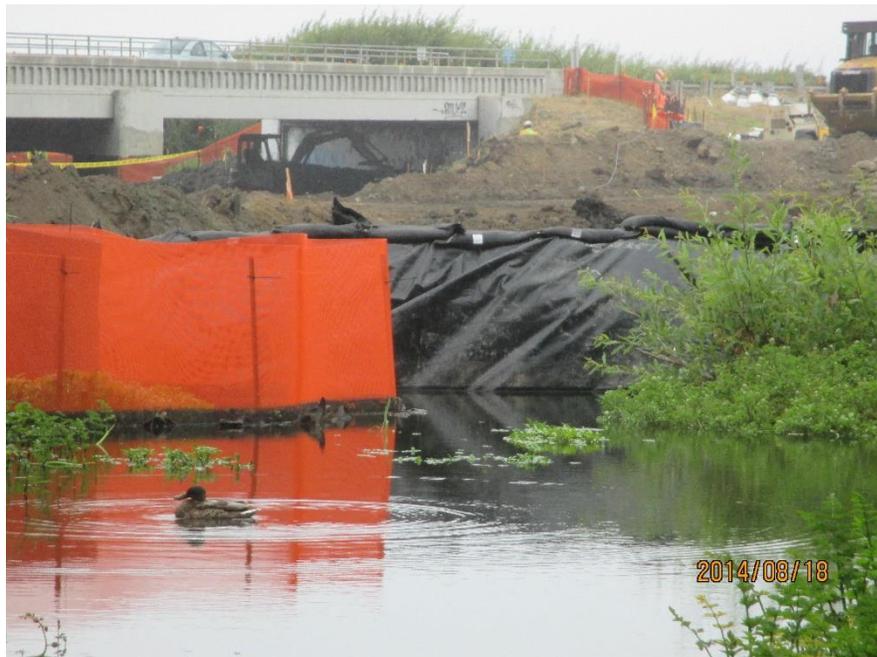
Figure 67: The Highway 1 Bridge was removed in 2014 and no longer had a trash dam. Traffic is shown re-routed over another adjacent bridge just downstream during reconstruction.

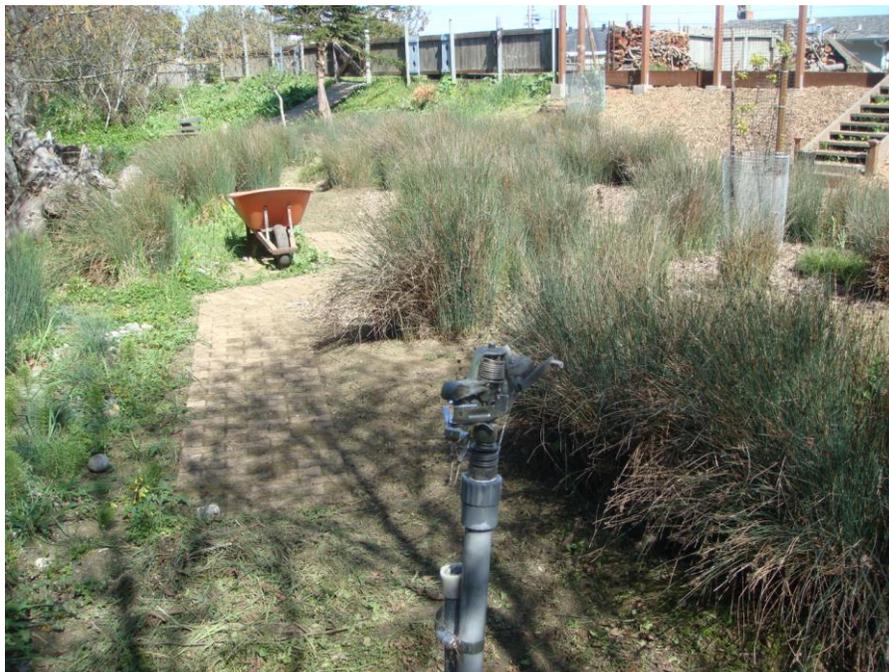
Figure 68: Homeowner landscaping with *Juncus* along the easement terrace at CS2. Sprinkler in foreground is part of CS2, and is a remnant of the now inactive revegetation watering system.
