GEOMORPHOLOGY AT THE CONFLUENCE  
OF STREAM RESTORATION AND FLOOD CONTROL

A Thesis submitted to the faculty of  
San Francisco State University  
In partial fulfillment of  
the requirements for  
the Degree

This study assesses the geomorphologic response of a stream management project integrating ecological restoration principles with flood control. Damaging floods on the coastal stream San Pedro Creek in Pacifica, California, led to replacement of the straightened and incised natural channel with a constructed meander and vegetated floodplain. The intention was to mitigate flooding and increase habitat for species such as the federally-listed threatened Central California steelhead (*Oncorhynchus mykiss*). Longitudinal profile data show a degradation and aggradation oscillation. Smaller scale meanders have begun to form on the straight reaches between larger designed meanders. Headcutting backwaters at an inflection point initiated a chute cut-off. Preliminary flood modeling demonstrates less than a 50-year flood protection level. These results suggest that the stream reach is not stabilizing as designed, but is instead adjusting according to geomorphological principles. Specif

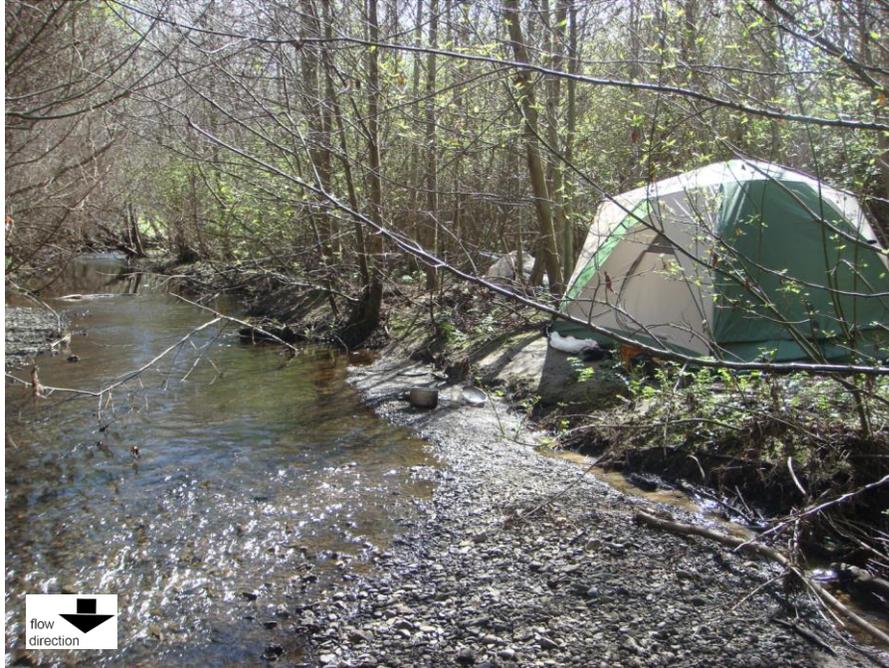
Figure 69: Homeless encampment near CS1. Cooking utensils are on the channel bar and the camp is surrounded by trash piles.

In 2013, a streamside encampment (Figure 69) appeared between bend 3 and bend 4, which has easy access to the decommissioned road through the trees. There were three large piles of garbage around the tent and pots and pans were on a point bar in the stream.
