MORPHOLOGY OF SMALL, DISCONTINUOUS MONTANE MEADOW STREAMS  
IN THE SIERRA NEVADA

A thesis submitted to the faculty of  
San Francisco State University  
In partial fulfillment of  
The requirements for  
The degree

Master of Arts  
in  
Geography: Resource Management and Environmental Planning

Michelle Laura Slocombe

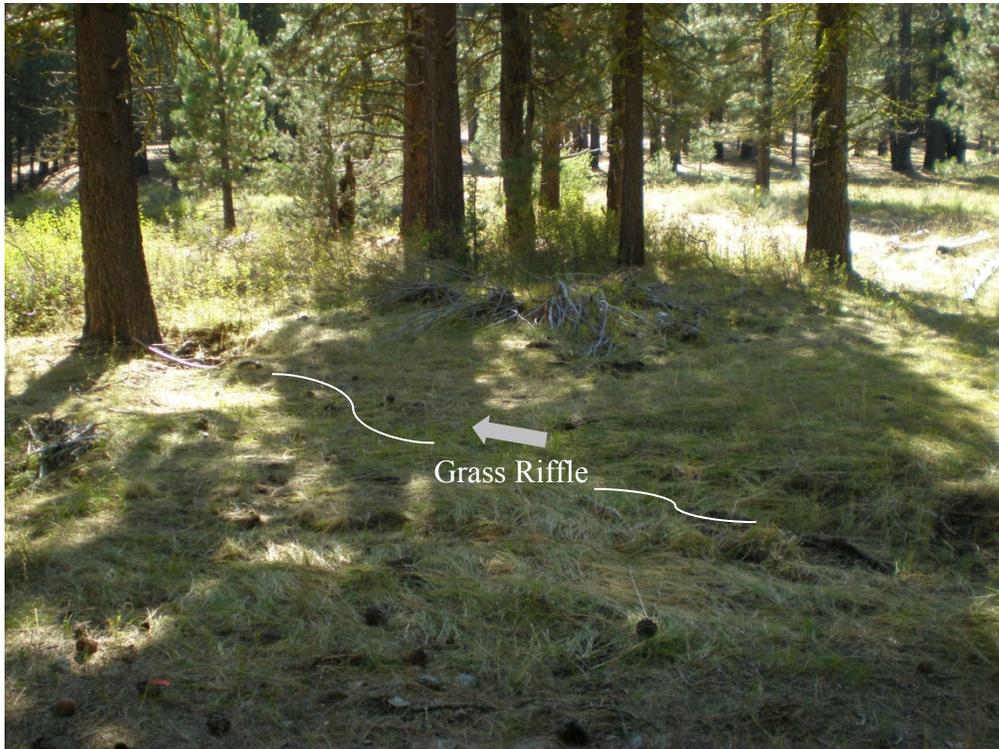
Figure 1. Instead of riffles composed of coarse sediment, the meadow channels exhibited “grass riffles”, or stretches of grass sod connecting two scour holes, as seen in this photograph of Carman Creek in Three Corner Meadow. Gray arrow indicates direction of water flow during the wet season.

Northern Sierra Nevada meadows are characterized by the presence of shallow, heavily vegetated stream channels that are almost indistinct, particularly when vegetation is thick during the summer months (Hagberg, 1995). In place of the classic gravel-bed entrenched channels typical of the West, a key distinguishing feature of these meadow channels is the presence of a series of scour pools connected by grass sod. The resistant grass sod serves a similar energy-drop function as riffles or steps in typical alluvial

systems (Figure 1). This research should provide better clarity for this unique geomorphic feature.

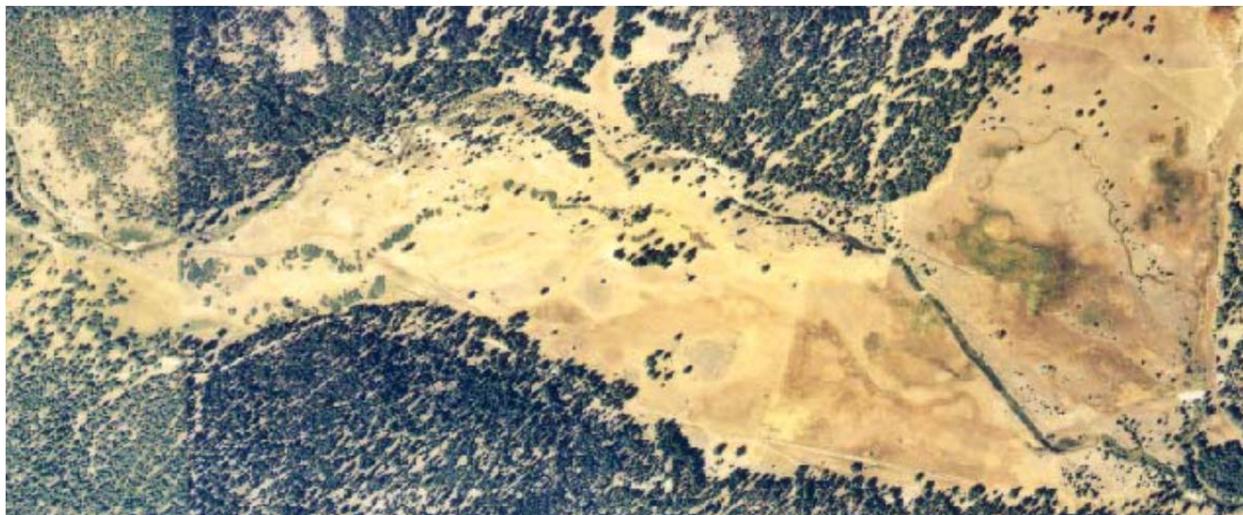
Figure 2. Aerial view of Knuthson Meadow pre-restoration. The incised channel can be seen as a straight line cutting across the meadow on the right (Sierra Valley Resource Conservation District, 2004).

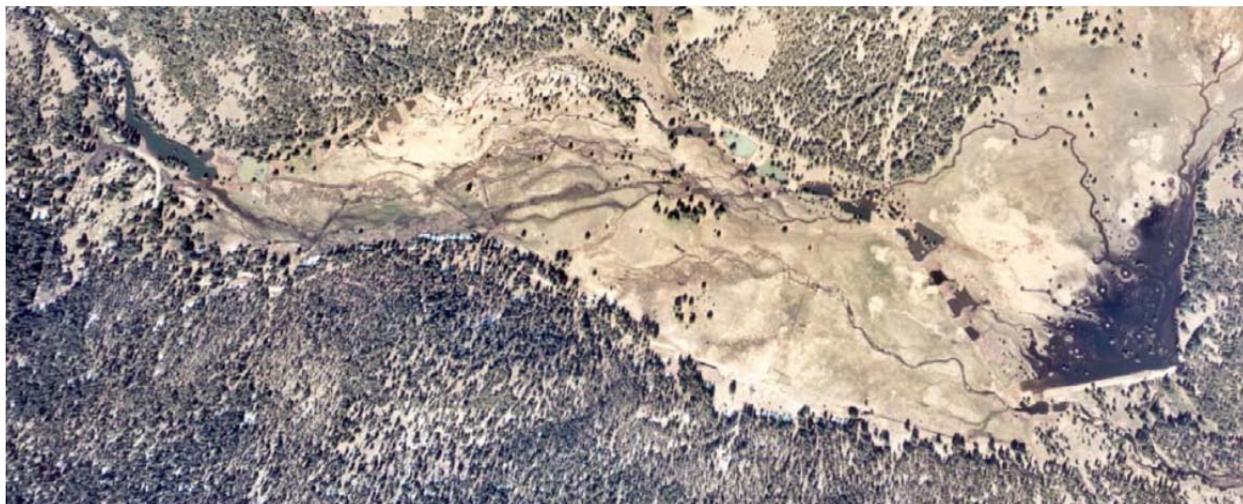
Figure 3. Aerial view of Knuthson Meadow post-restoration. The ponds created by the restoration are located where the incised channel used to be and multiple natural channels are visible on the meadow surface (Sierra Valley Resource Conservation District, 2004).

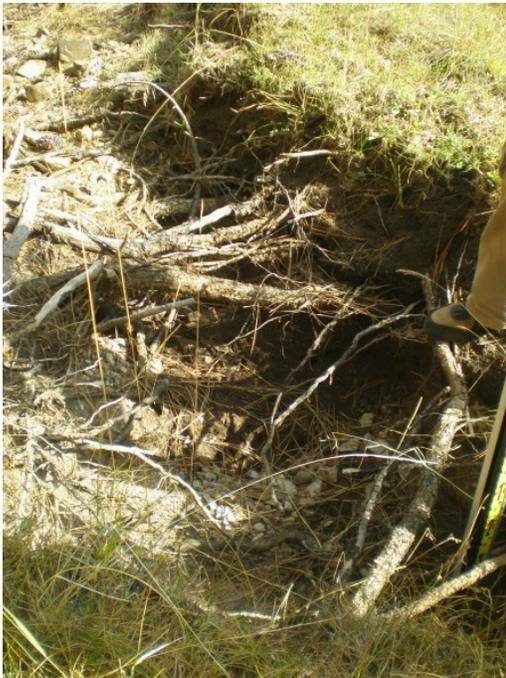
Figure 13. A scour pool caused by extensive tree roots in Carman Creek, Three Corner Meadow.

Each location contained different environmental factors contributing to pool formation. In Carman Creek (Three Corner Meadow), deep pools occurred where roots and large substrate caused eddies to scour the channel (Figure 13).

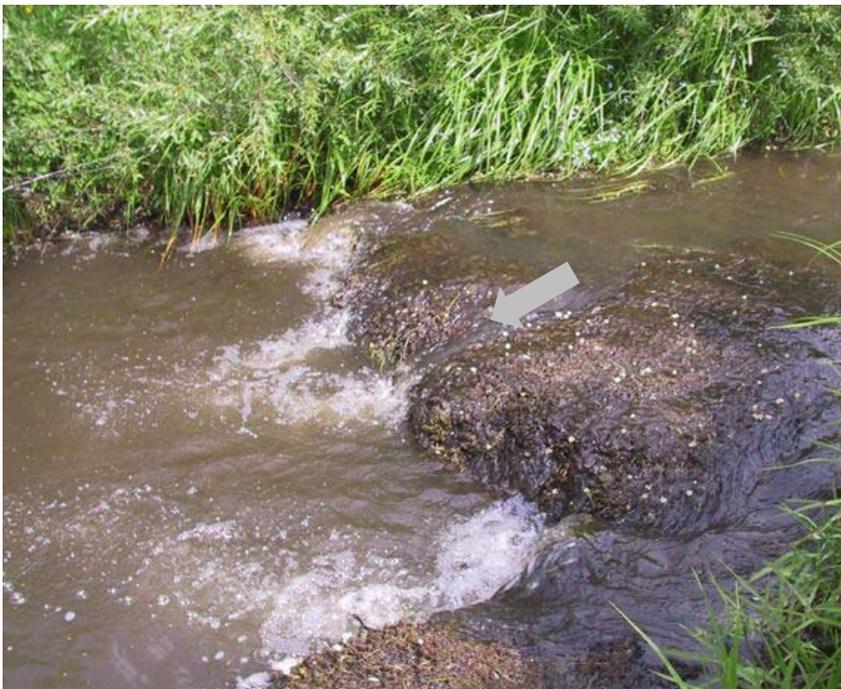
Figure 14. Headcut step in sod creating a plunge pool in Haskell Creek. Gray arrow indicates flow direction.

Headcut development in the resistant sod contributed to pool formation at regular, cyclic intervals. For example, several headcut steps were observed in Haskell Creek, leading to the creation of plunge pools (Figure 14).

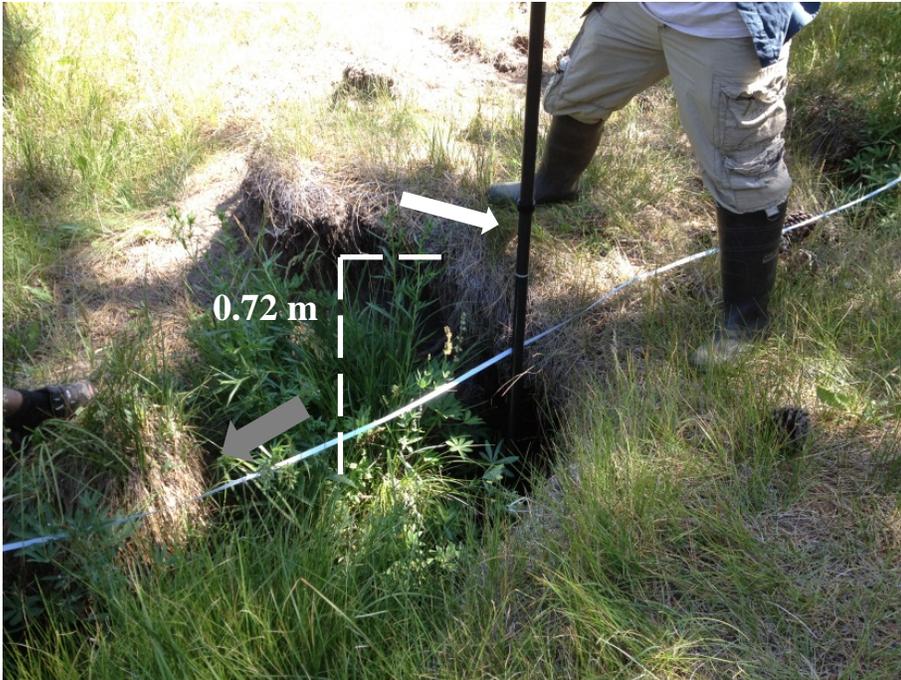
Figure 15. Surveying a sod bridge in the channel of Rowland Creek. The top of the bridge is indicated by the white arrow. Flow direction is indicated by the gray arrow.

In Rowland Creek, resistant sod bridges (a form of piping) developed from eroding headcuts, allowing water to penetrate deeply into the bed material (Figure 15). Piping has been linked to discontinuous gully formation where it is a mechanism for deepening the channel (Leopold and Miller, 1956).
