**SAN PEDRO CREEK WATERSHED
SEDIMENT SOURCE ANALYSIS**

**Volume II:
Hillslope Sediment Source Assessment**

Stephanie Sims

San Francisco
State University

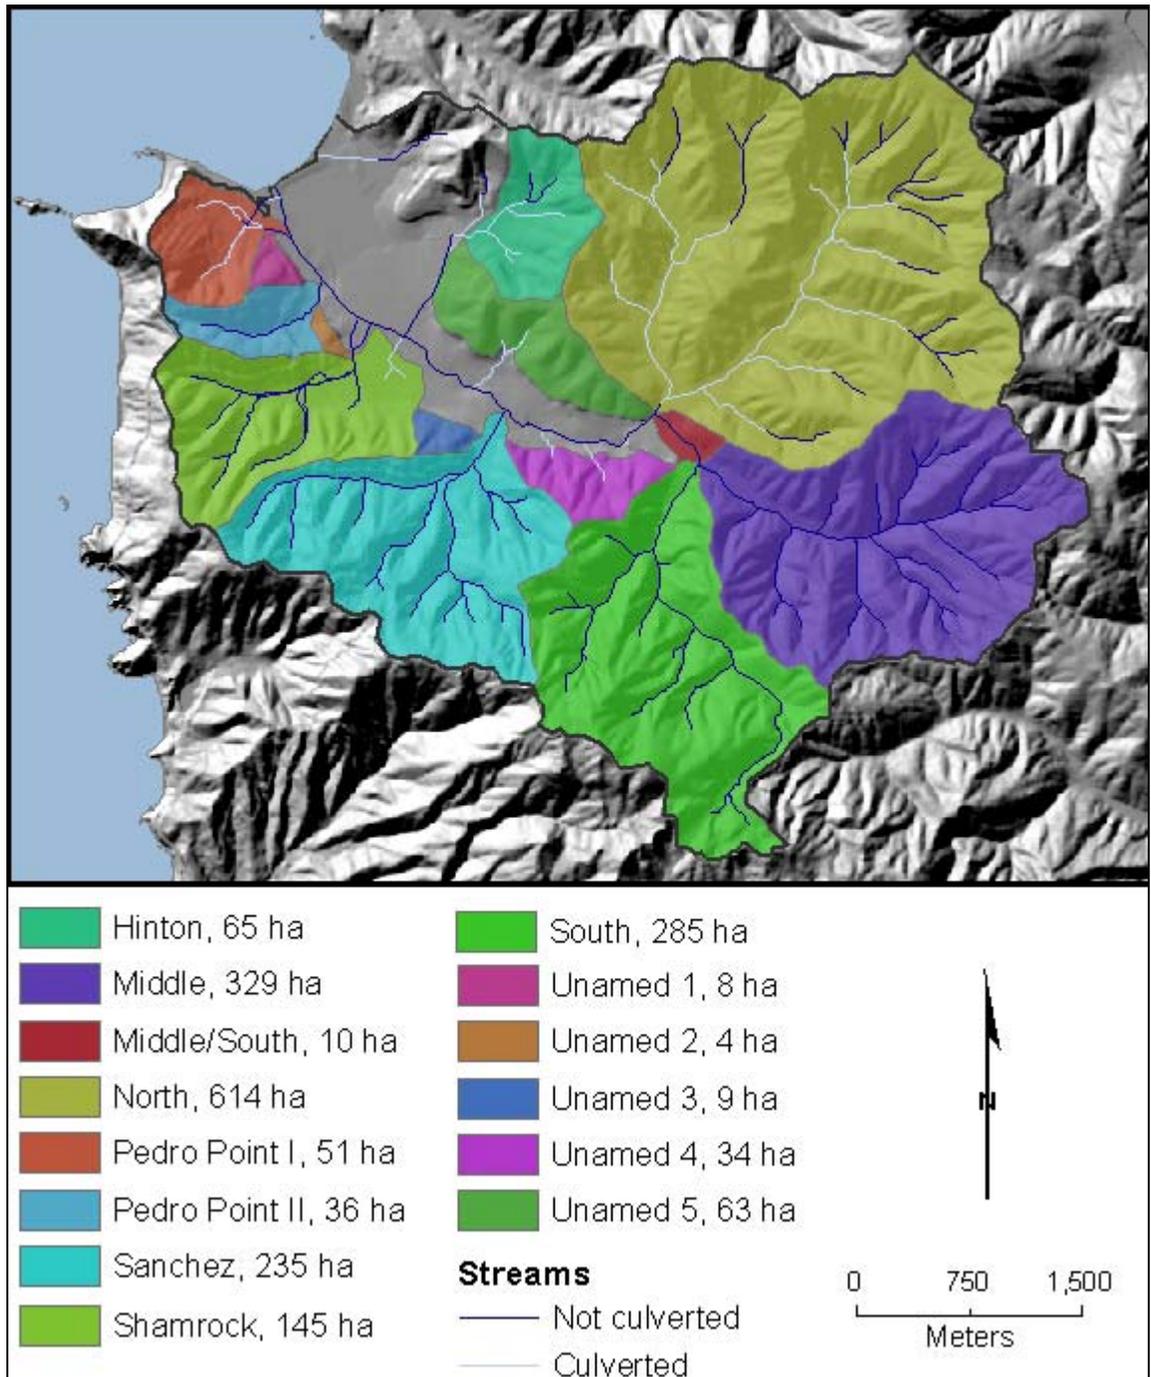
Figure 3: SPCW draining northwest to the Pacific Ocean. The subwatershed drainages shown are overlaying a gray-shaded topography layer representing the remainder of the watershed and surrounding areas. (SPCWC 2000).

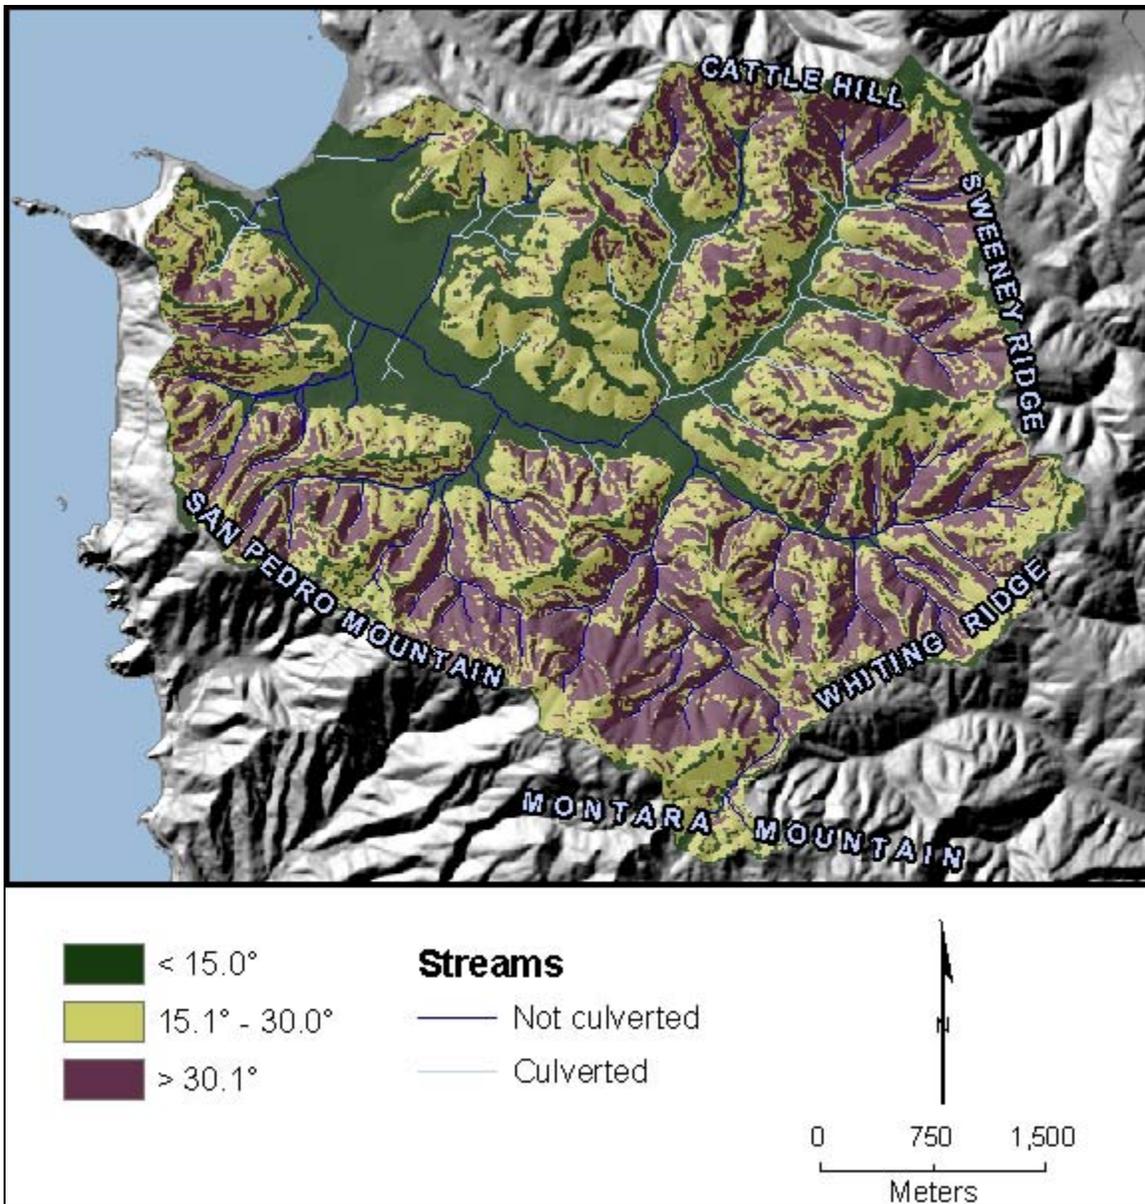
Figure 4: Slope of SPCW in degrees with labeled prominent range and mountain features (USGS 2003).

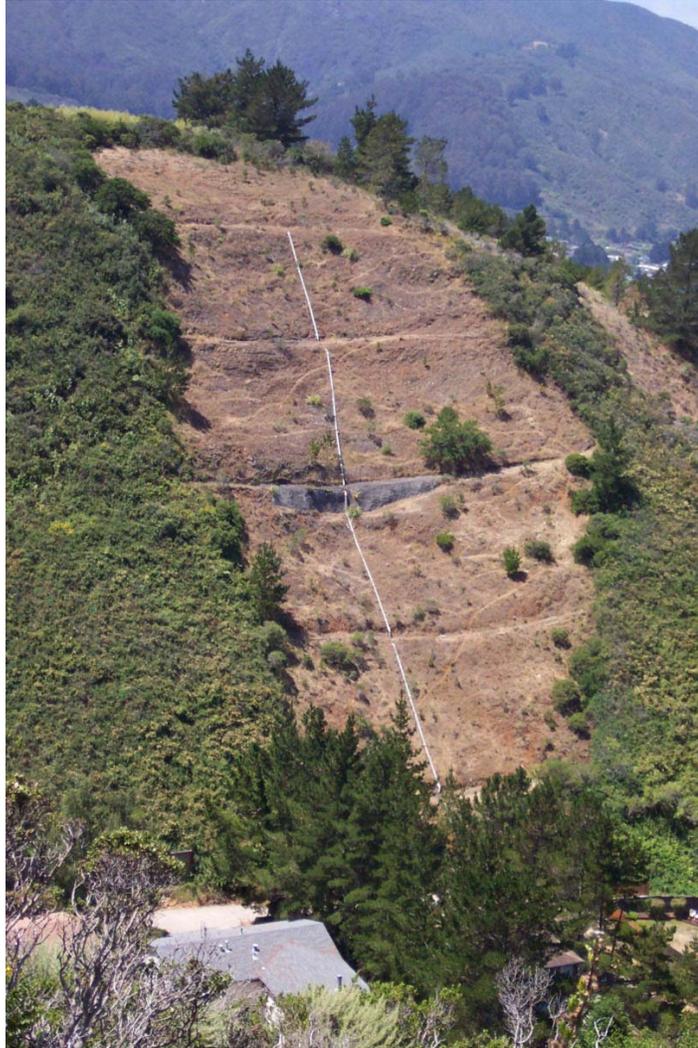
Figure 6: Terraced hillslopes altering the geomorphology of natural slopes.

Urbanization has increased the gradient of some hillslopes. Pampeyan (1994) found that toe hillslope removal associated with increased development altered hillslope morphology and increased landslide potential within the Linda Mar neighborhood. To reduce this hazard, hillside terraces are now common throughout much of the North subwatershed (Figure 6) to prevent excess moisture and debris accumulation.

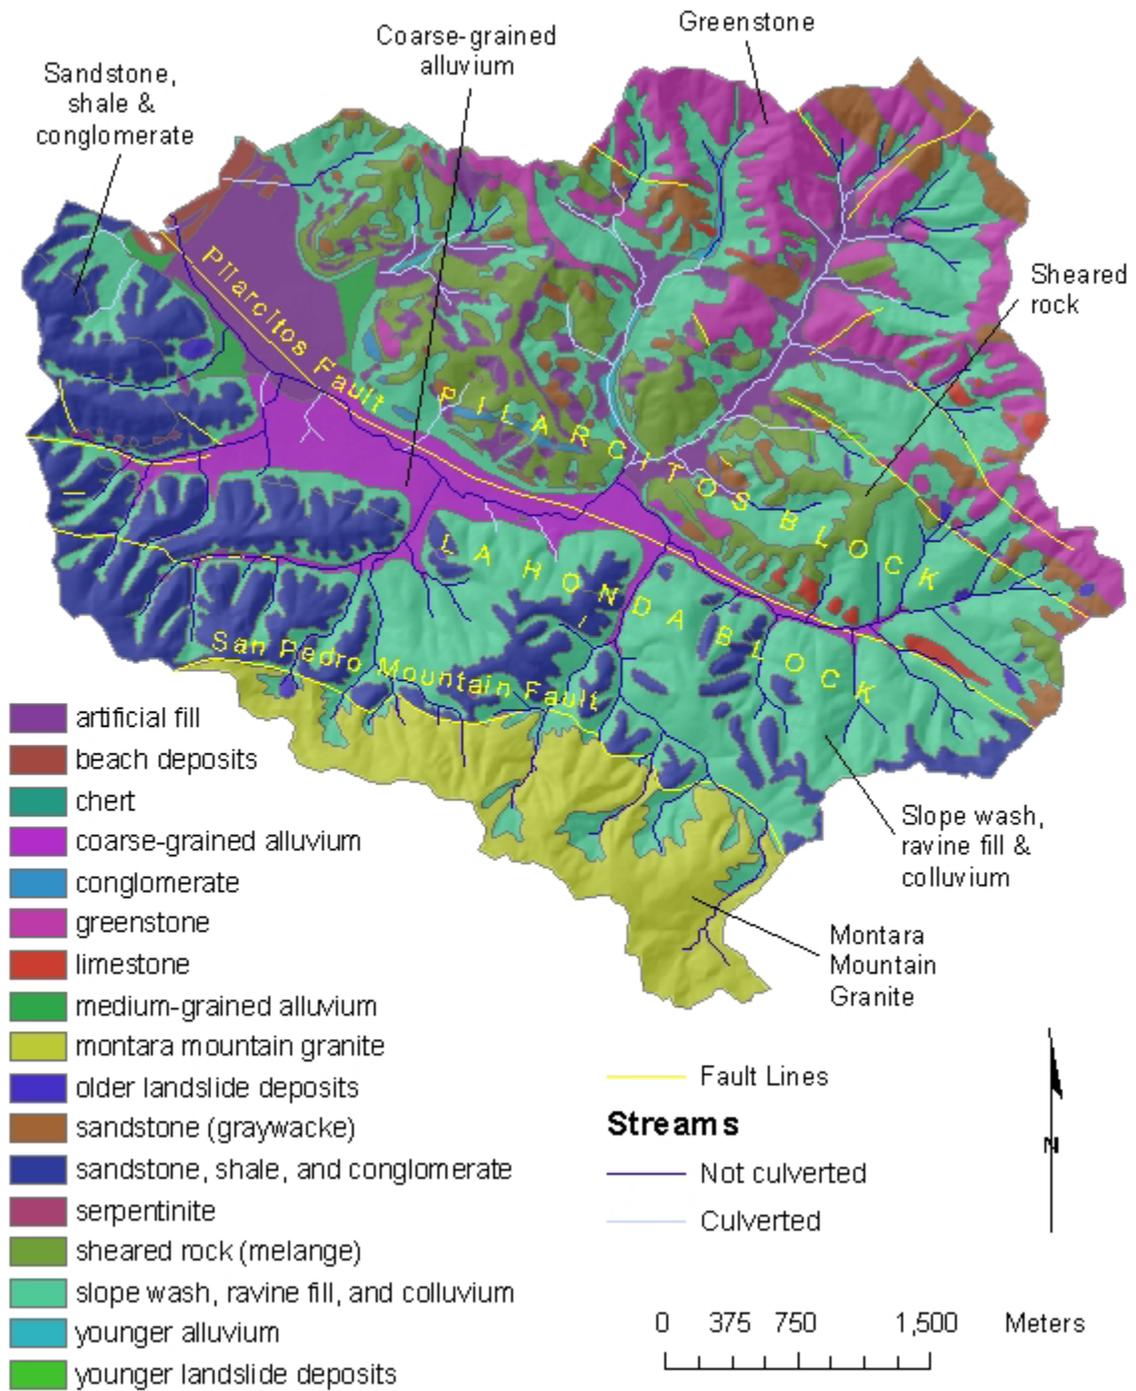
Figure 7: Geology and fault lines of SPCW (Pampeyan 1994).

The underlying geology of SPCW is relatively complex due to the abundance of faults (Figure 7). Unless otherwise noted all of the geology information in this section is based on Pampeyan (1994). The Pilarcitos fault, a strike-slip fault, is the largest and most structurally influential fault within the study area running along the center of SPCW. It demarcates the boundary between the Franciscan complex of the Pilarcitos block to the north and the granitic rocks of the La Honda block to the south. Running parallel to and south of the Pilarcitos fault lays the San Pedro Mountain fault (Figure 8) spanning through large portions of the Sanchez and South Forks. This fault further distinguishes the geology of the La Honda Block from sandstone shale and conglomerate to the north and granitics to the south. Many smaller inconspicuous faults predominately lay parallel to these larger faults but are not as influential in controlling geologic structure. One of these faults that has been significant in controlling the underlying sandstone and greenstone runs perpendicular to the others within the North fork subwatershed.

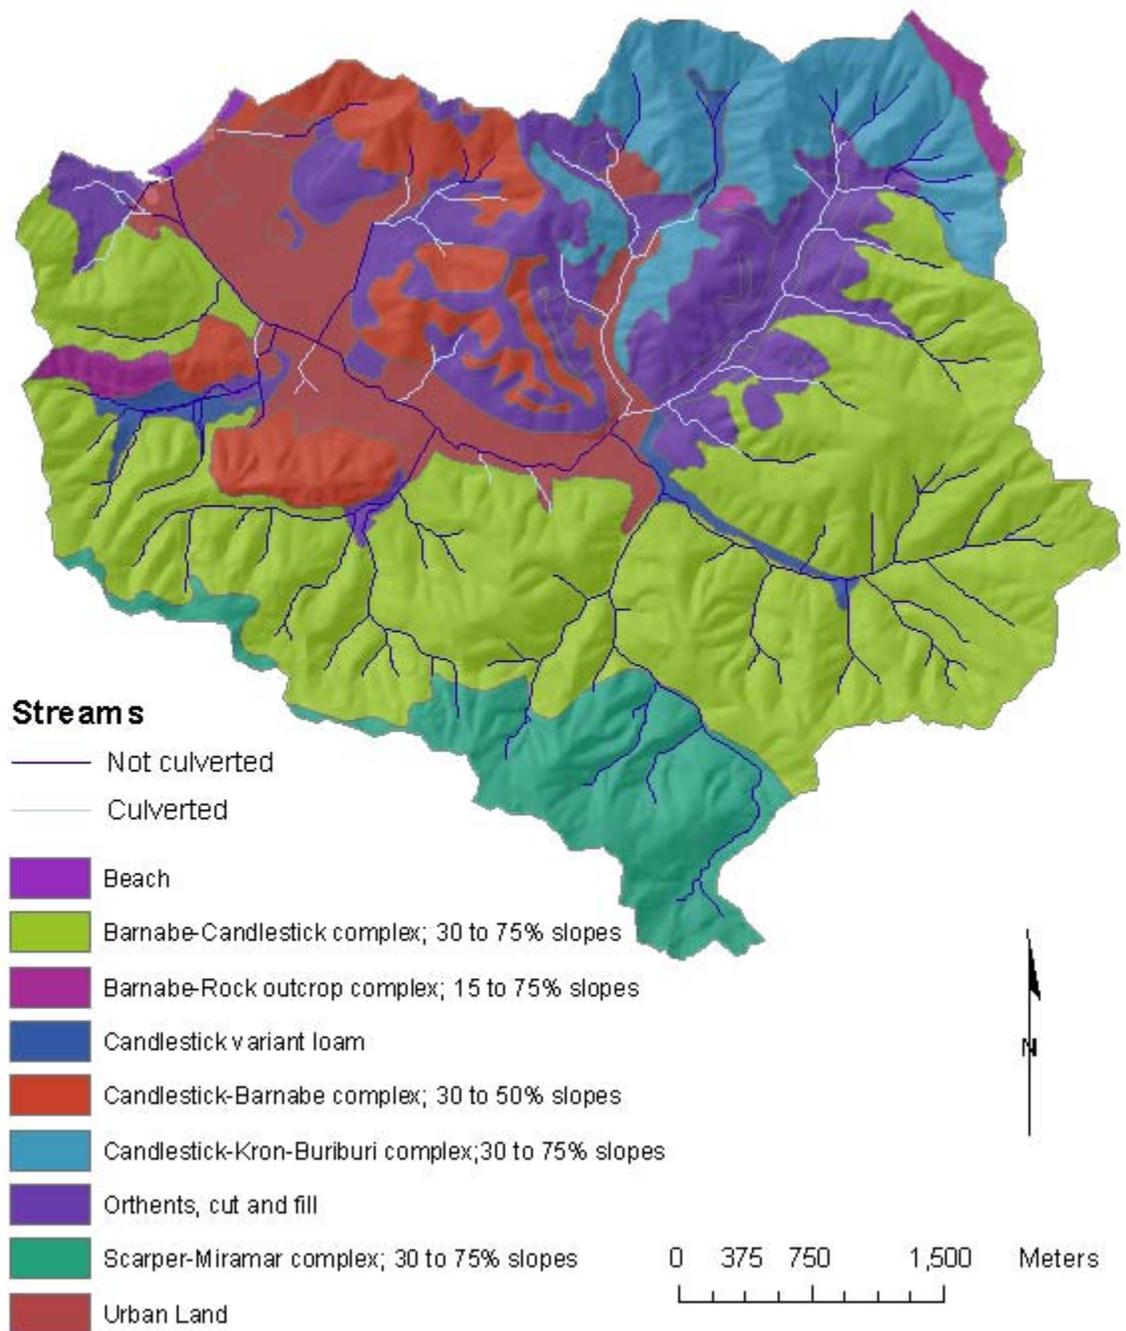
Figure 9: Soil complexes of SPCW (Kashiwagi and Hokholt 1991).

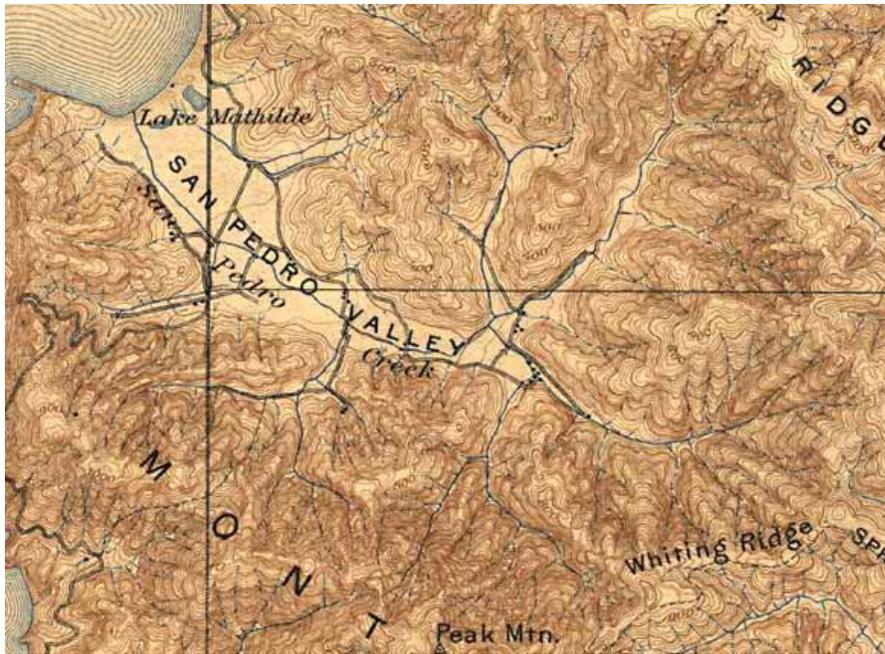
Figure 10: USGS topography map of SPCW in 1896 with little urban development and few roads (OMC 2003).

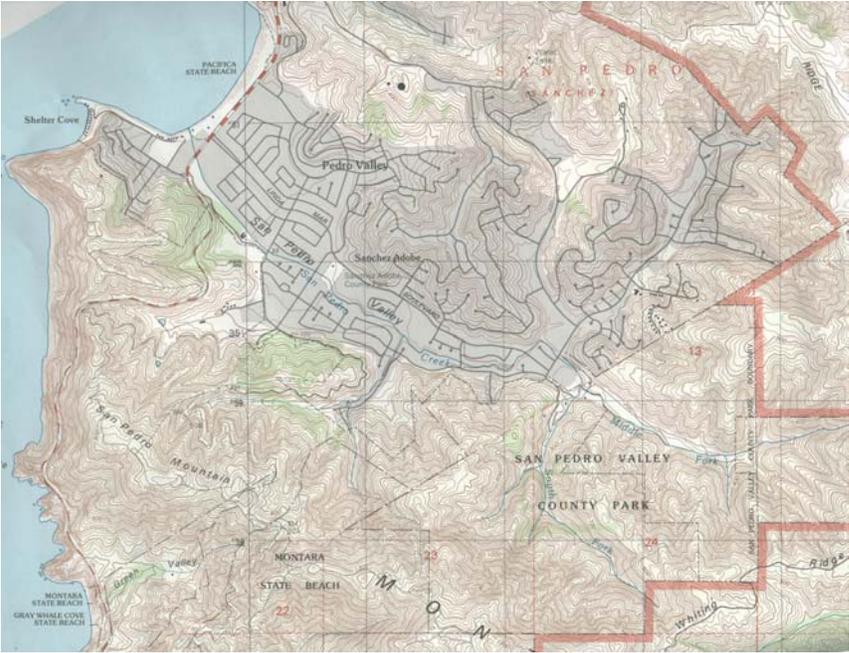
Figure 11: USGS topography map of SPCW in 1997 showing extensive development throughout most of the valley floor as indicated by the gray fill and the broad road system (USGS 1997).

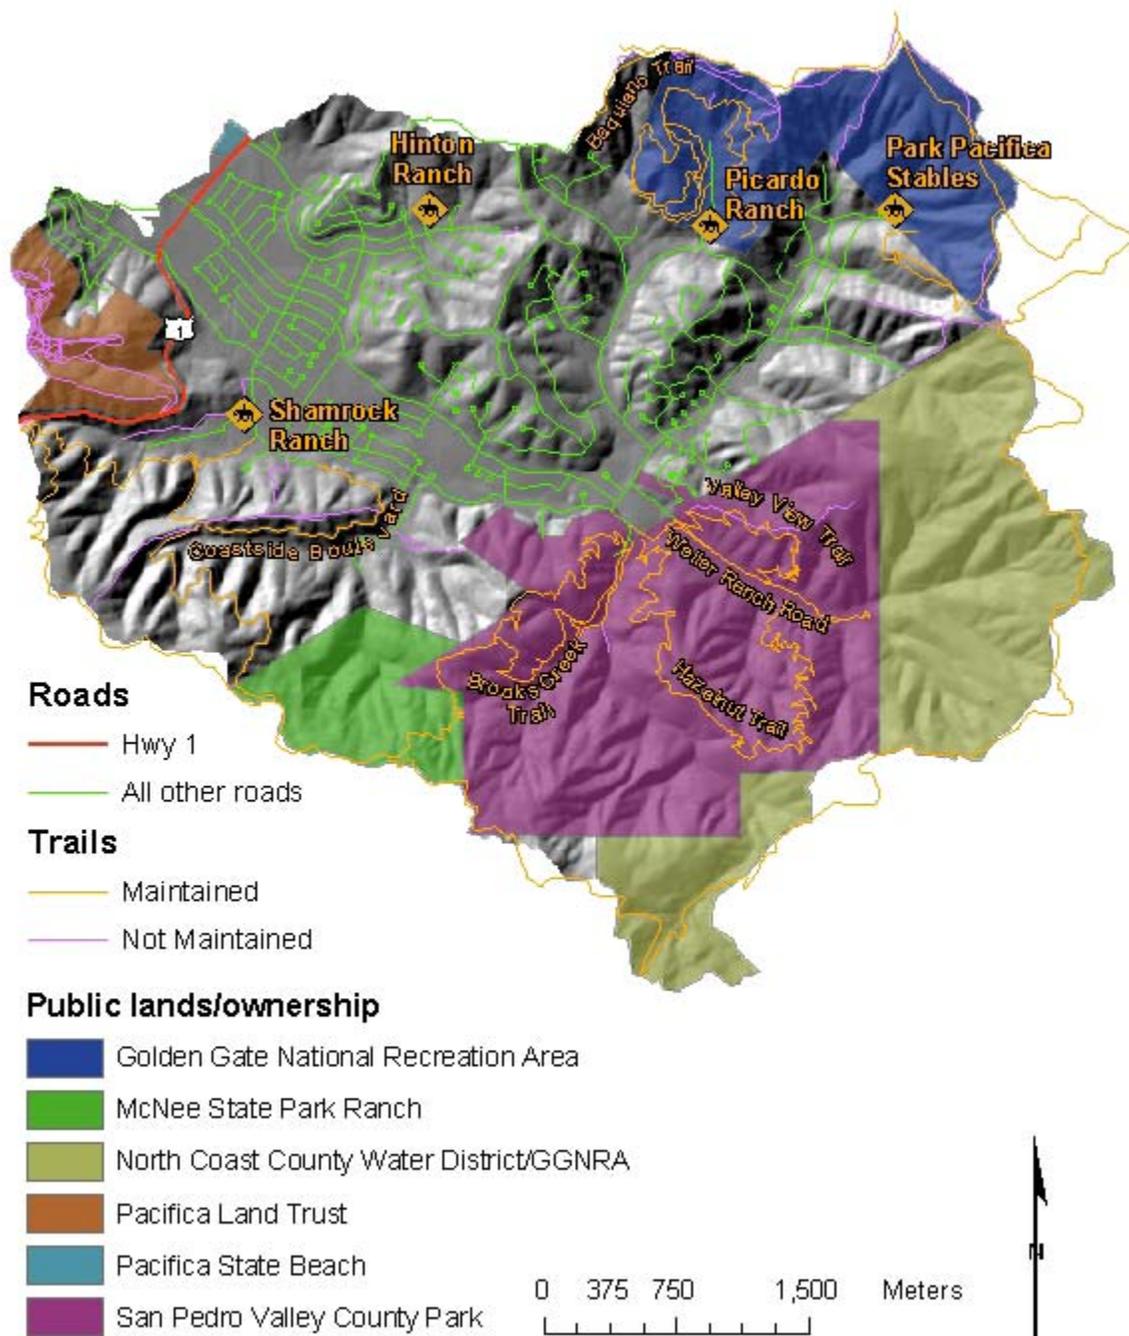
Figure 12: Roads, trails, and public lands of SPCW. Some of the more prominent trails that were surveyed are labeled. Ranches are labeled and the remainder of the gray areas is under private landownership (SPCWC 2000).

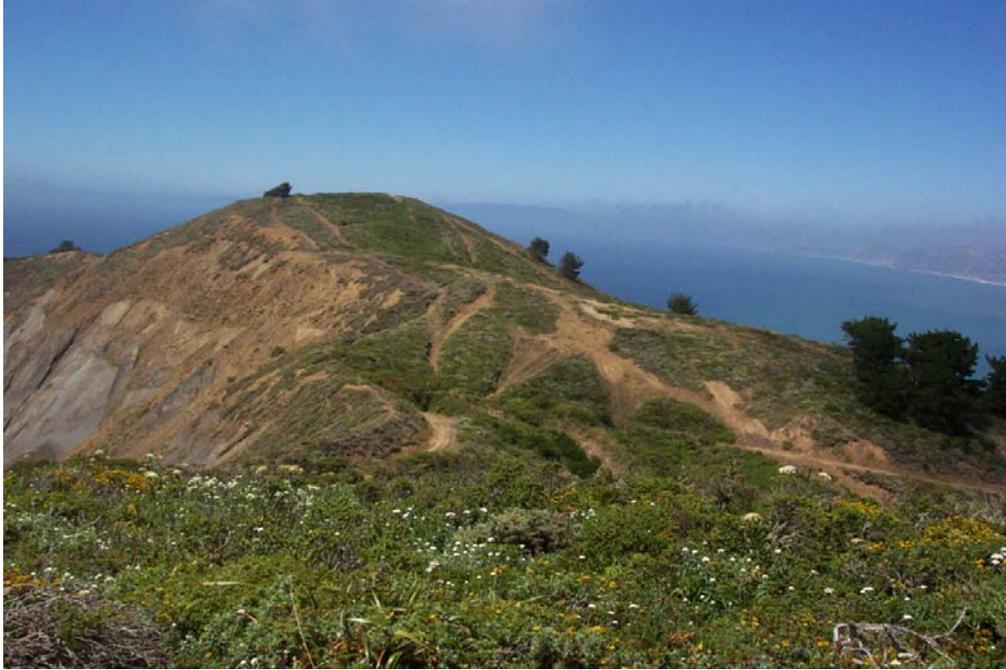
Figure 13: Remnant bare soil and erosion from previous off-road use in Pedro Point II subwatershed.

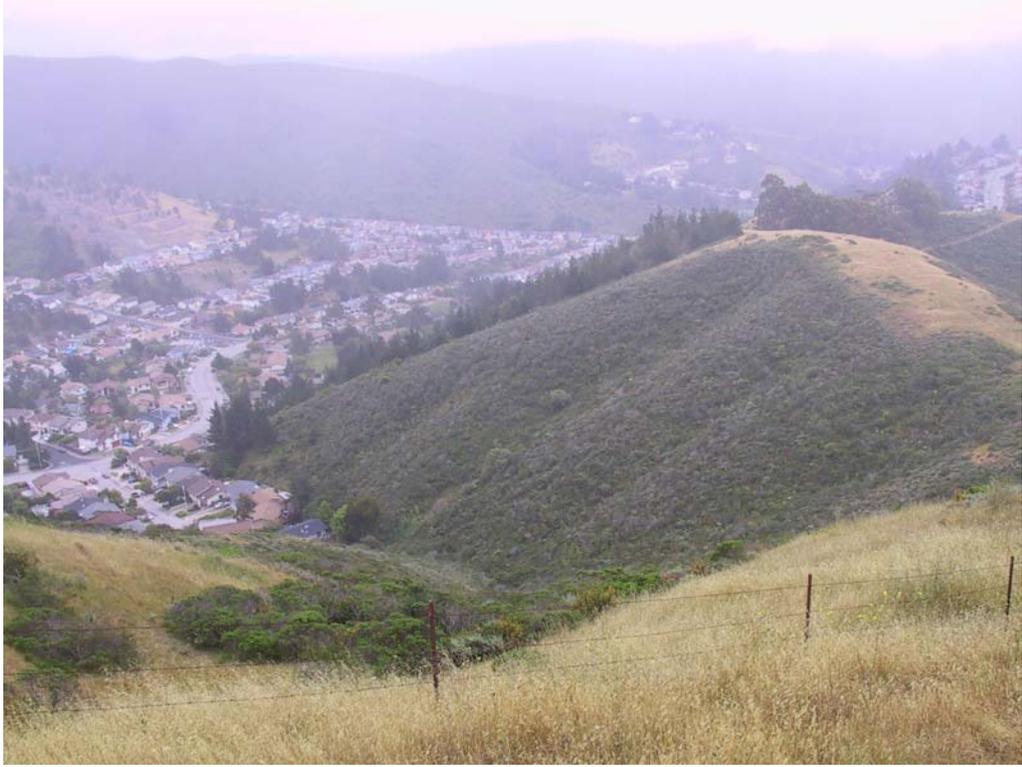
Figure 15: Urbanization in the North subwatershed from the valley floor encroaching on the toe slopes of hillsides. The northern profile of the Oddstead landslide is shown covered in trees to stabilize the hillside.

While lower portions of the Middle, South, Sanchez, and Shamrock Forks remain relatively undeveloped, residential development has encroached up the valley along the North, Hinton, and Pedro Point I forks culverting most of the flow. Urbanization has overtaken several hillsides primarily in the North fork and has extended as far up the valleys as possible. This development has pressured toe slopes of adjacent hillsides and increased the potential hazard for landslides (Figure 15).

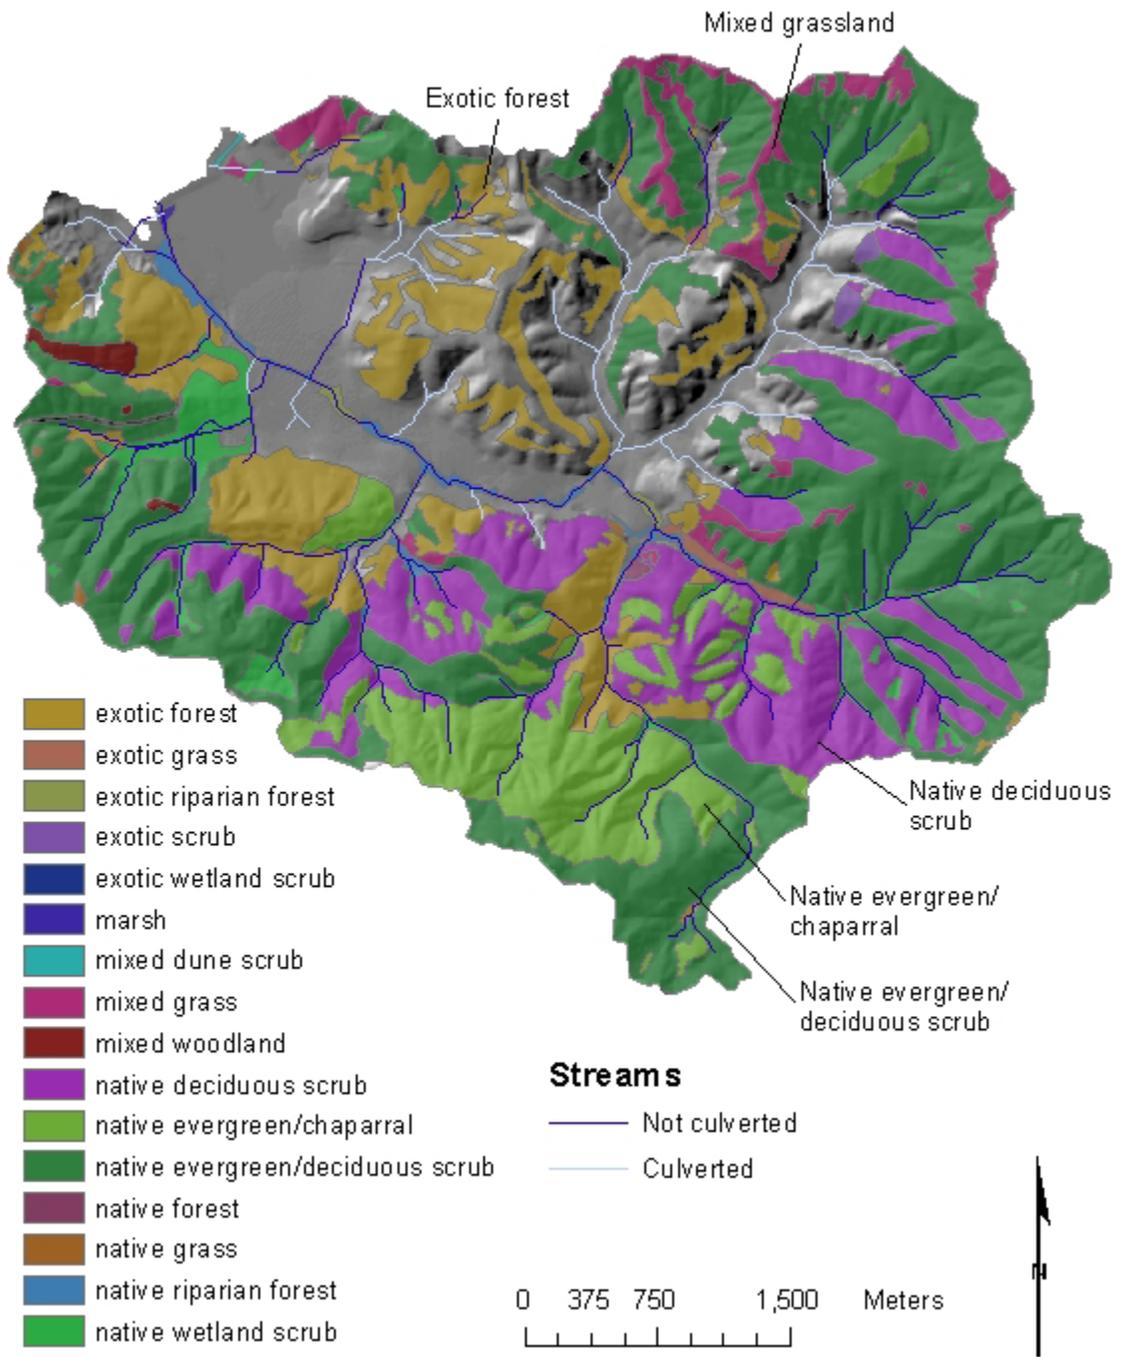
Figure 16: Land cover of SPCW. Vegetation data for the gray areas either was not collected or is urban land cover (SPCWC 2002)

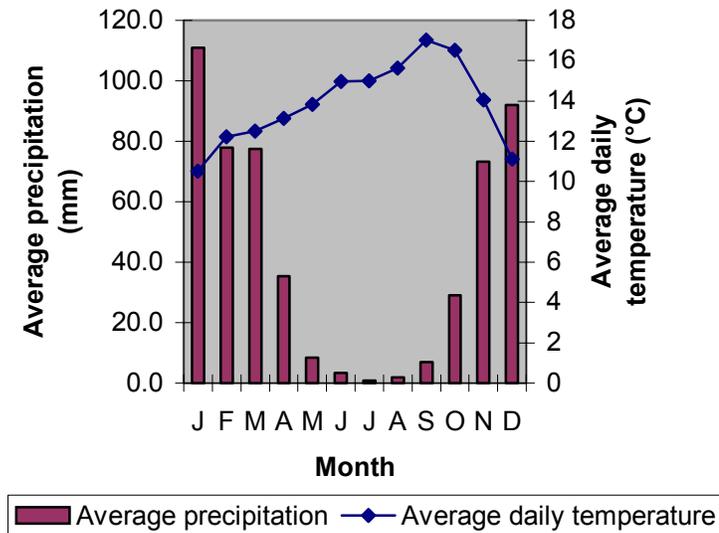
Figure 20: Monthly average temperature and precipitation for San Francisco between 1948-1988. The precipitation data is lower than that collected in SPCW but effectively displays the general yearly pattern of rainfall (Kashiwagi and Hokholt 1991).

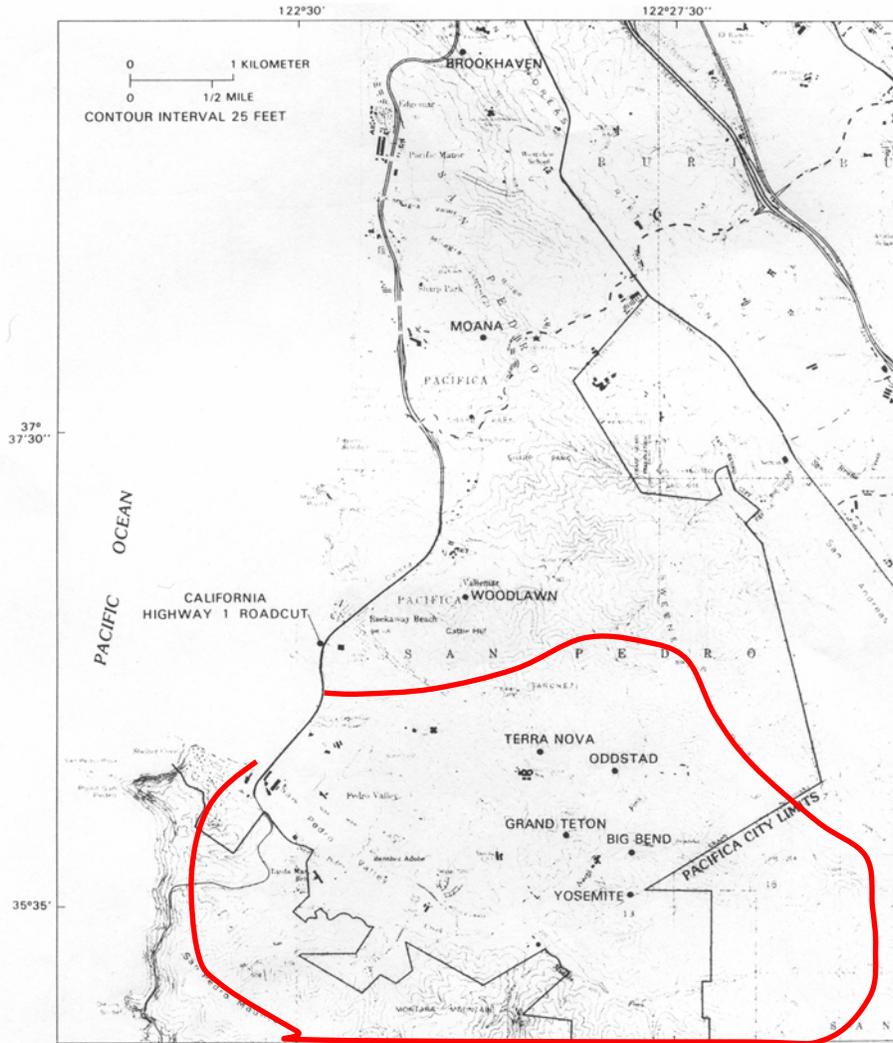
Figure 21: Select landslides triggered from January 1982 storm event that were studied in detail. Five of the nine occurred within the North subwatershed and fall within the generalized extents of SPCW outlined in red (modified from Howard *et al.* 1988).

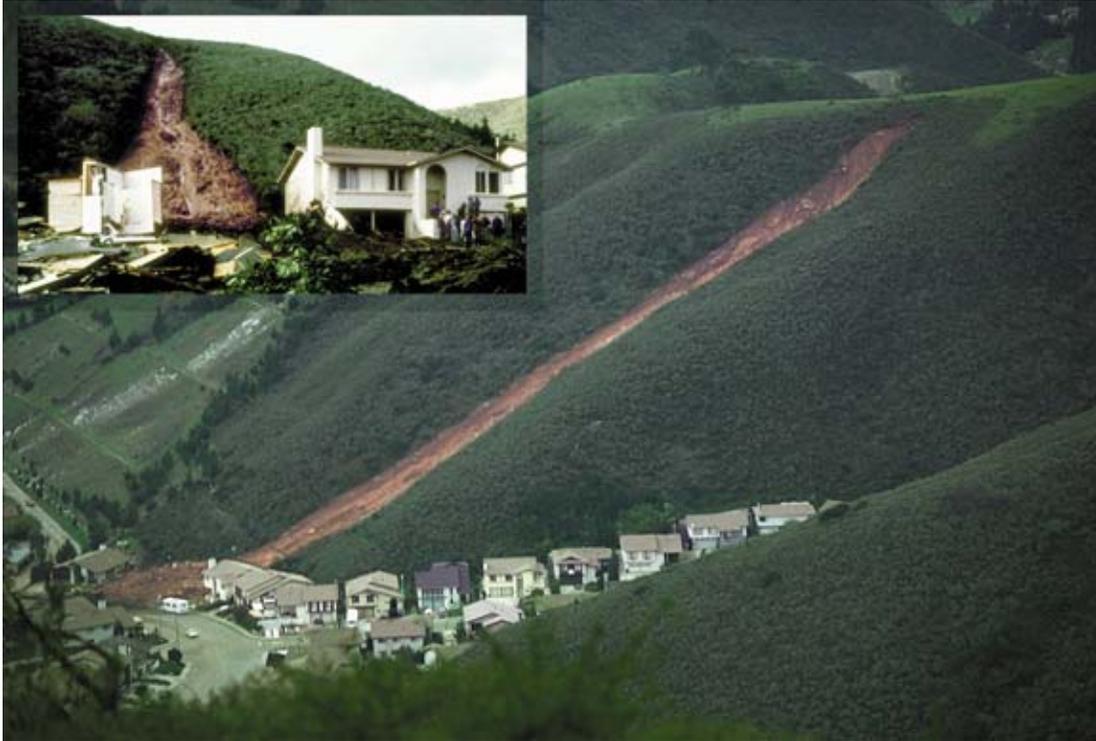
Figure 22: Oddstad slide in the North subwatershed (USGS 1998).

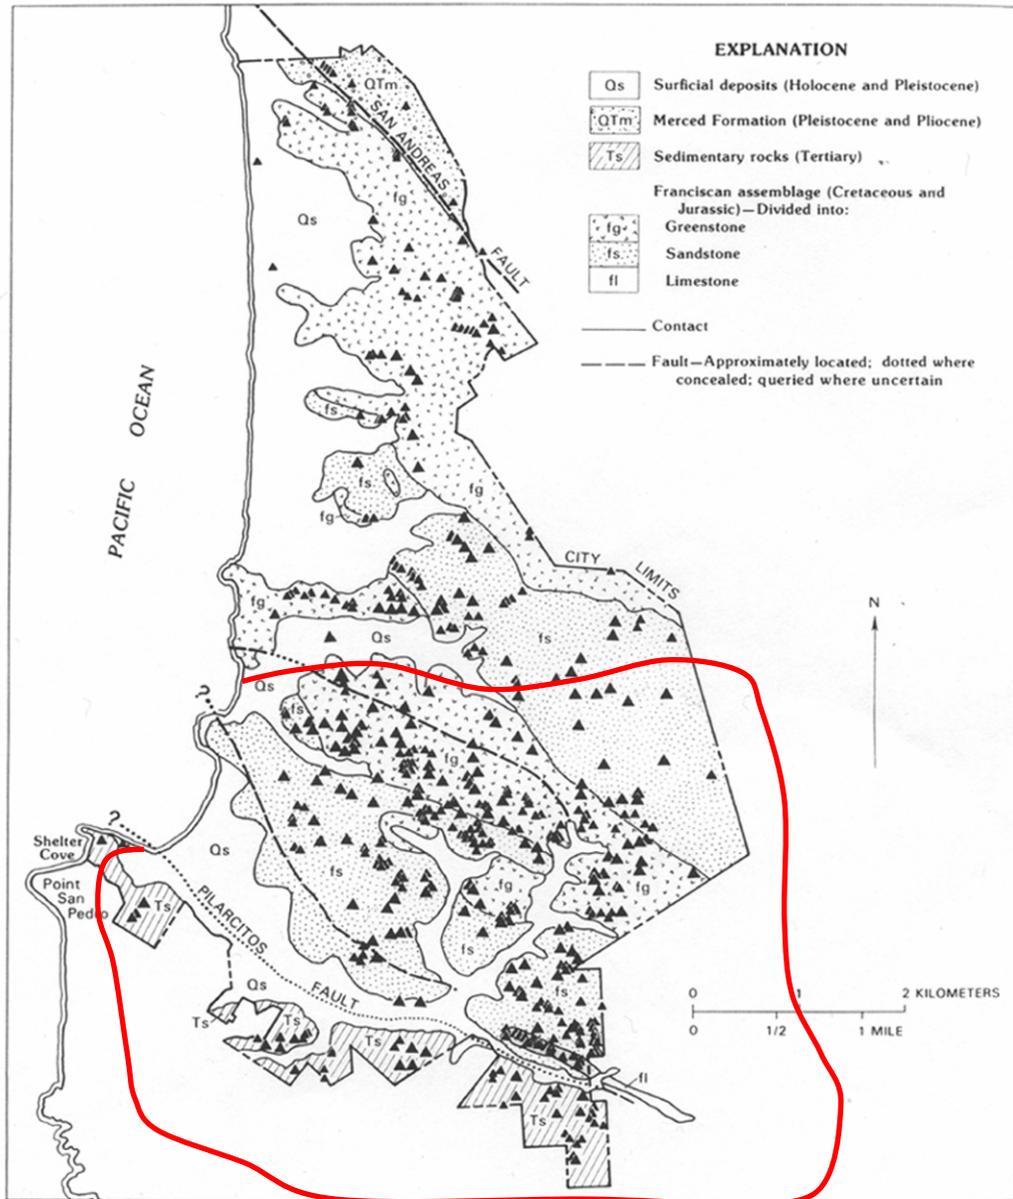
Figure 24: Landslides triggered from January 1982 storm event with corresponding geological units, Pacifica, CA. Generalized extents of SPCW outlined in red. (modified from Howard *et al.* 1988).

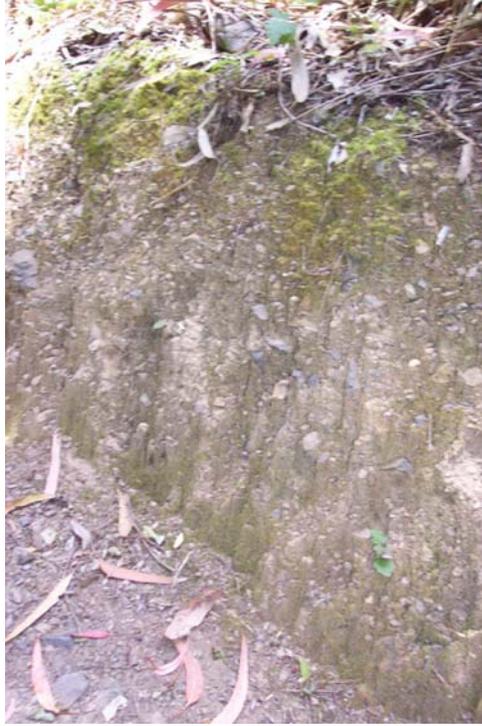
Figure 25: Rills on the nearly vertical face of an uphill trail cut in the South subwatershed.

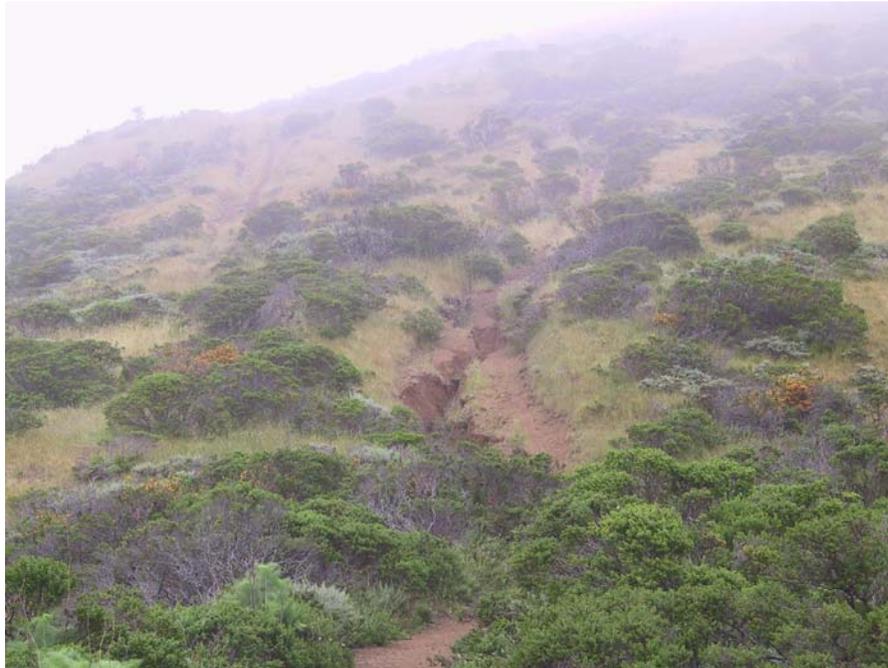
Figure 26: Gullies along a trail on Cattle Hill in the upper North subwatershed.

Rills and gullies are physical features formed in areas with sparse or no vegetative cover or with heavily compacted soil. Rills are shallower and occur when saturation overland flow becomes concentrated from an increased slope gradient or where the surface roughness increases, both creating more turbulent flow (Figure 25) (Ahnert 1996). Gullies, which are formed from the same initial processes, are much deeper than rills and have incised into deep channels (Figures 26 and 27) (Collins *et al.* 2001).

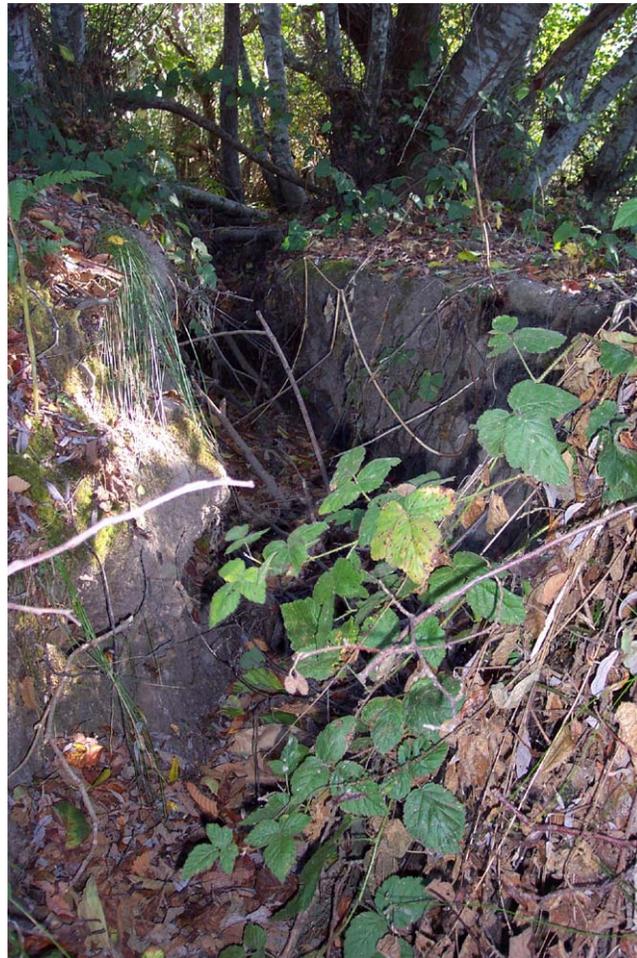
Figure 28: Fluvial erosion causing incision through a former landslide deposit in an intermittent tributary draining into Sanchez Fork (Davis 2003).

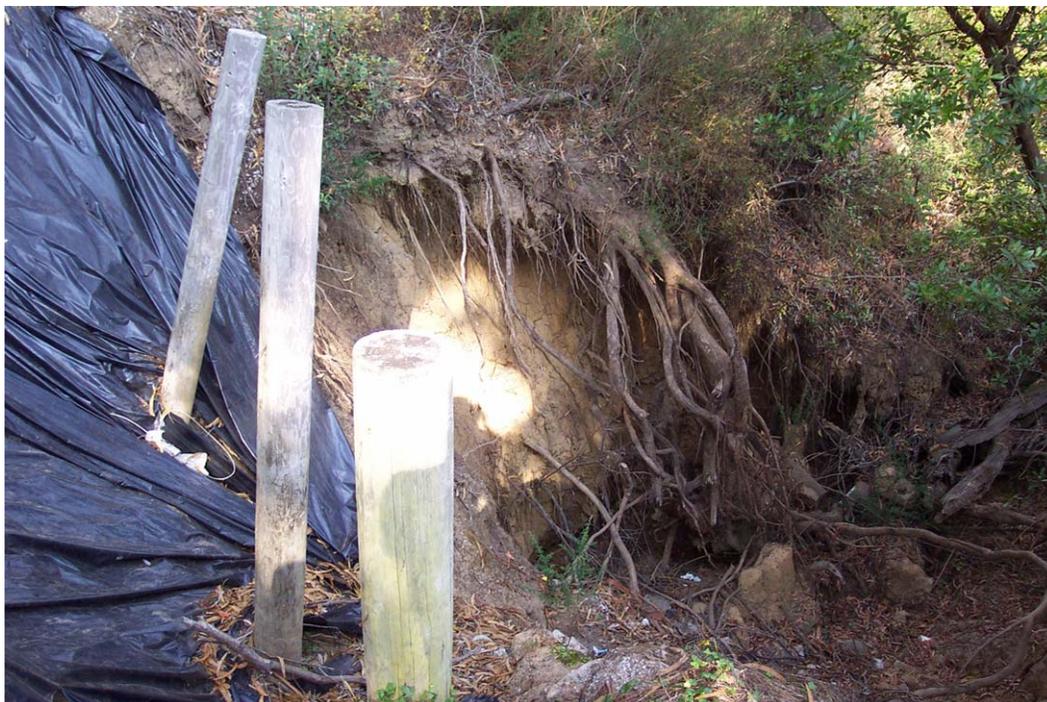
Figure 29: Severe surface erosion from concentrated Horton overland flow downslope of Coastside Boulevard, draining to a culvert draining to the storm drain network near Sanchez Fork.

Sediment generated from natural processes in SPCW is often enhanced by land use practices (Figures 29 & 30). Agriculture, grazing, and a regular fire regime have historically influenced SPCW hillslopes and tributaries. Significant gullies have developed along some of the coastal hillslopes as a result of agriculture and subsequent grazing (Davis 2002). While a large portion of SPCW is currently urbanized, the main sediment influenced by anthropogenic activities is derived from concentrated and diverted flows from trails and roads on hillslopes and along the tributary.

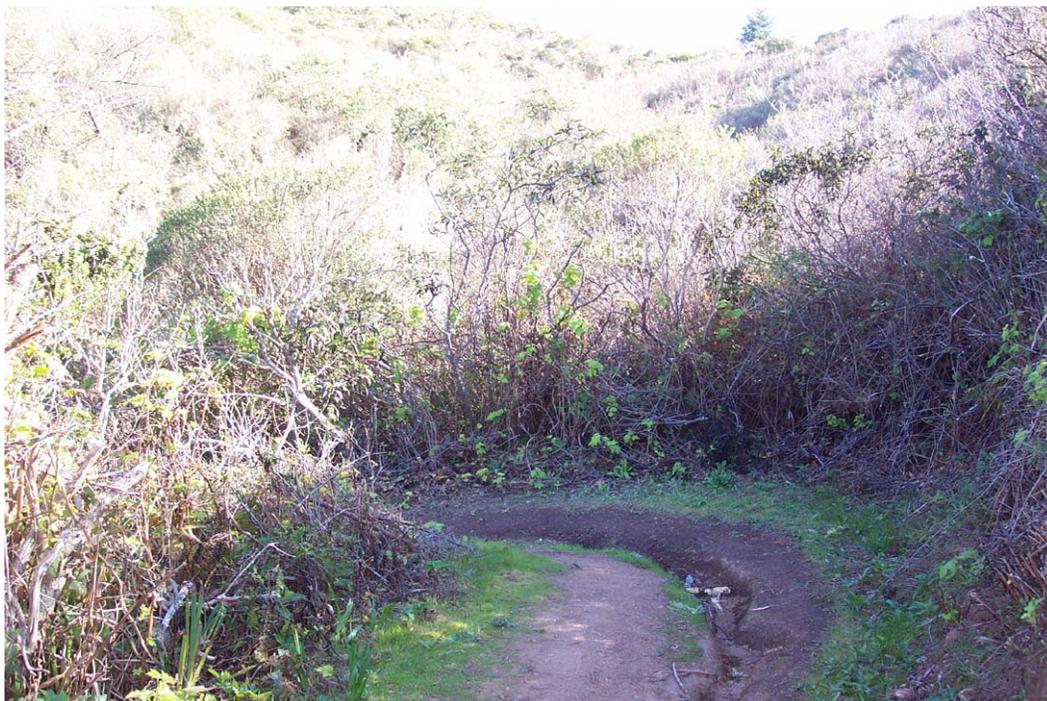
Figure 30: Concentrated flow creating surface erosion and increasing the effective drainage density along the Hazelnut Trail draining to South Fork.

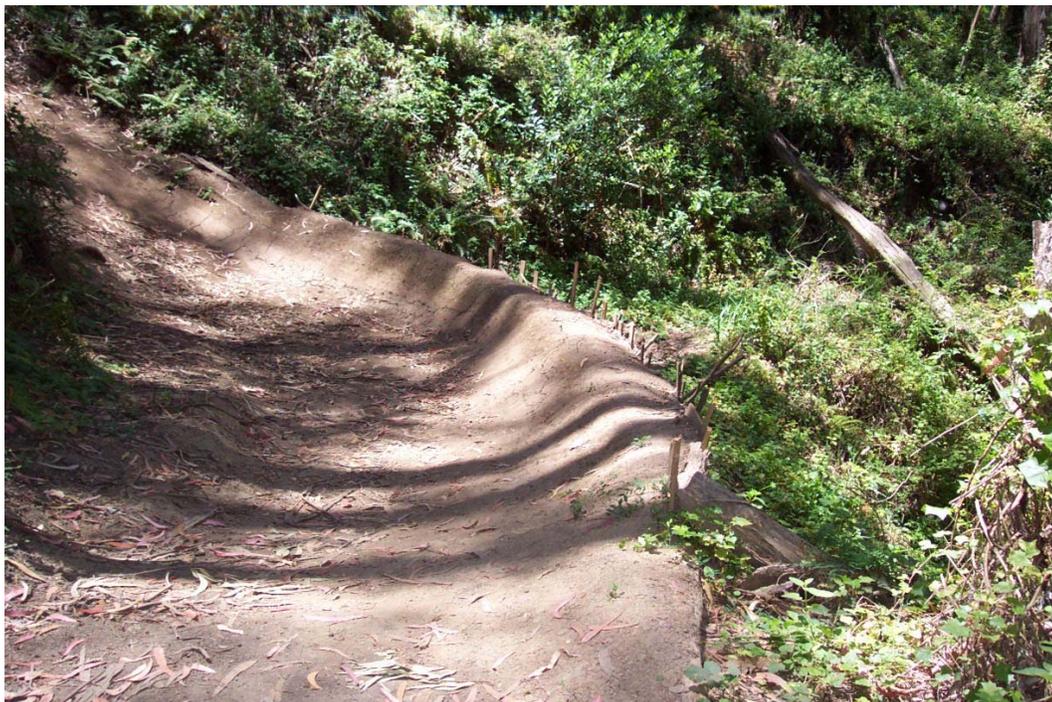
Figure 31: Mountain bike trails and constructed features along an otherwise unmaintained trail draining to Shamrock Fork.

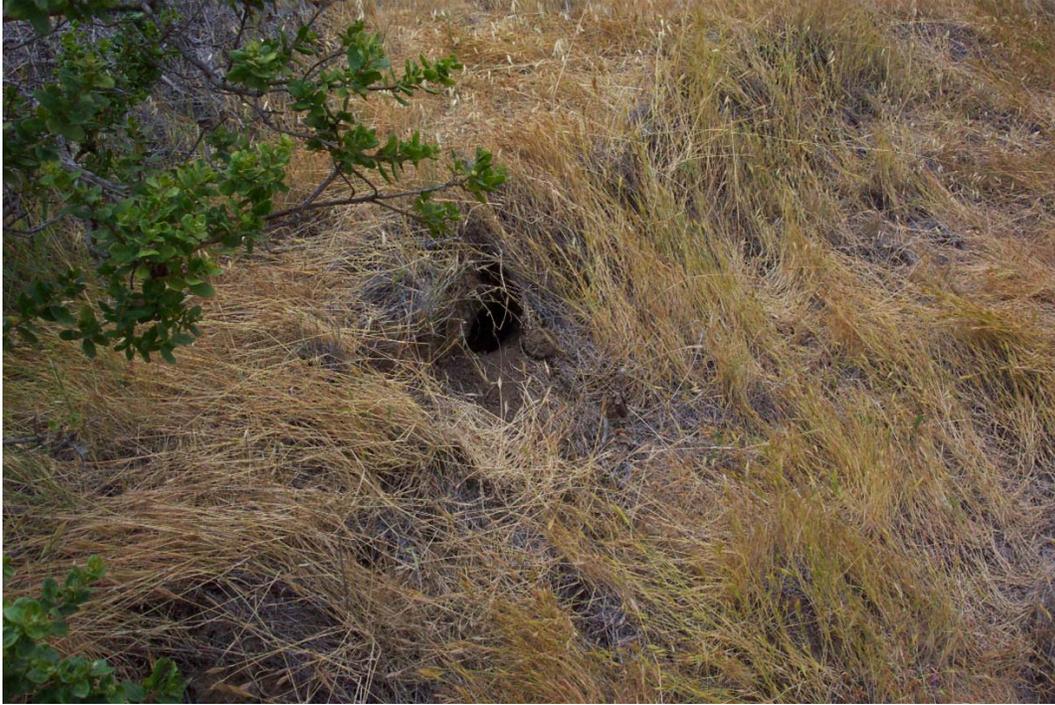
Figure 32: Burrow hole that may soon lead to piping along the upper edge of a gully complex in the Middle subwatershed.

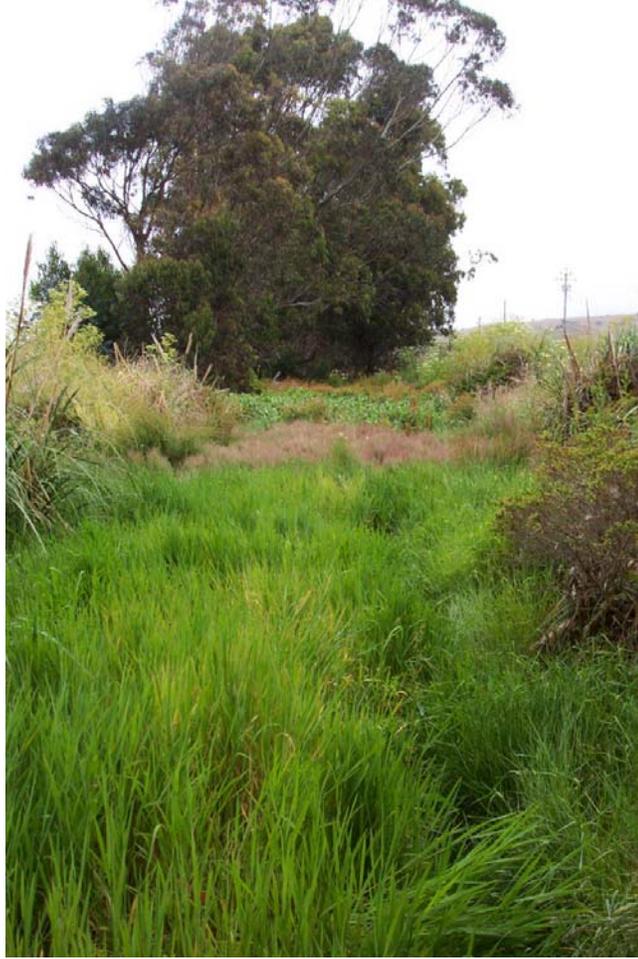
Figure 33: Riparian corridor along Pedro Point I channel. Most of the vegetation is growing directly in the channel in this intermittent stream while in other parts of the watershed it is mainly concentrated adjacent to the channel.
