**SAN PEDRO CREEK WATERSHED
SEDIMENT SOURCE ANALYSIS**

**Volume II:
Hillslope Sediment Source Assessment**

Stephanie Sims

San Francisco
State University

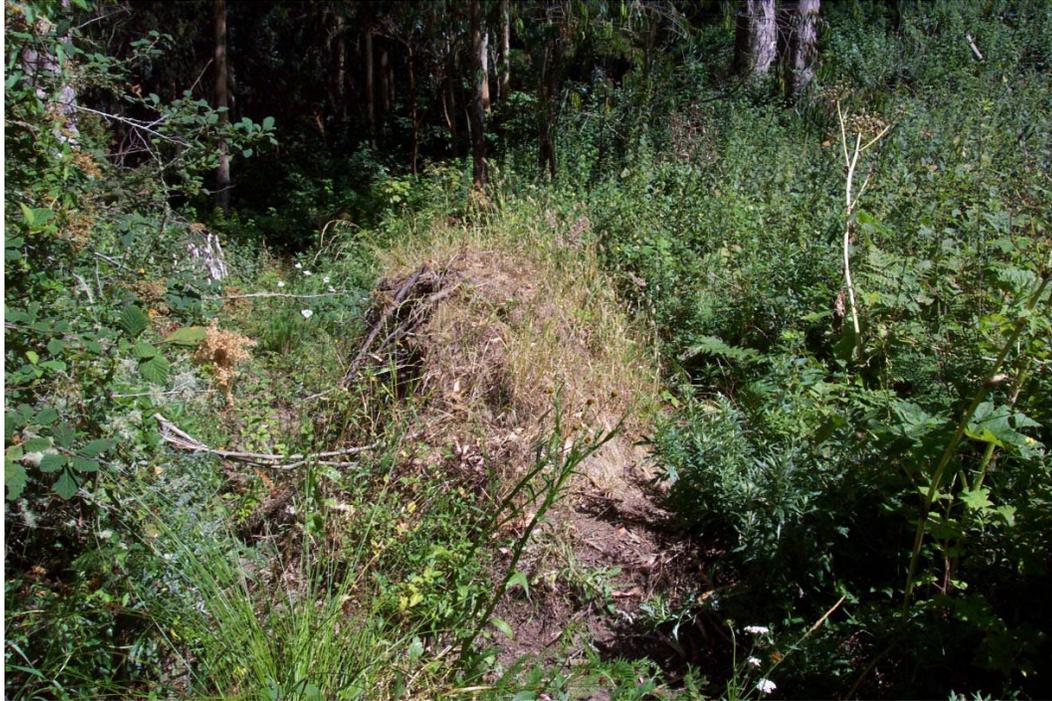
Figure 34: Tree throw from an overturned blue gum eucalyptus creating mound $\sim 3 \frac{1}{2}$ feet tall adjacent to the tributary channel Pedro Point II subwatershed.

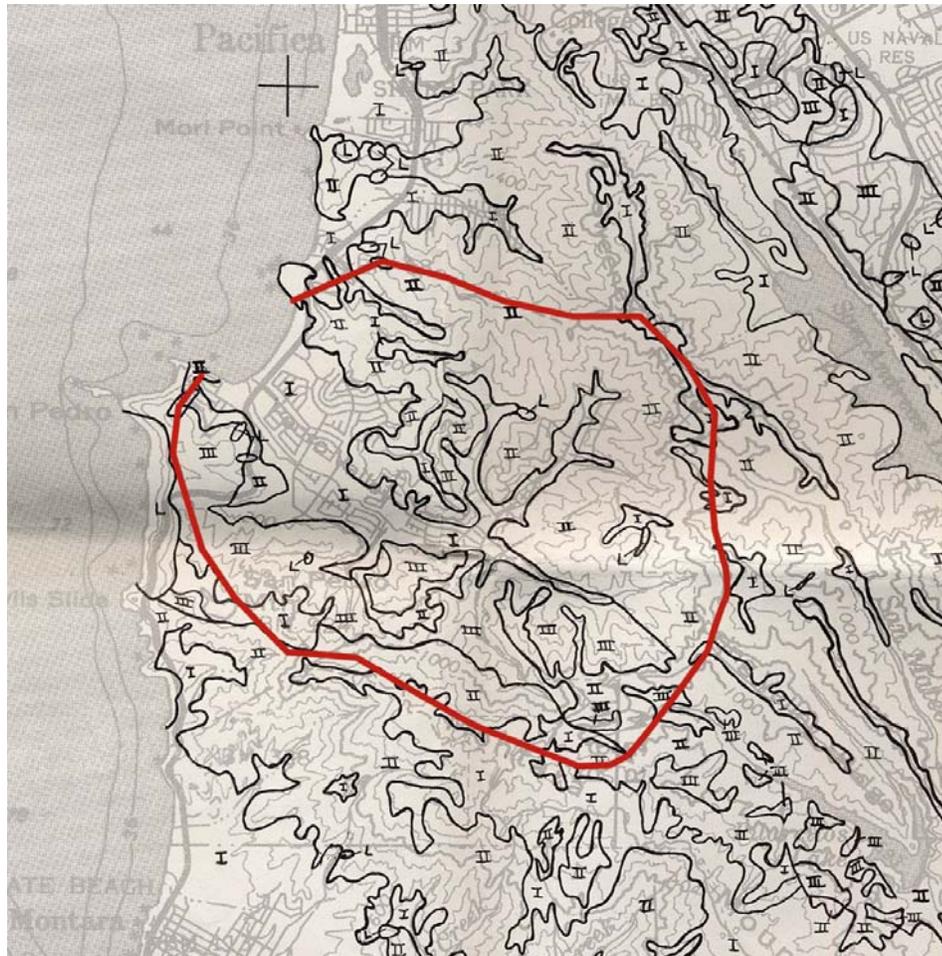
Figure 35: Generalized relative slope susceptibility map of SPCW (shown in red) at 1:62,500. Ranges on a scale of most stable at I to least stable at III (Brabb *et al.* 1972).

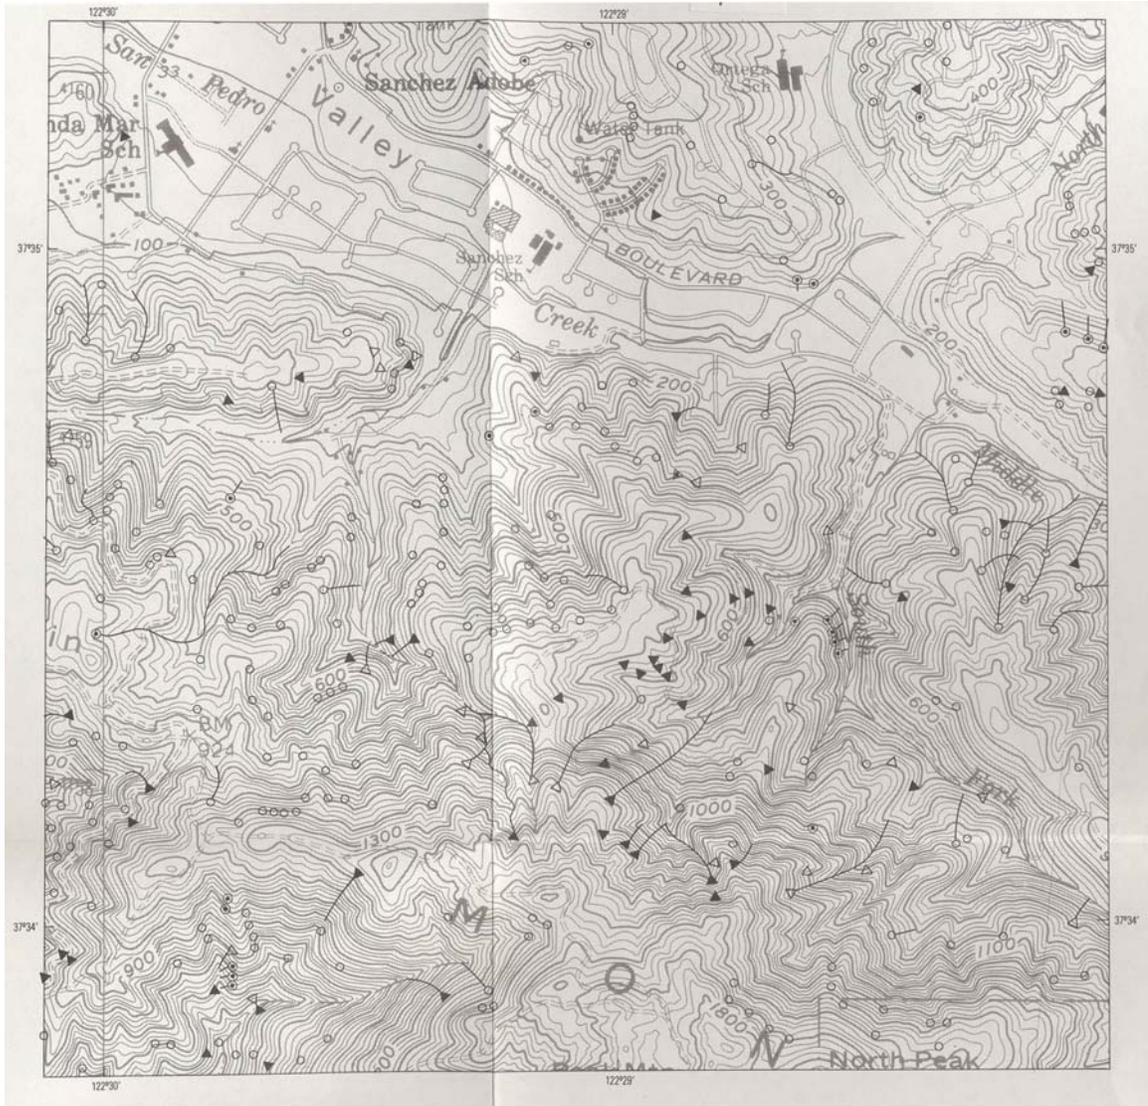
Figure 36a: Pre-1982 debris flow scars and tracks mapped from aerial photographs. Originally mapped at 12K, large portions of the Sanchez, South, and Middle Subwatersheds are covered (Smith 1988).

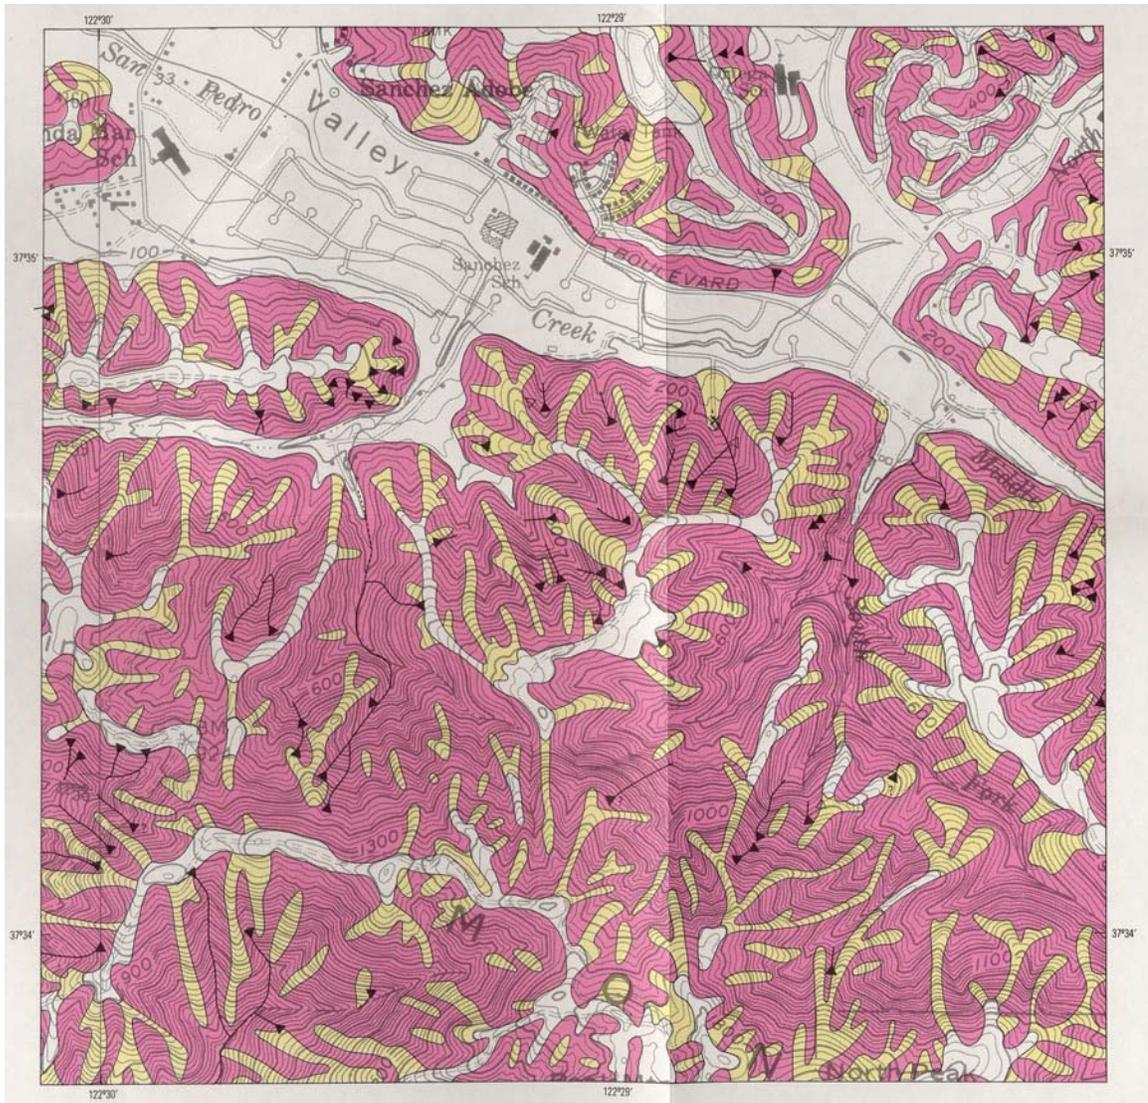
Figure 36b: Landslides and tracks from the 1982 storm event superimposed on a 1977 susceptibility map previously created by the author. The pink areas are the most susceptible, the yellow are intermediate, and white are the least (Smith 1988).

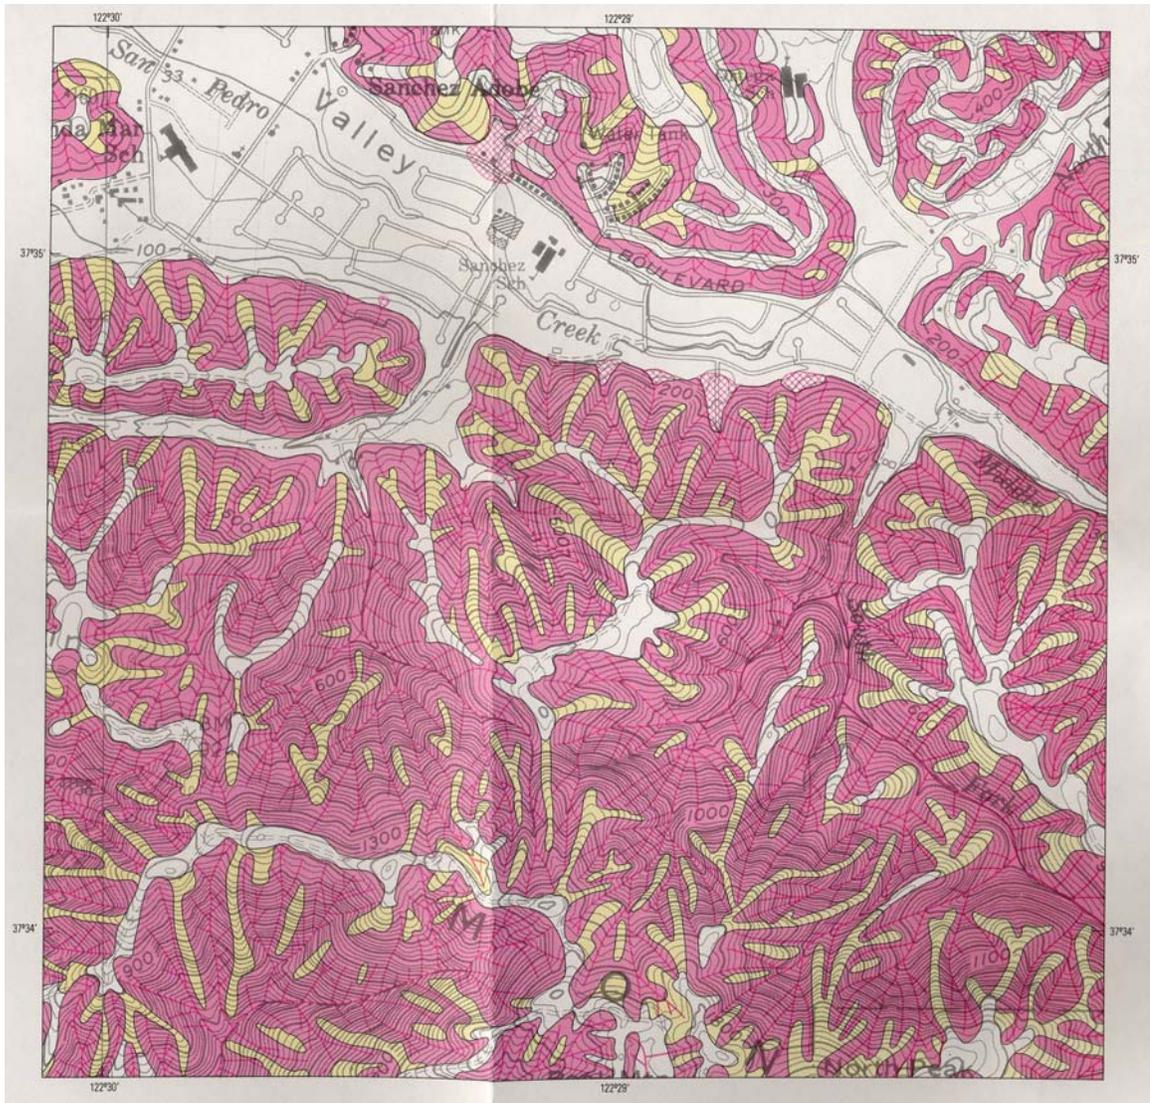
Figure 36c: Debris flow susceptibility map updated from the 1977 version with likely debris flow runout paths (Smith 1988).

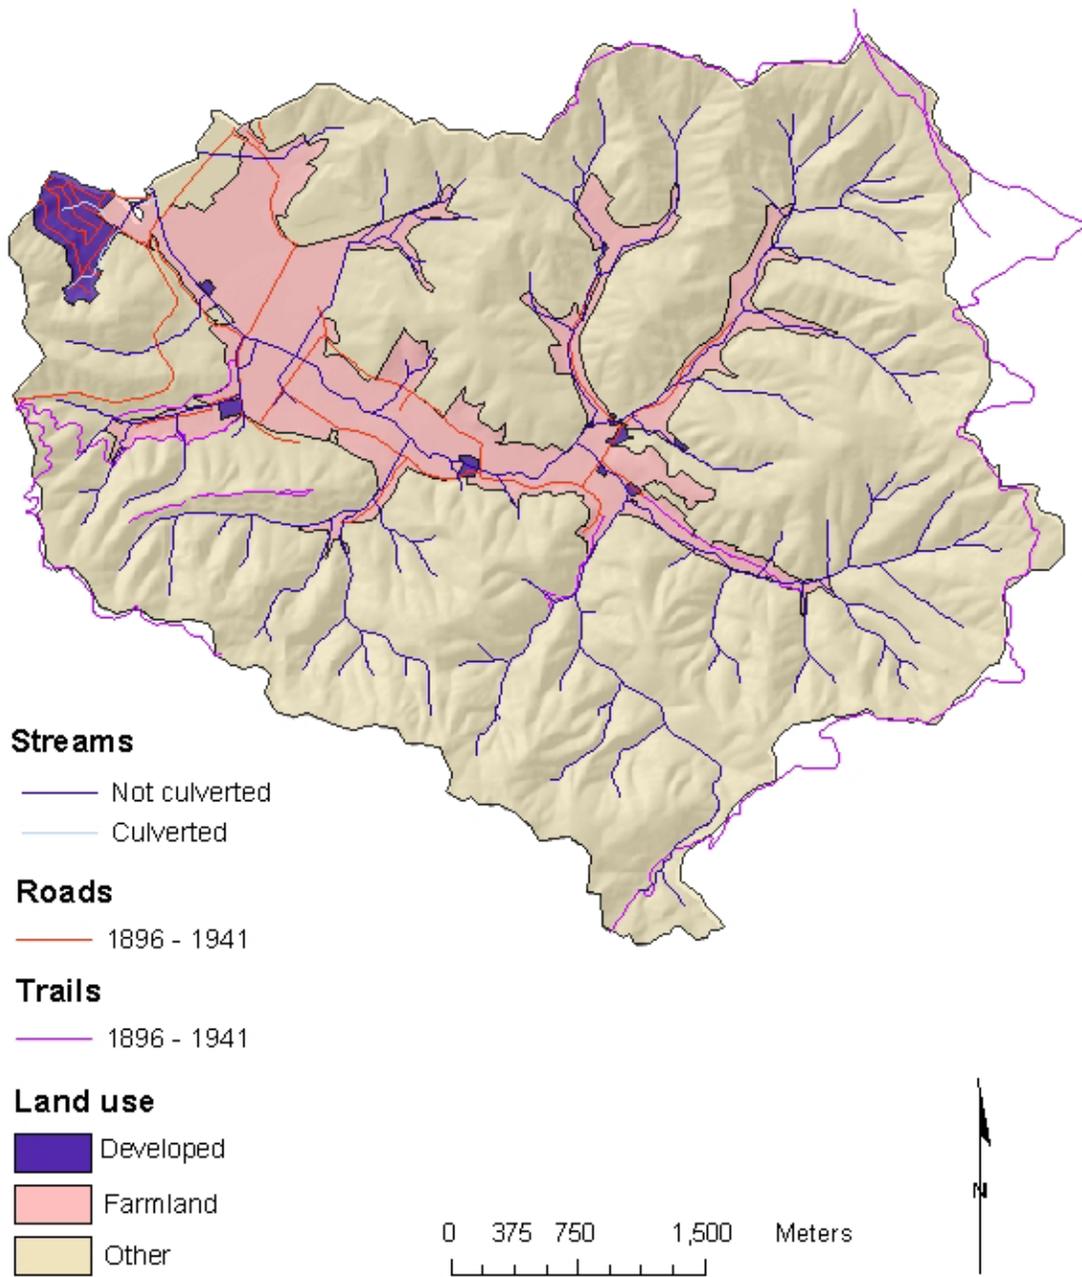
Figure 37a: Land use in 1941 with existing roads and trails.

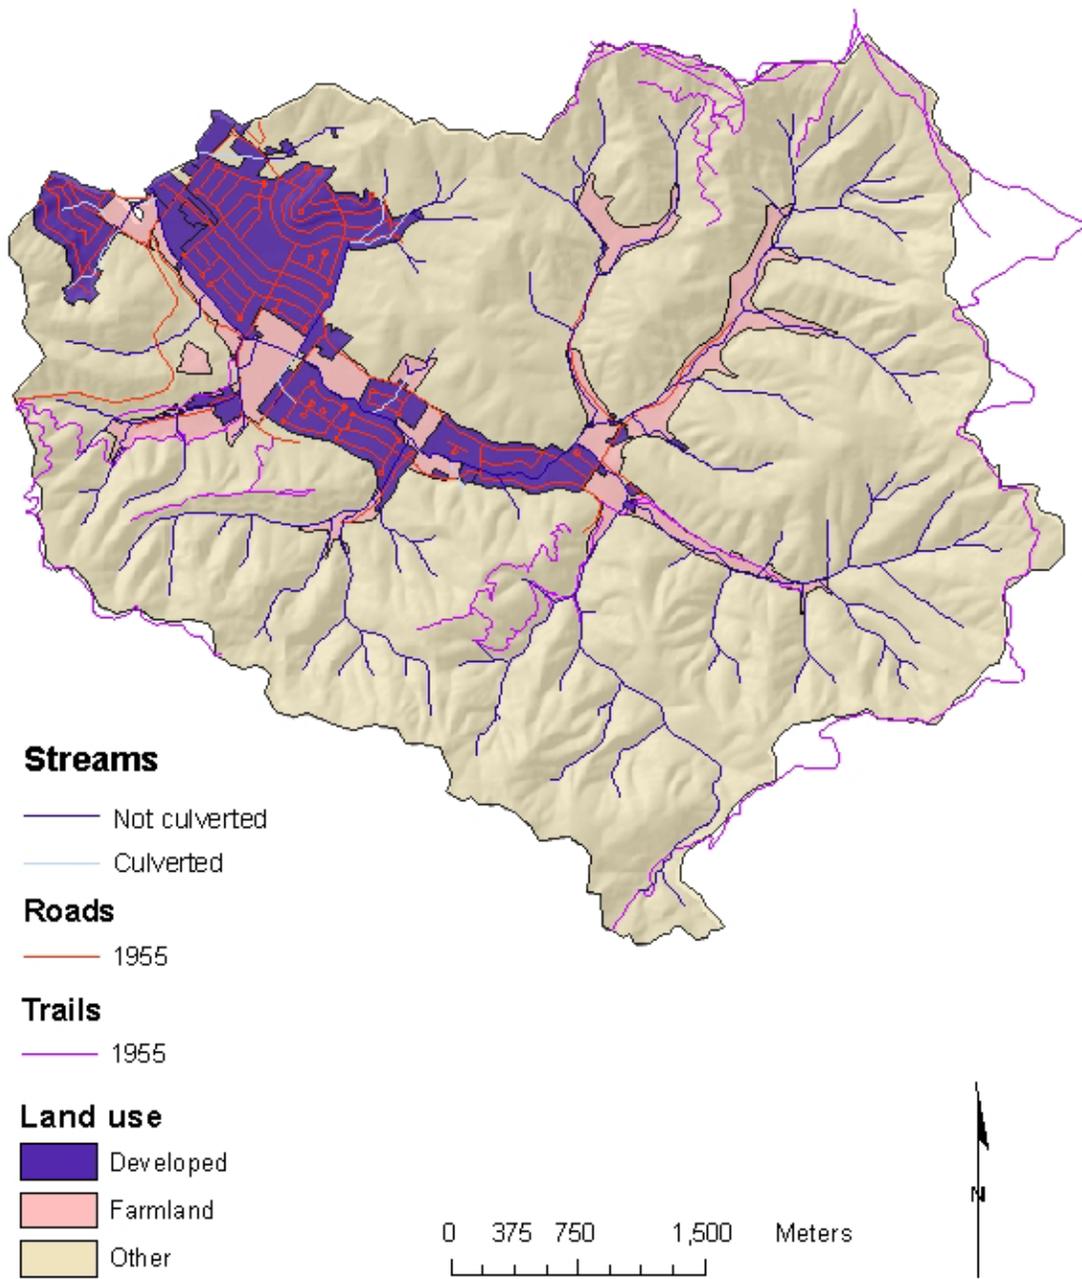
Figure 37b: Land use in 1955 with existing roads and trails.

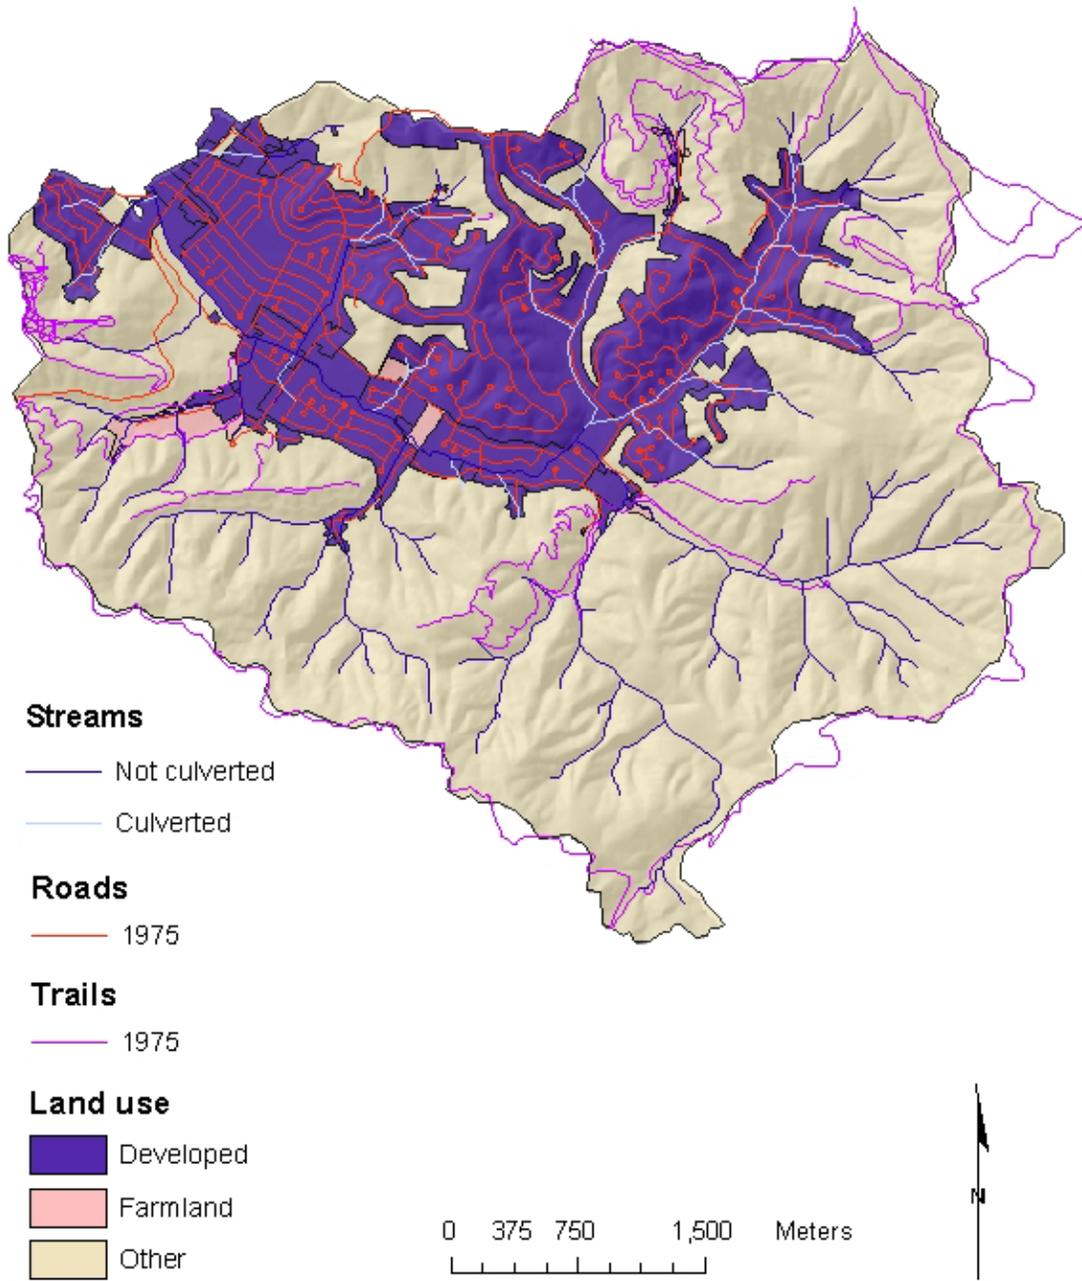
Figure 37c: Land use in 1975 with existing roads and trails.

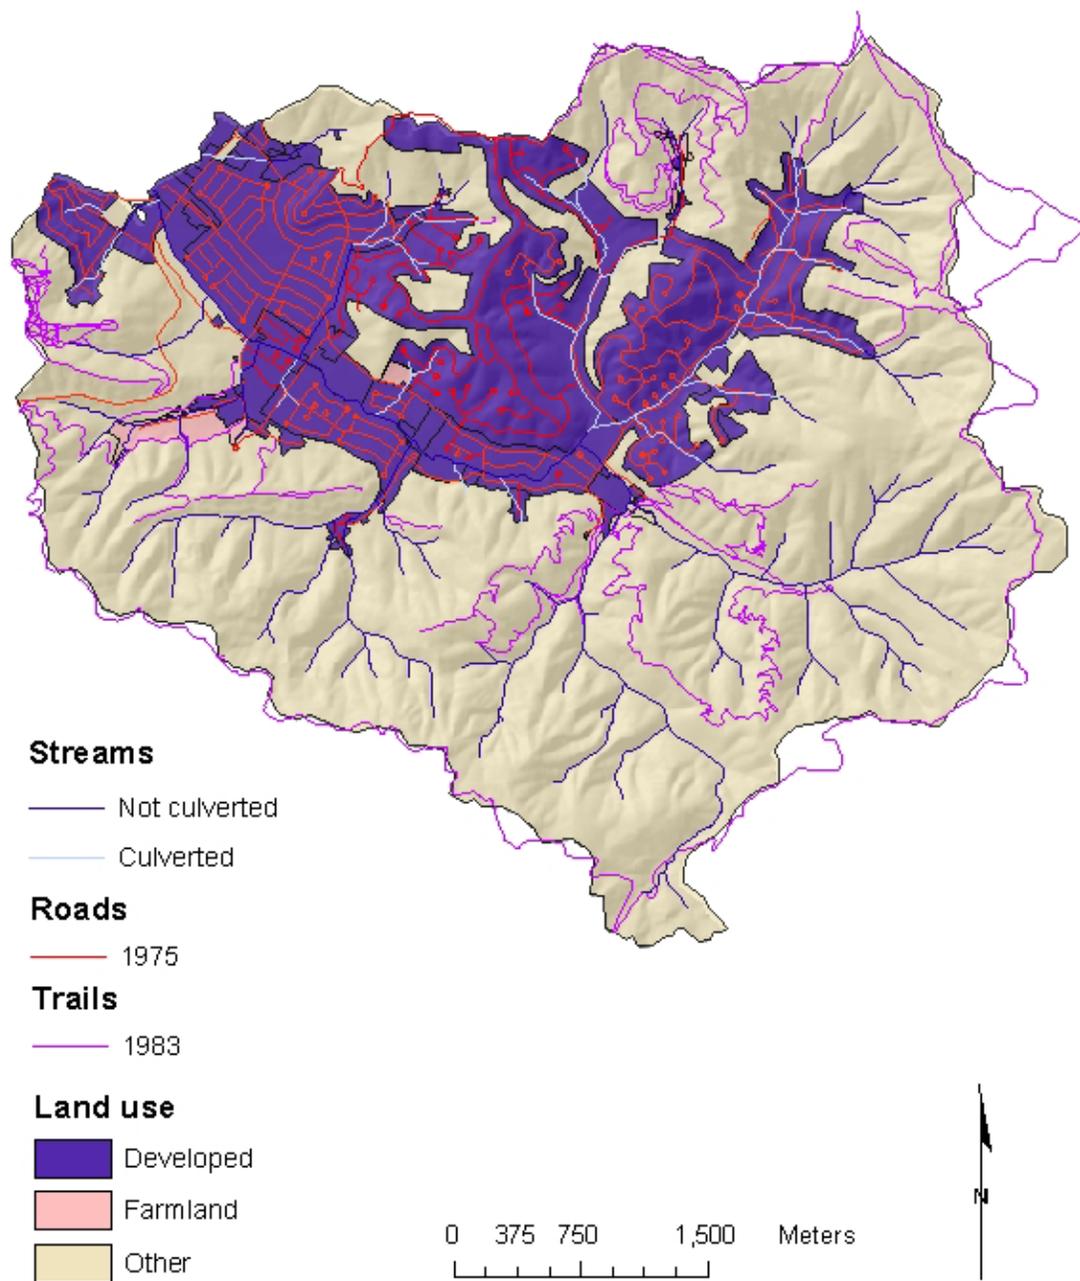
Figure 37d: Land use in 1983 with existing roads and trails.

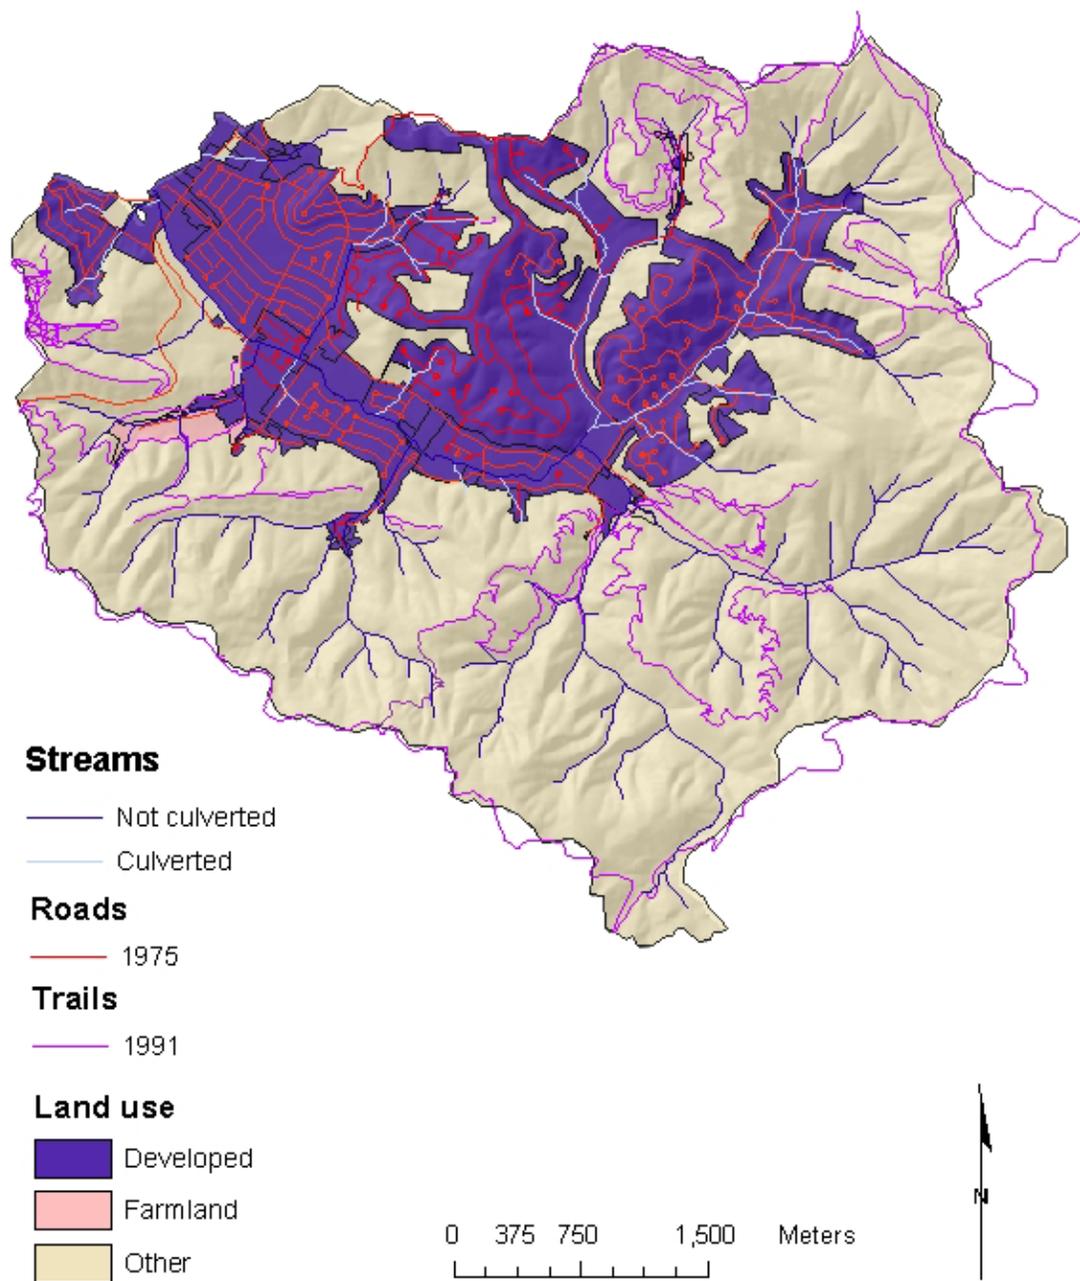
Figure 37e: Land use in 1997 with existing roads and trails.

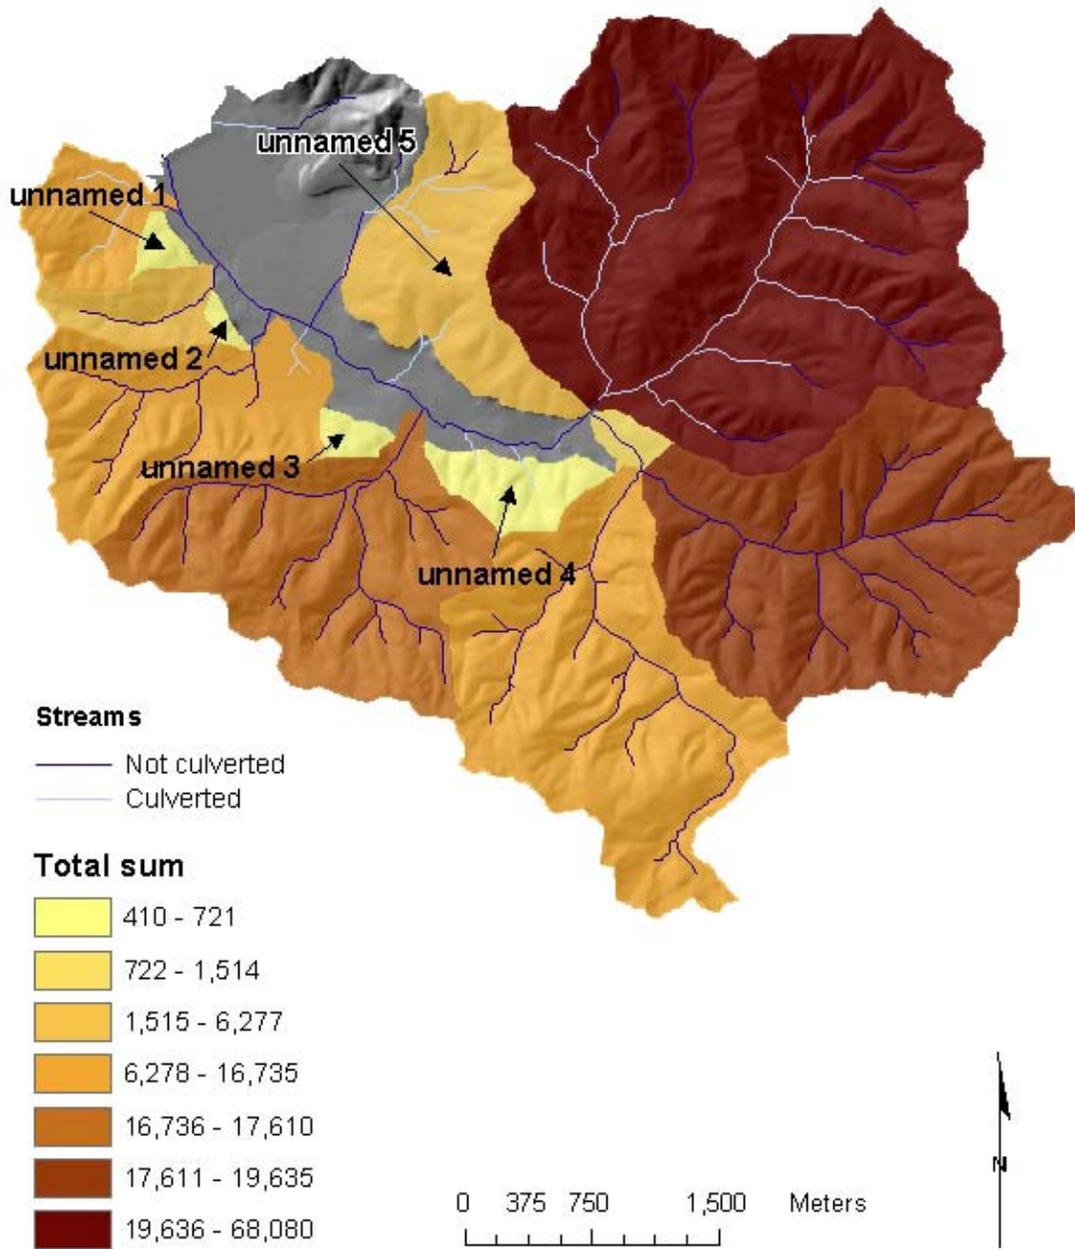
Figure 38: Total sum of the stream network, roads, trails, and urban drainage channels per subwatershed displayed in meters.

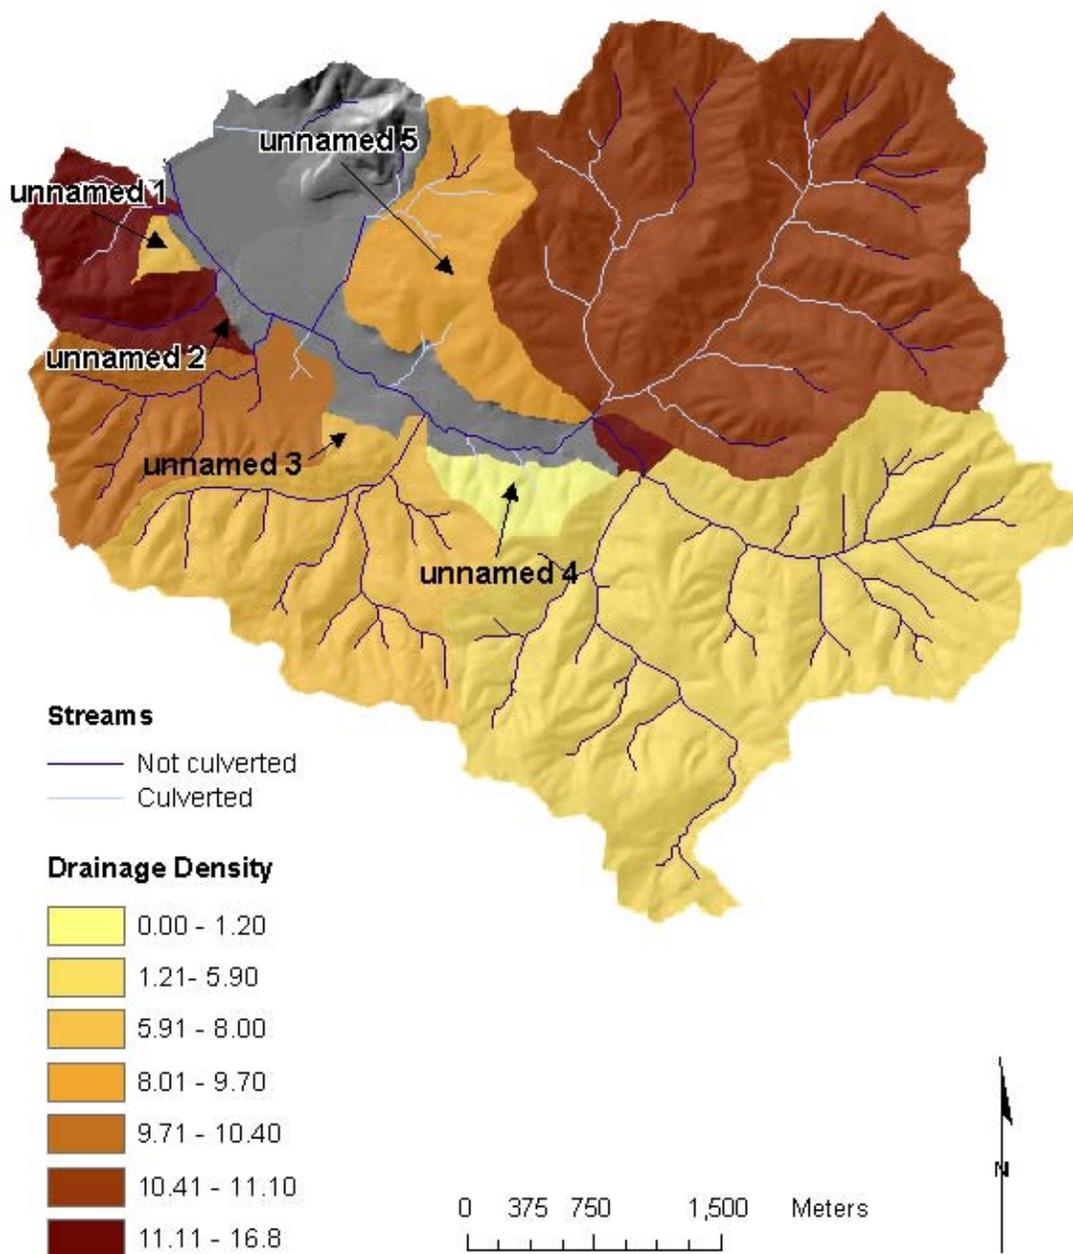
Figure 39: Effective drainage density of the individual subwatersheds displayed in km/km^2 .

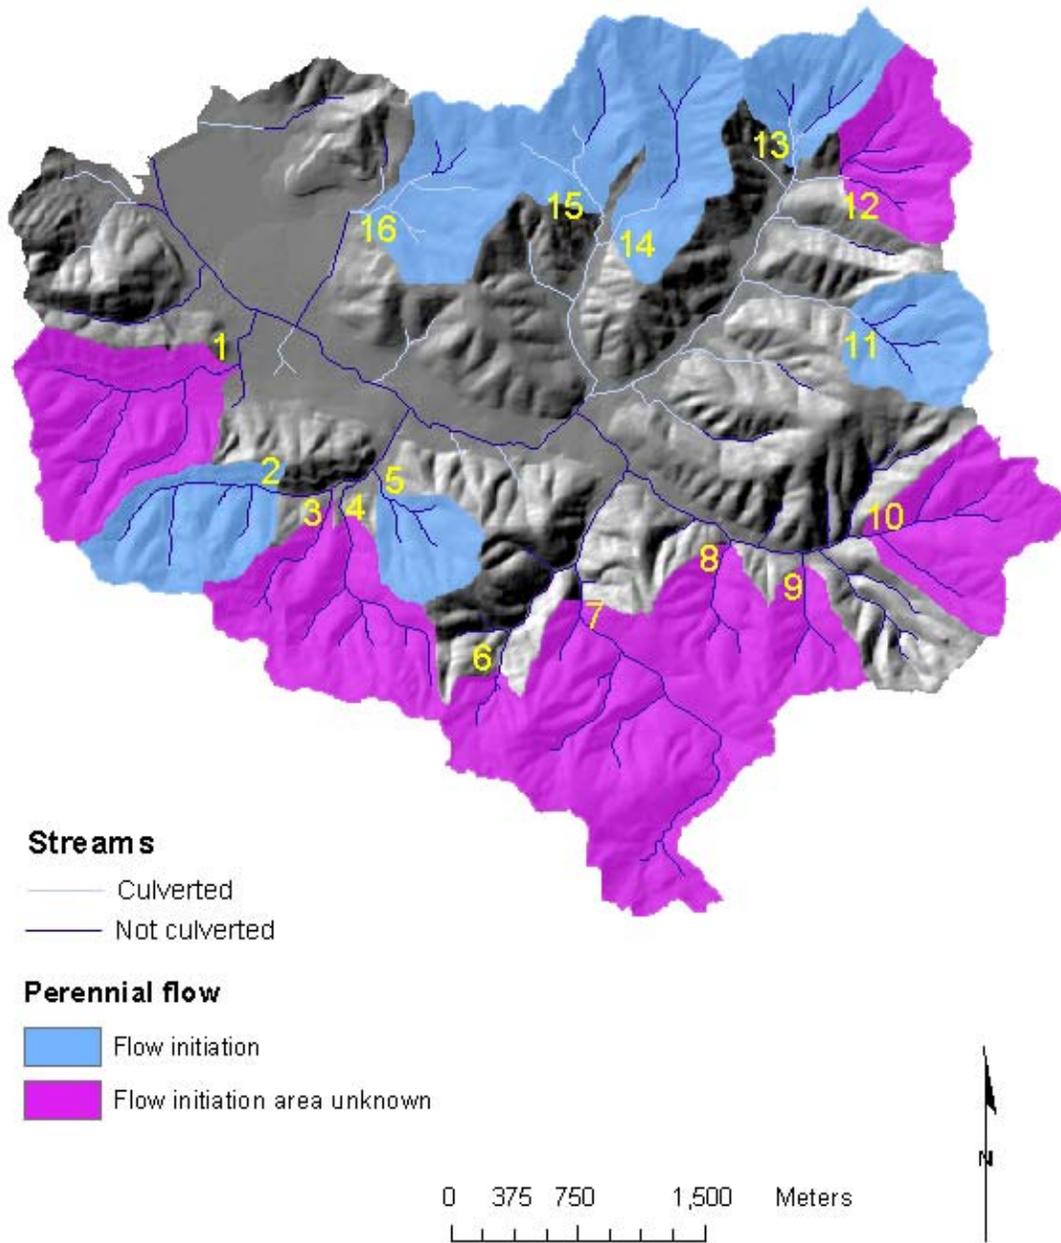
Figure 40: Sample tributaries surveyed to determine the area required to maintain perennial flow. Numbers on map correspond to Table 9.

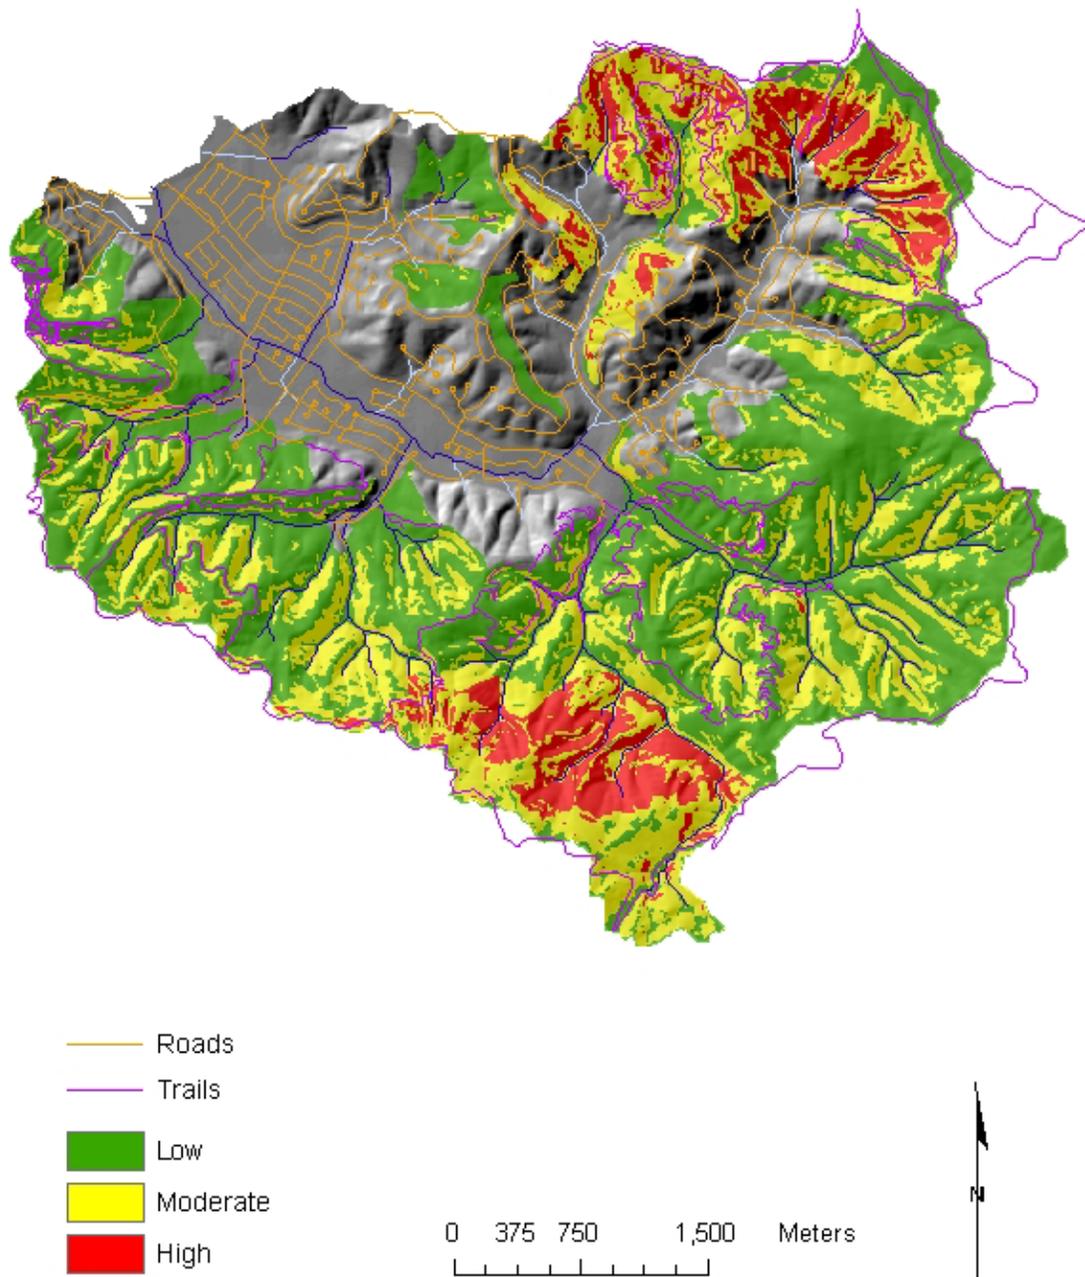
Figure 41: Sediment erosion model of SPCW showing high soil detachment in the upper watersheds of the South and North forks

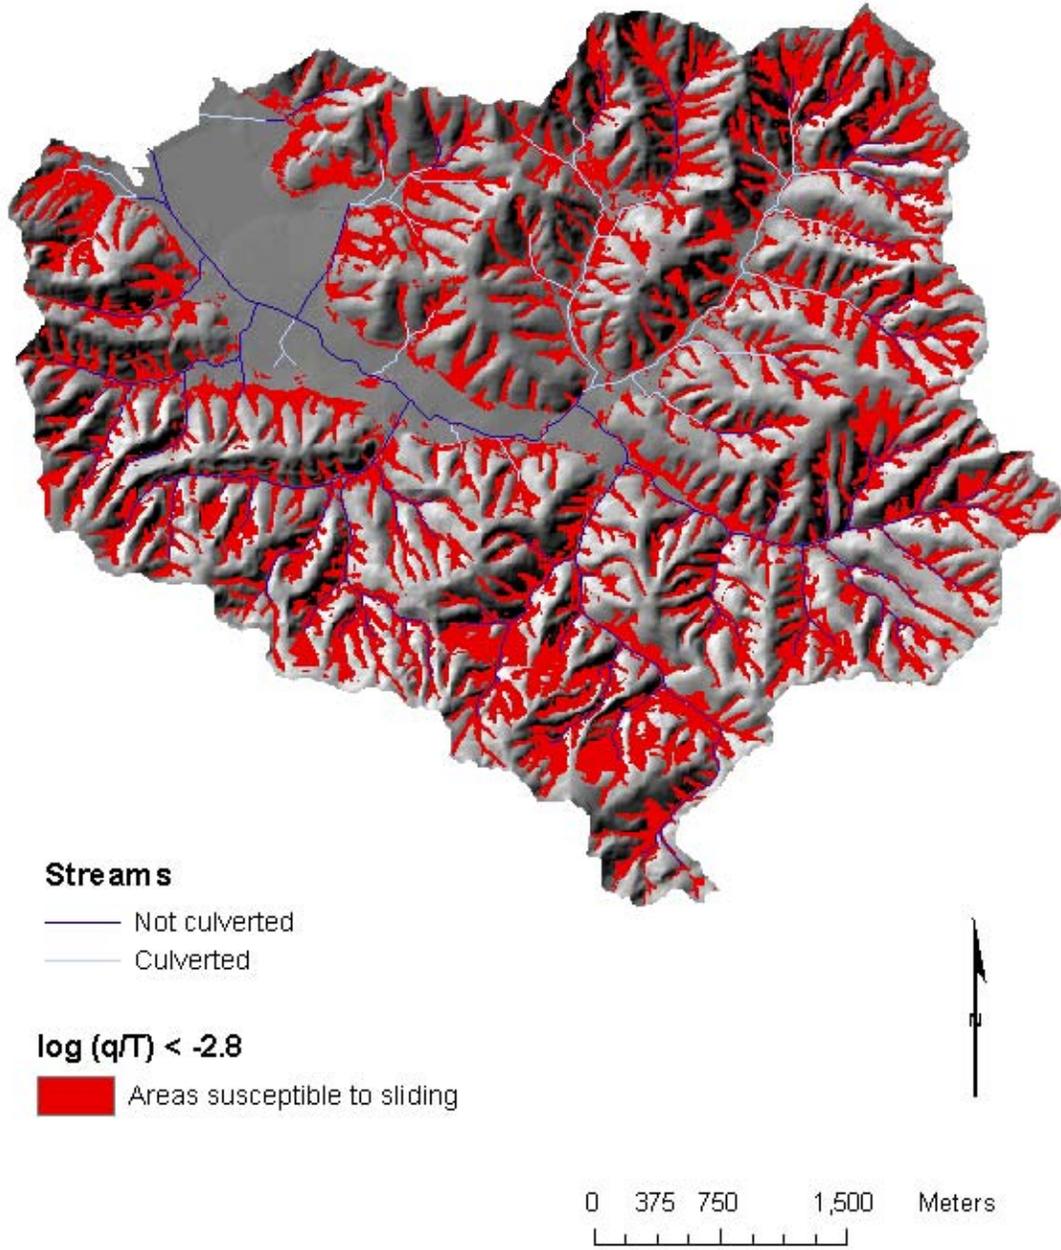
Figure 42: Relative shallow slope stability estimated from SHALSTAB where units are the ratio of effective precipitation/transmissivity (m^{-1}).

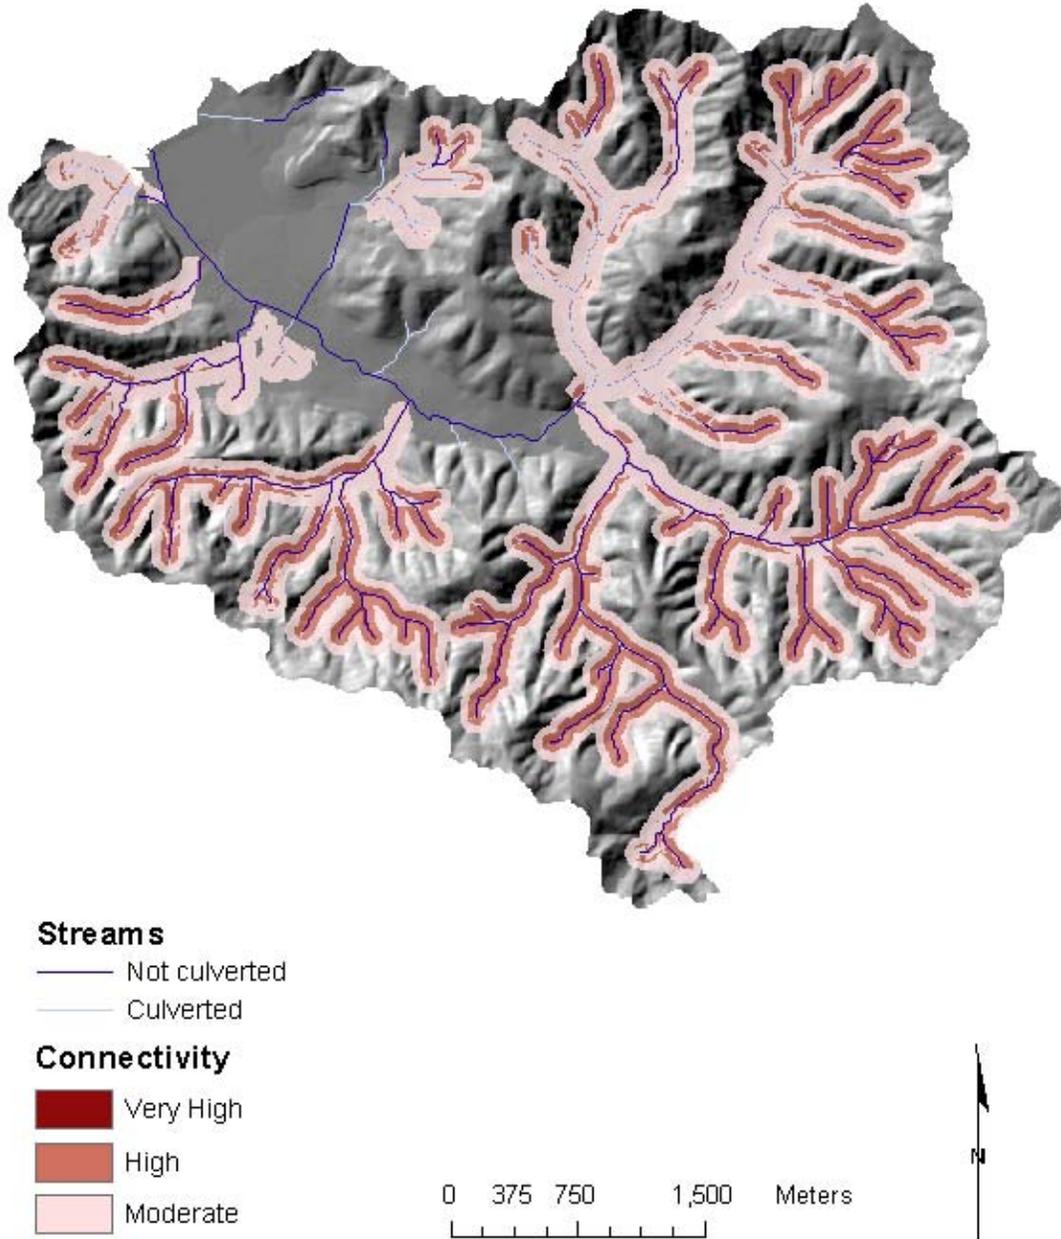
Figure 43: Connectivity at concentric distances in meters from the stream network.

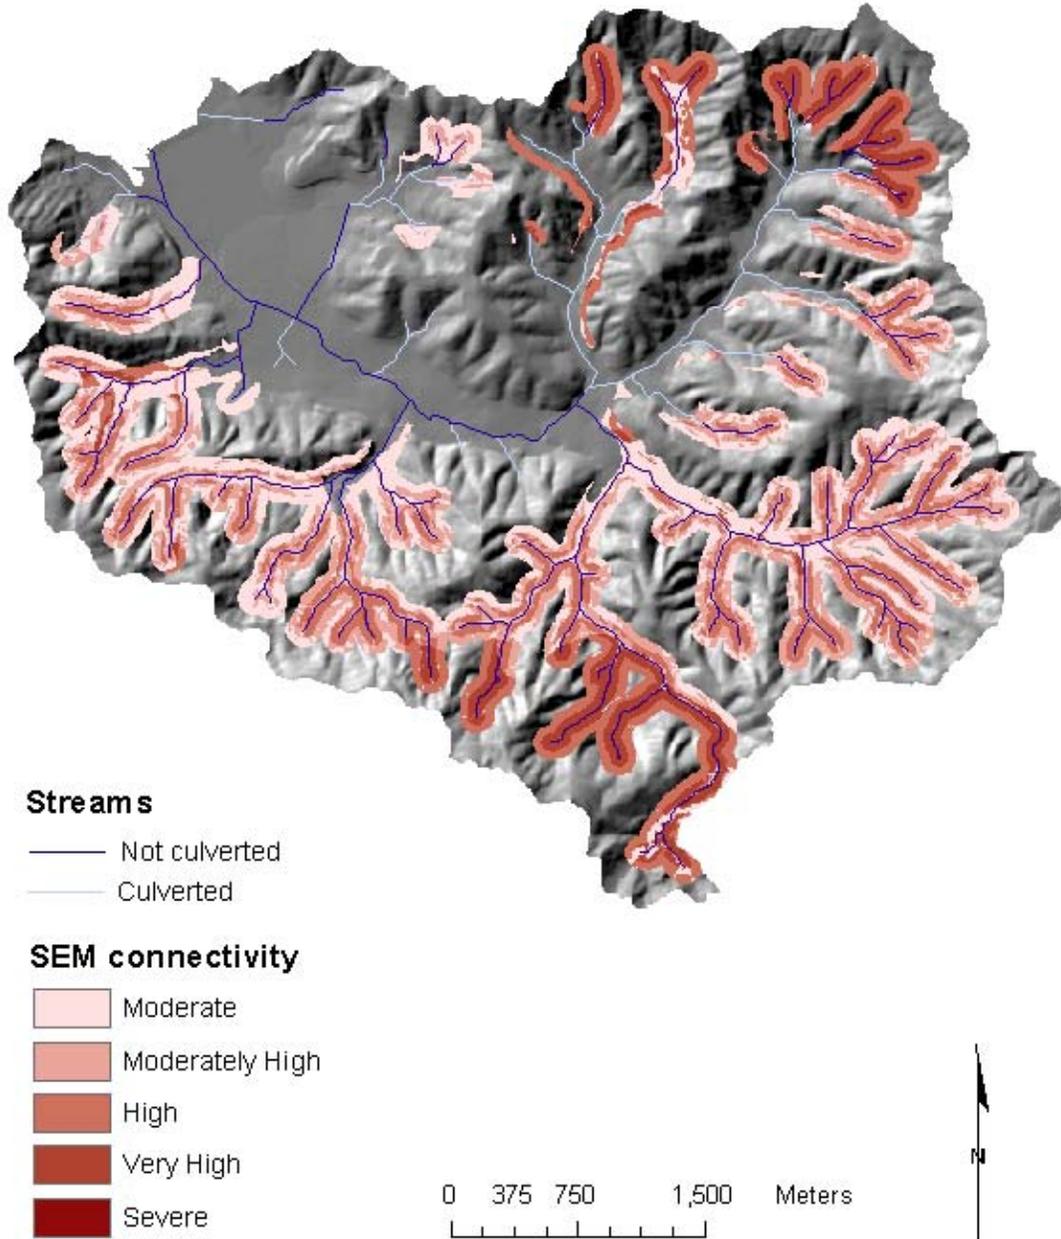
Figure 44: Results of Table 11 displaying areas significantly susceptible to surface erosion with direct potential connectivity to the drainage network.
