**SAN PEDRO CREEK WATERSHED
SEDIMENT SOURCE ANALYSIS**

**Volume II:
Hillslope Sediment Source Assessment**

Stephanie Sims

San Francisco
State University

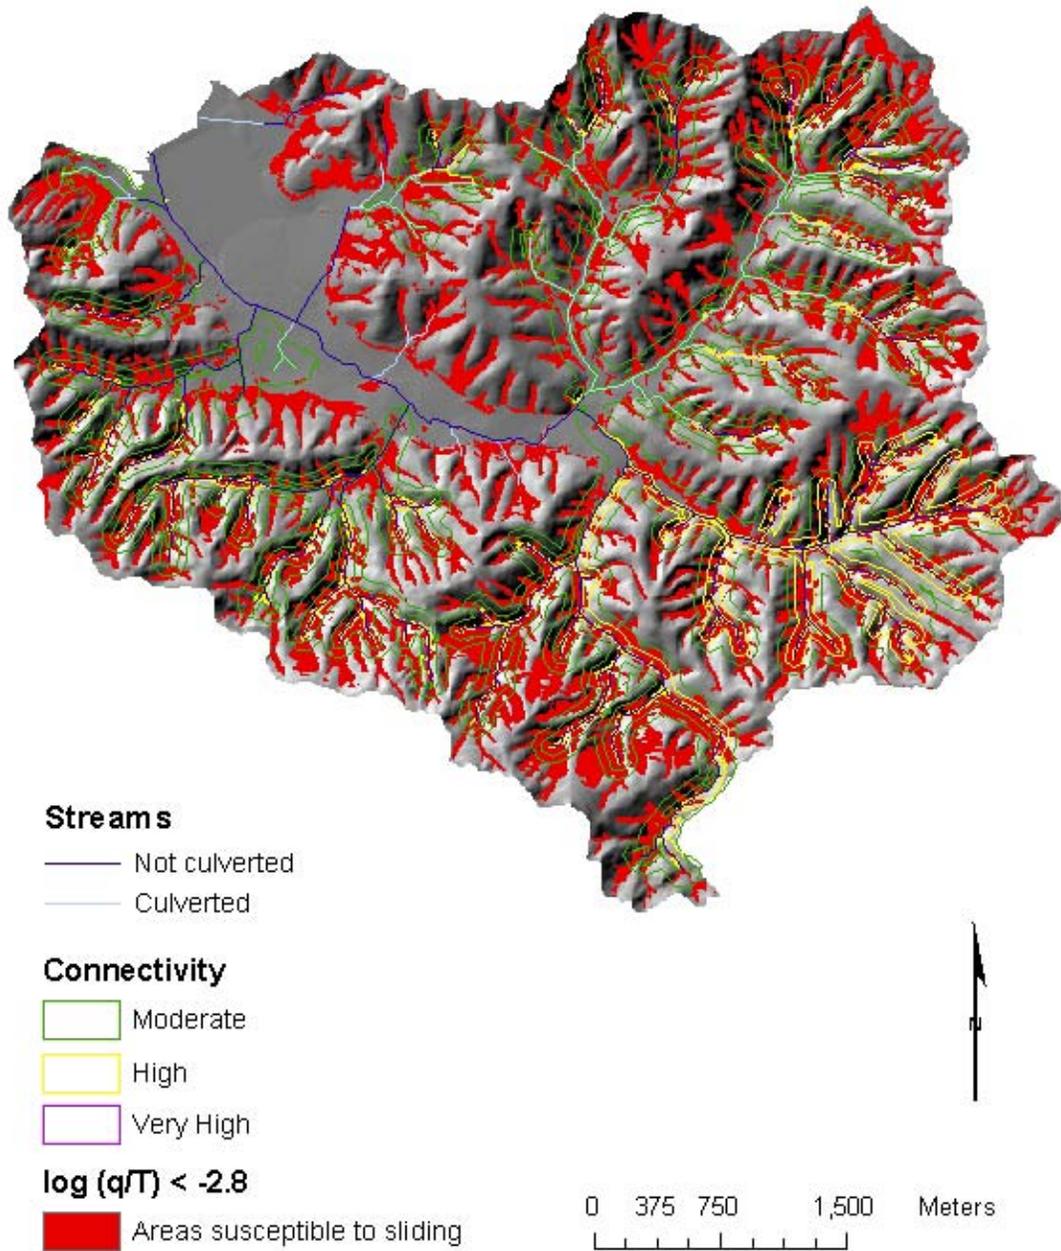
Figure 45: SHALSTAB displayed with results of Table 10 displaying relative landslide potential connectivity.

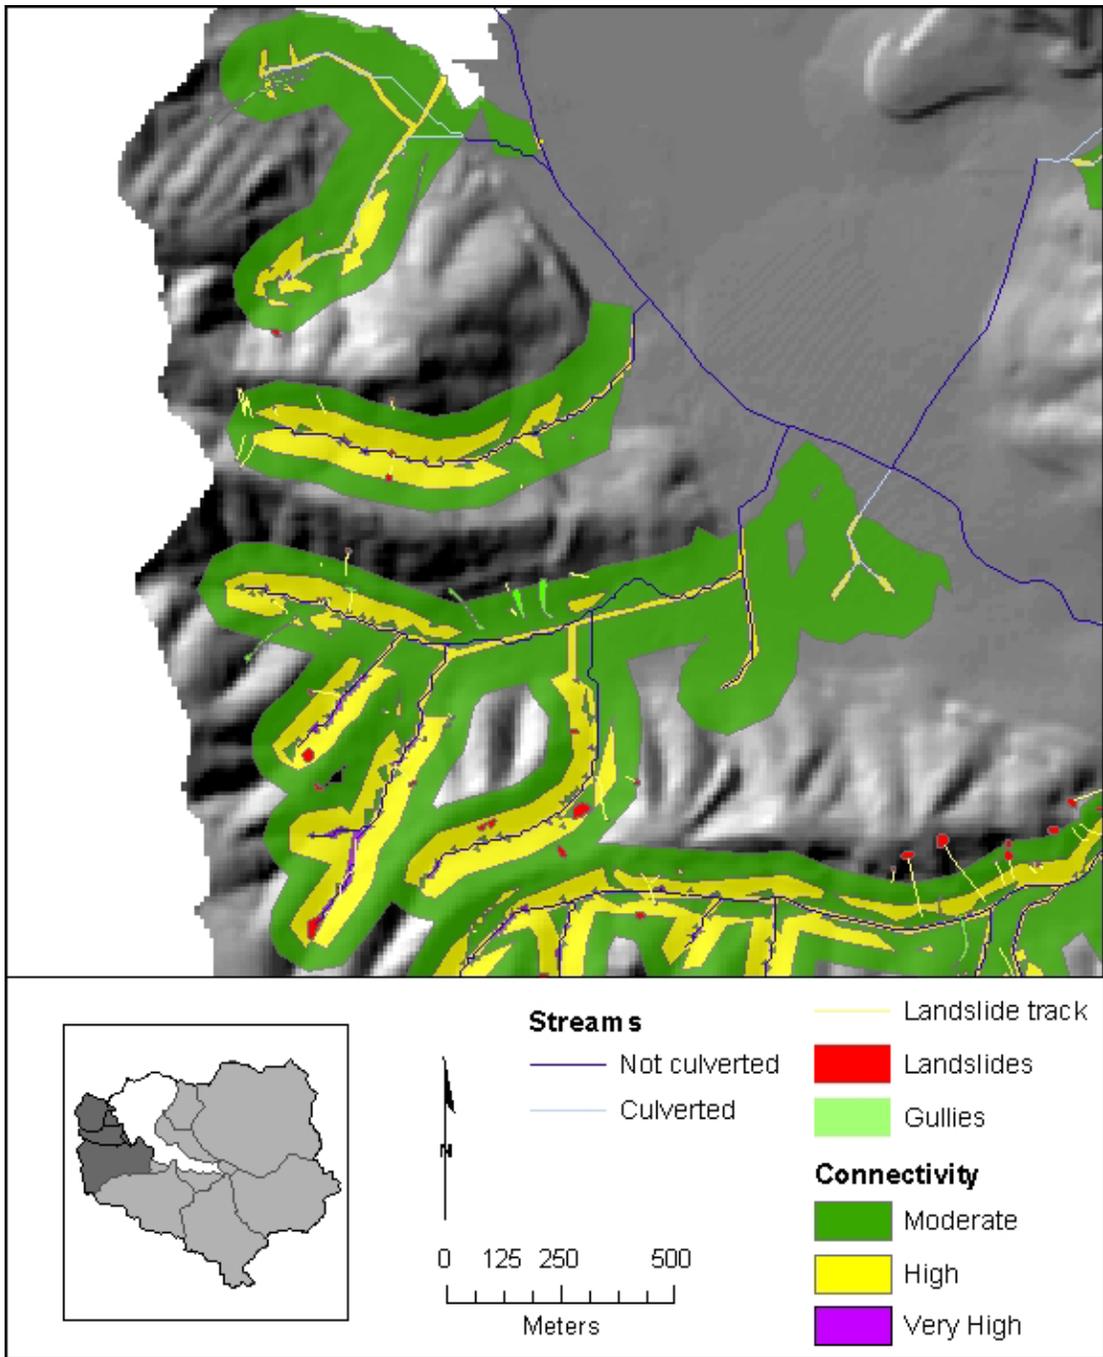
Figure 46a: Landslide and gully connectivity to the stream network in Crespi and Pedro Point I and II subwatersheds.

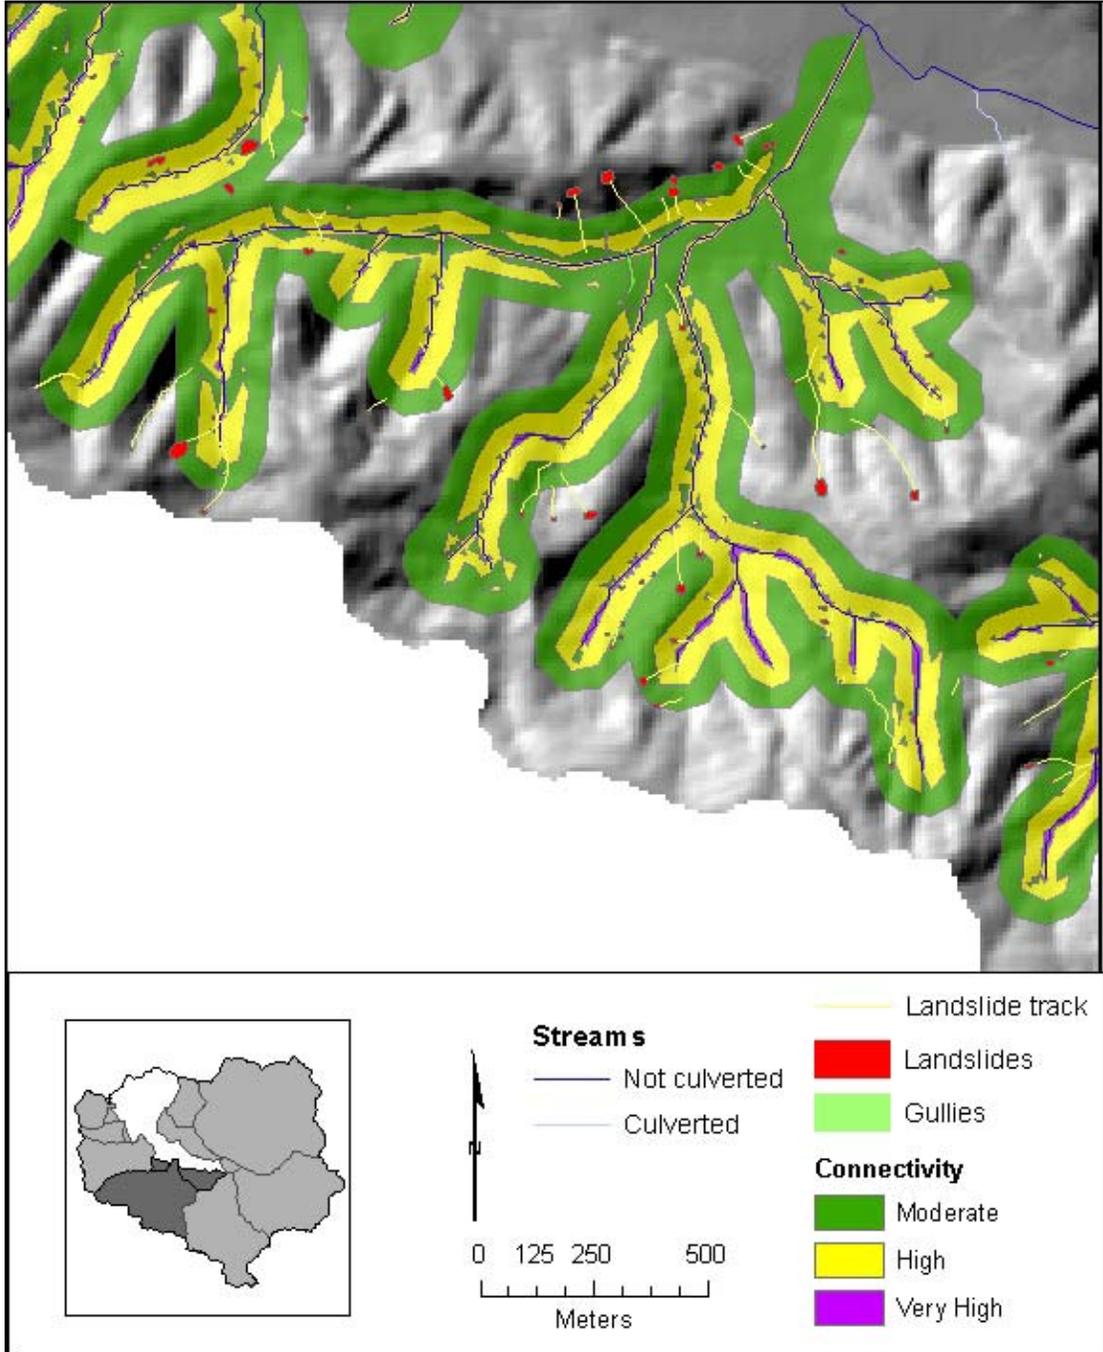
Figure 46b: Landslide and gully connectivity to the stream network in Sanchez subwatershed.

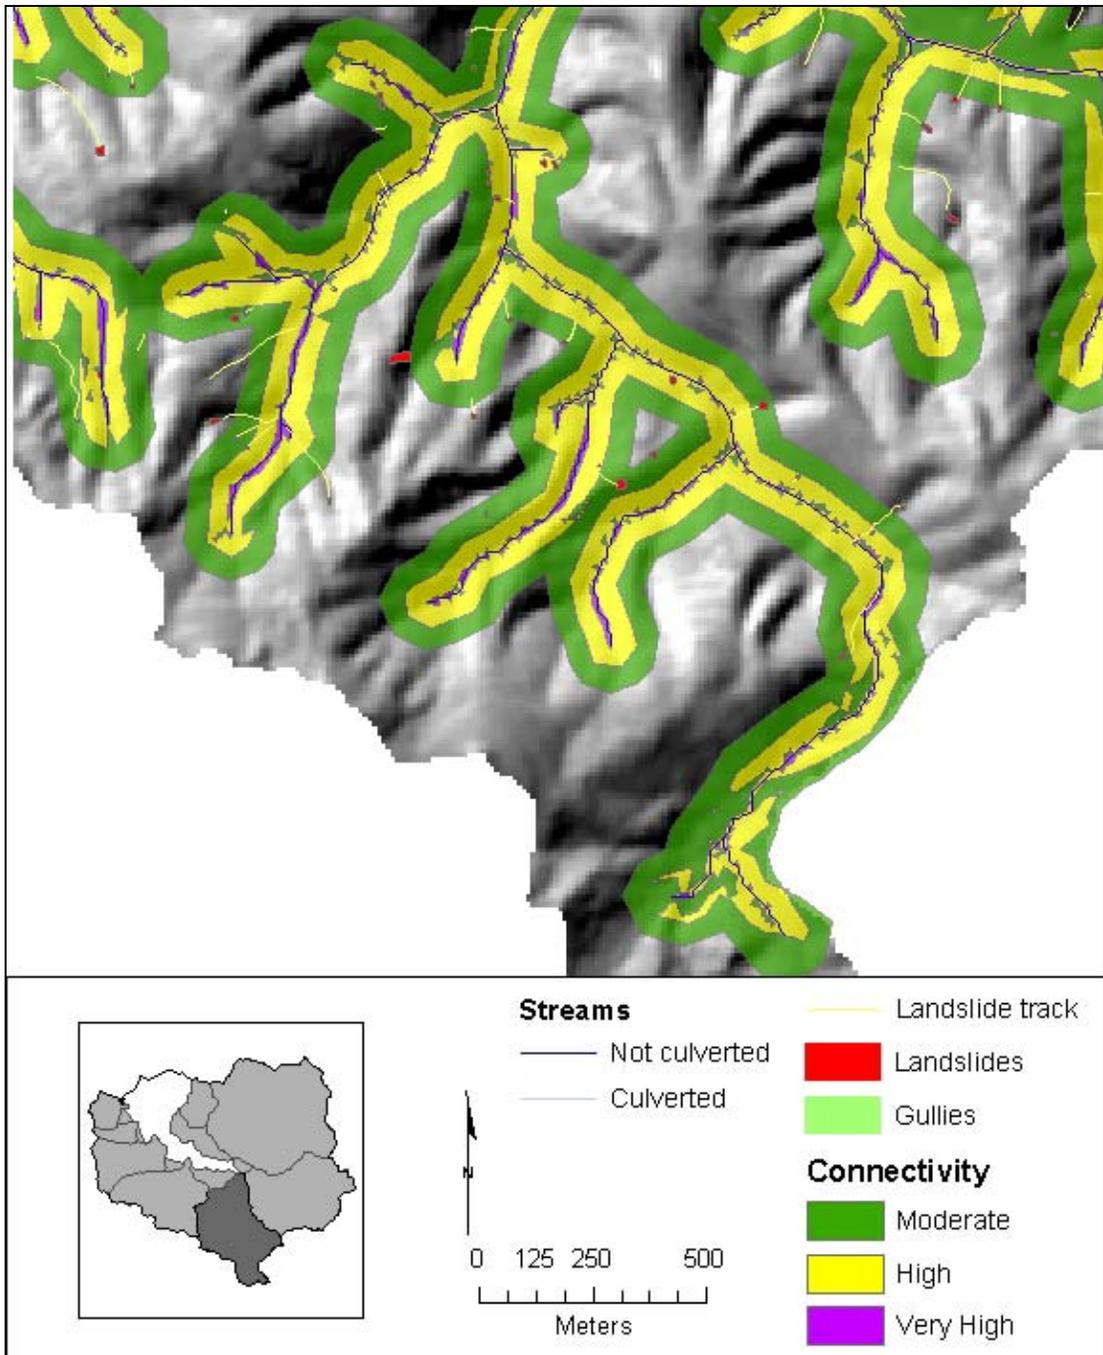
Figure 46c: Landslide and gully connectivity to the stream network in South subwatershed.

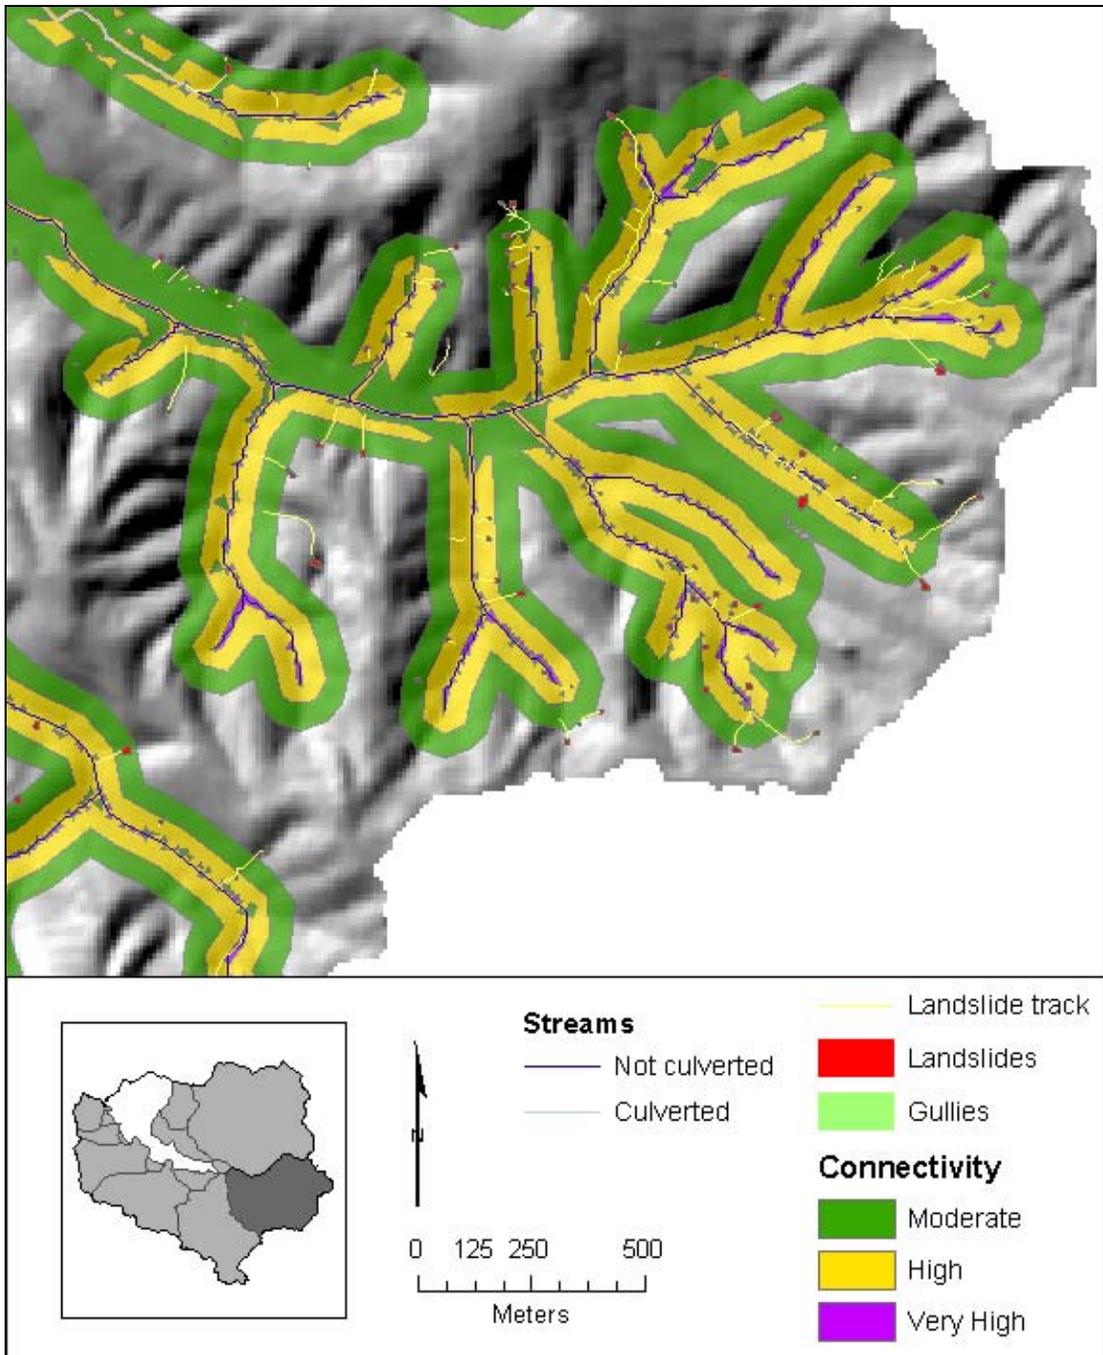
Figure 46d: Landslide and gully connectivity to the stream network in Middle subwatershed.

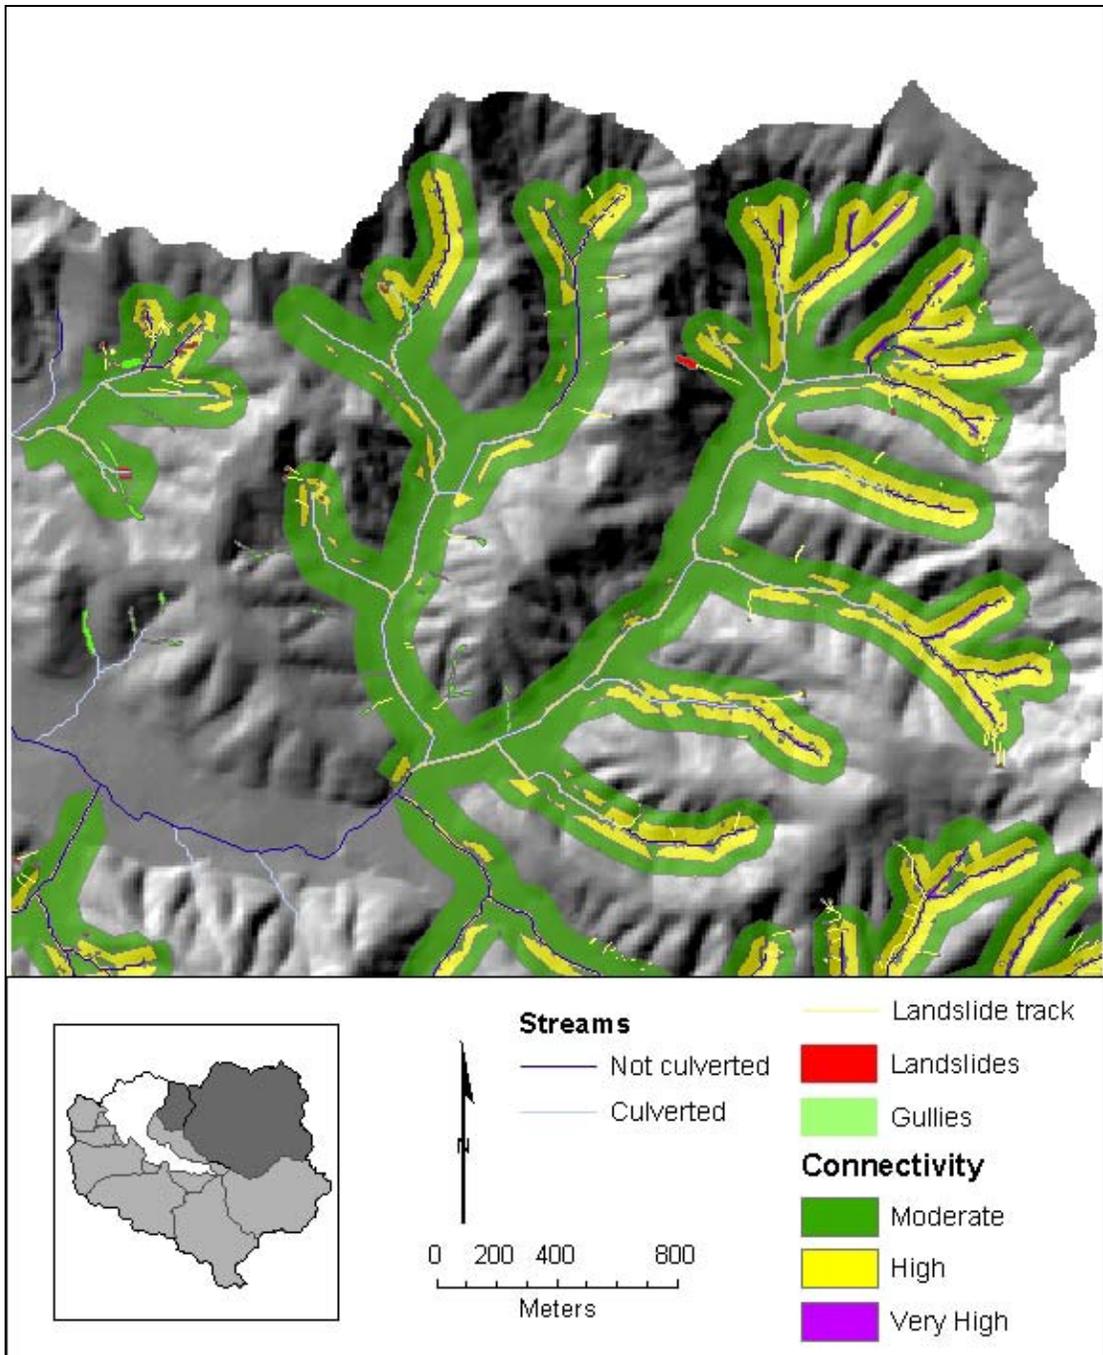
Figure 46e: Landslide and gully connectivity to the stream network in North and Crespi subwatersheds.

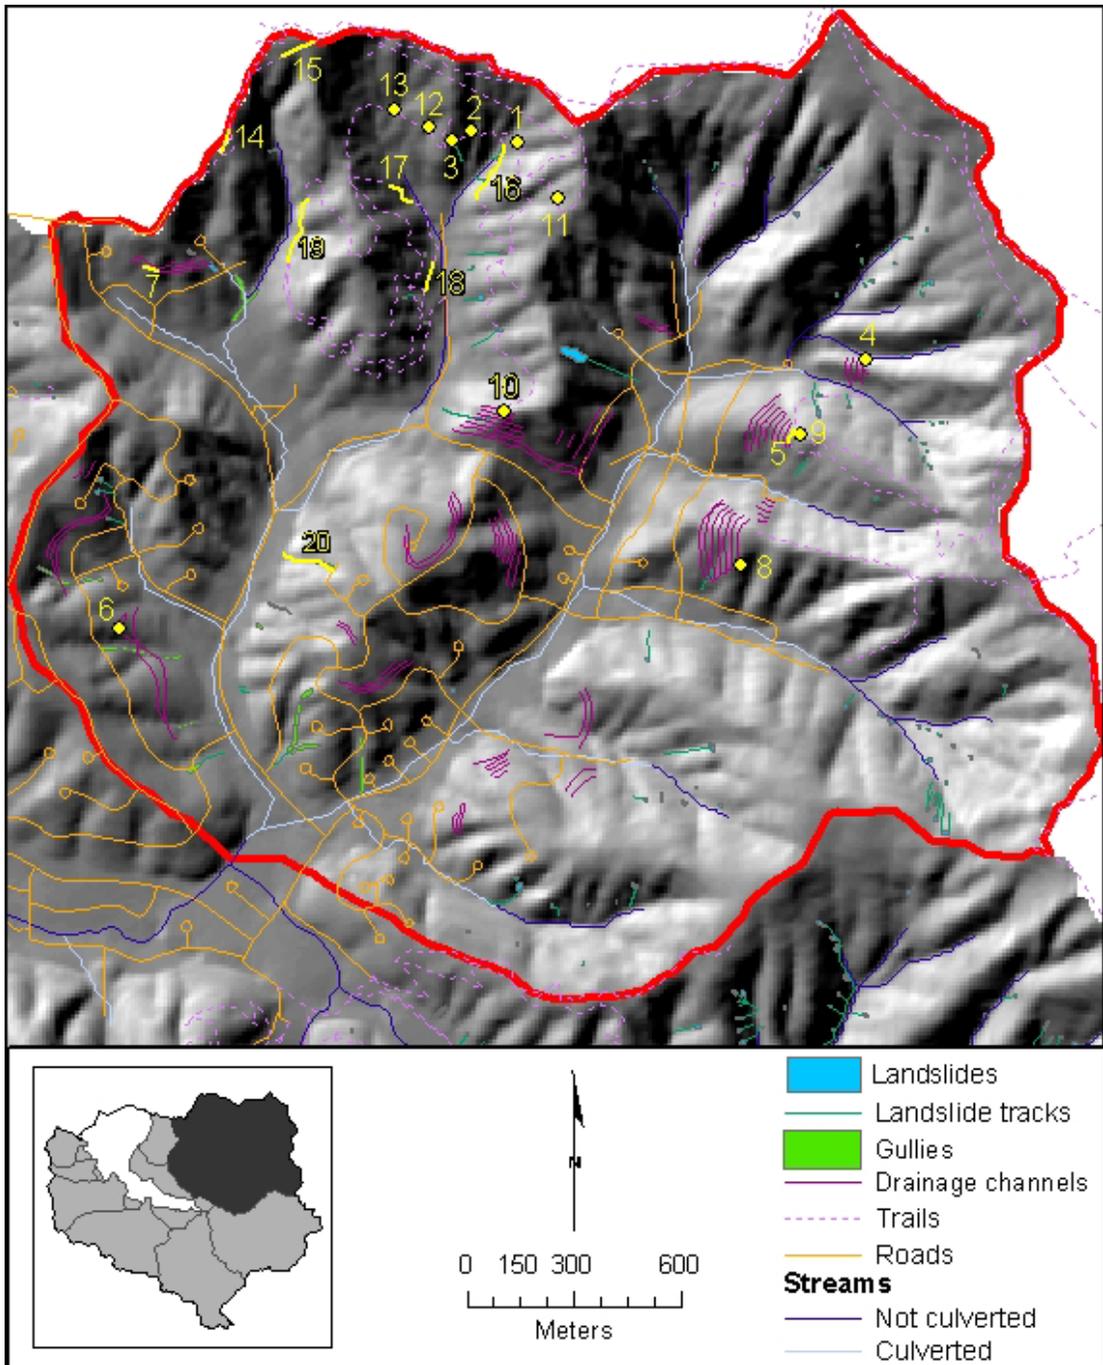
Figure 47: North subwatershed outlined in red indicating significant sediment sources in yellow. Also showing landslides and gullies with predicted connectivity.

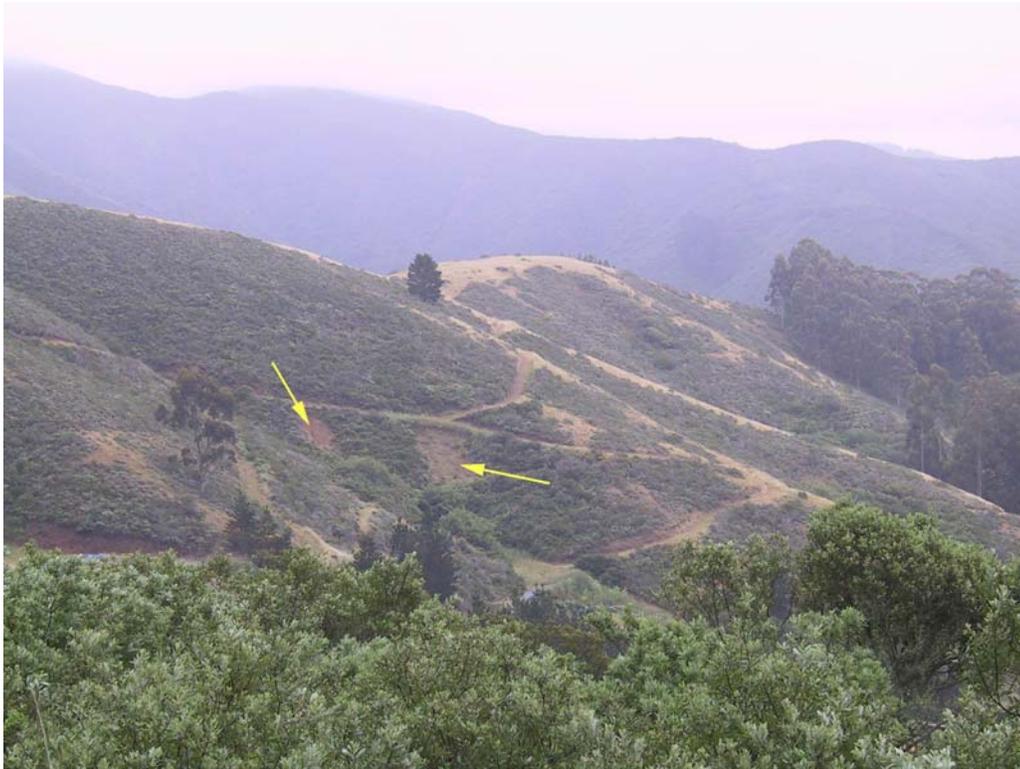
Figure 48: Trail network along the upper slopes of the Picardo Ranch. Landslide scars are visible downslope from road at the arrows and in many other places along the trails (Points 1, 2, 3, 11, 12, & 13). Surface erosion is also significant on many of these trails (Lines 16 – 19 on Figure 47).

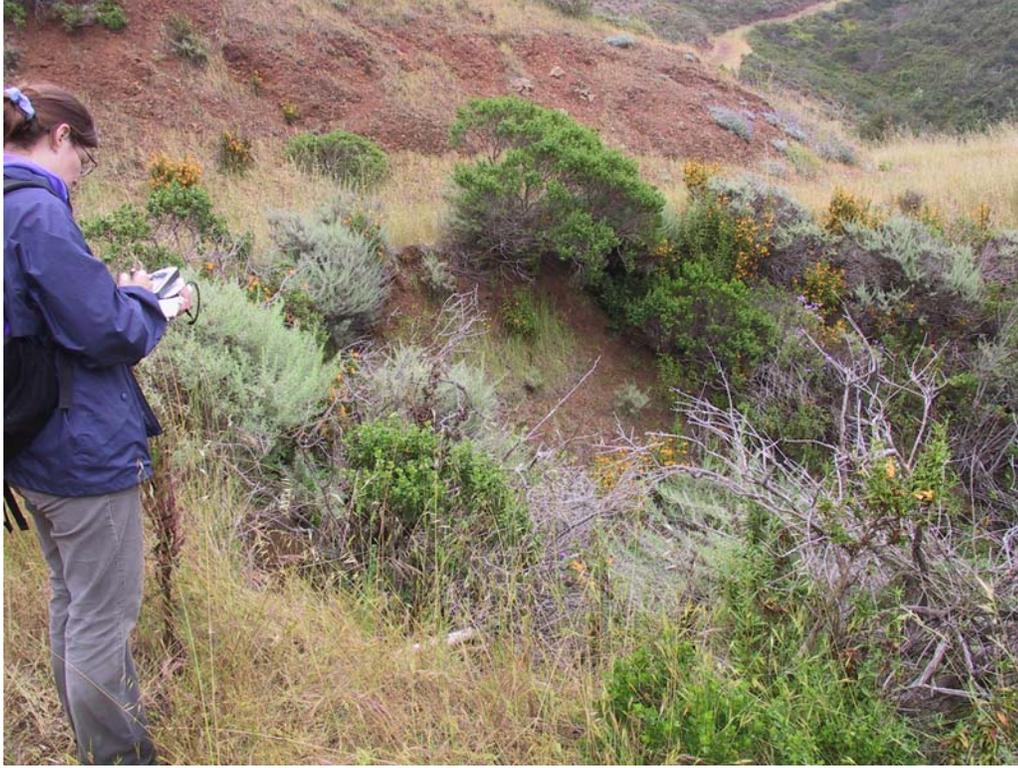
Figure 49: Landslide deposit downslope from trail on Picardo Ranch subjected to surface erosion (Point 3 on Figure 47).

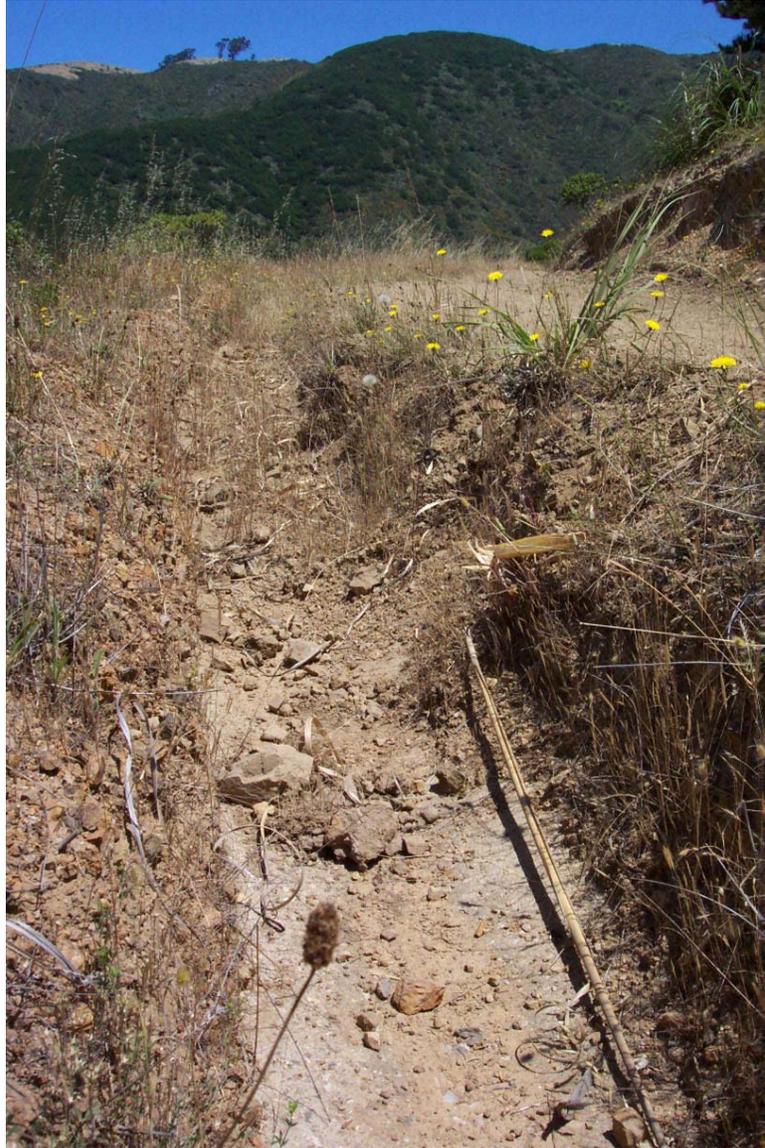
Figure 50: Trail eroding into drainage culvert of terraced hillslopes (Line 5 on Figure 47).

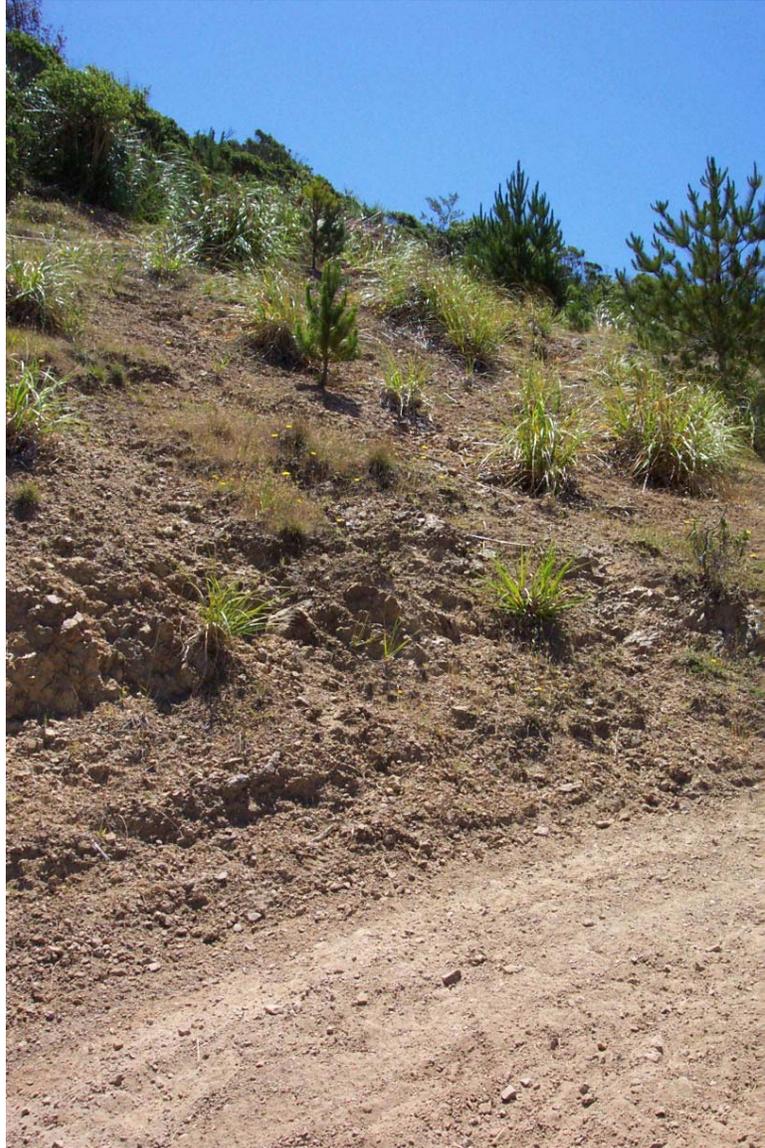
Figure 51: Rilling upslope of trail on terraced hillslope contributing to the sediment delivered to the drainage ditch in Figure 50 (Point 9 on Figure 47).

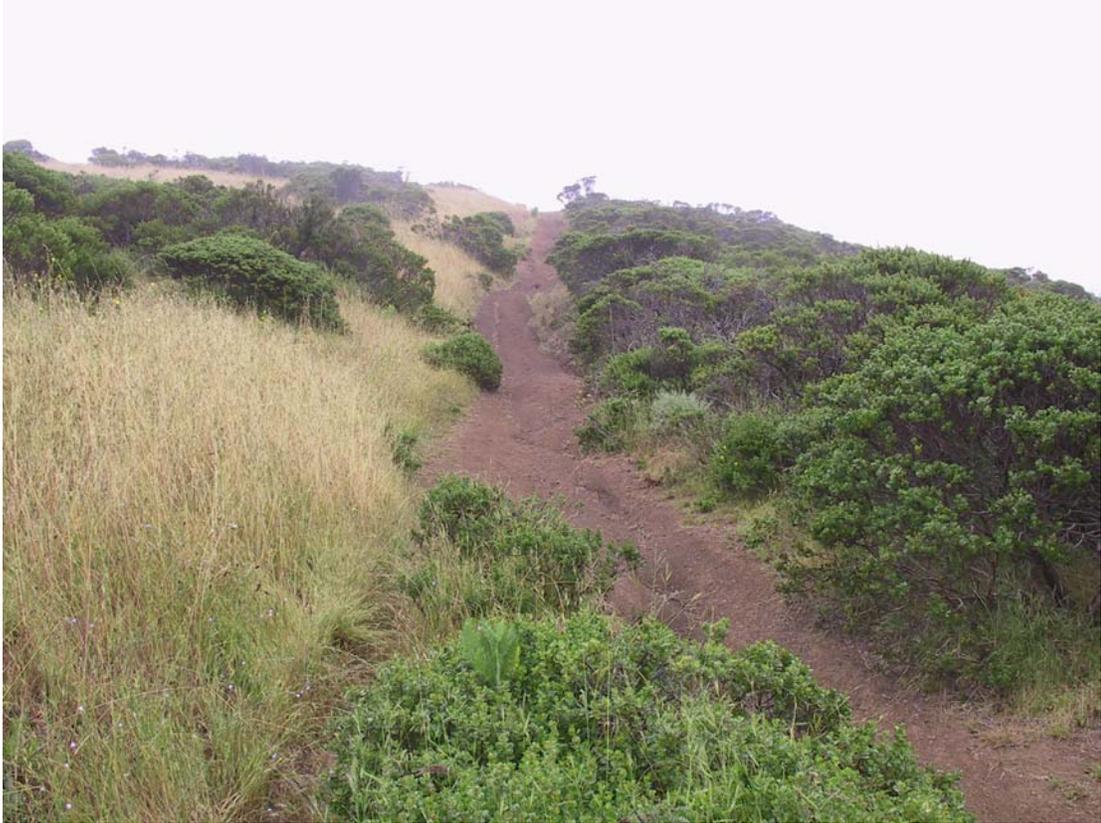
Figure 52: Trail channeling flow and creating a moderate gully draining toward the North Fork (Line 15 on Figure 47).

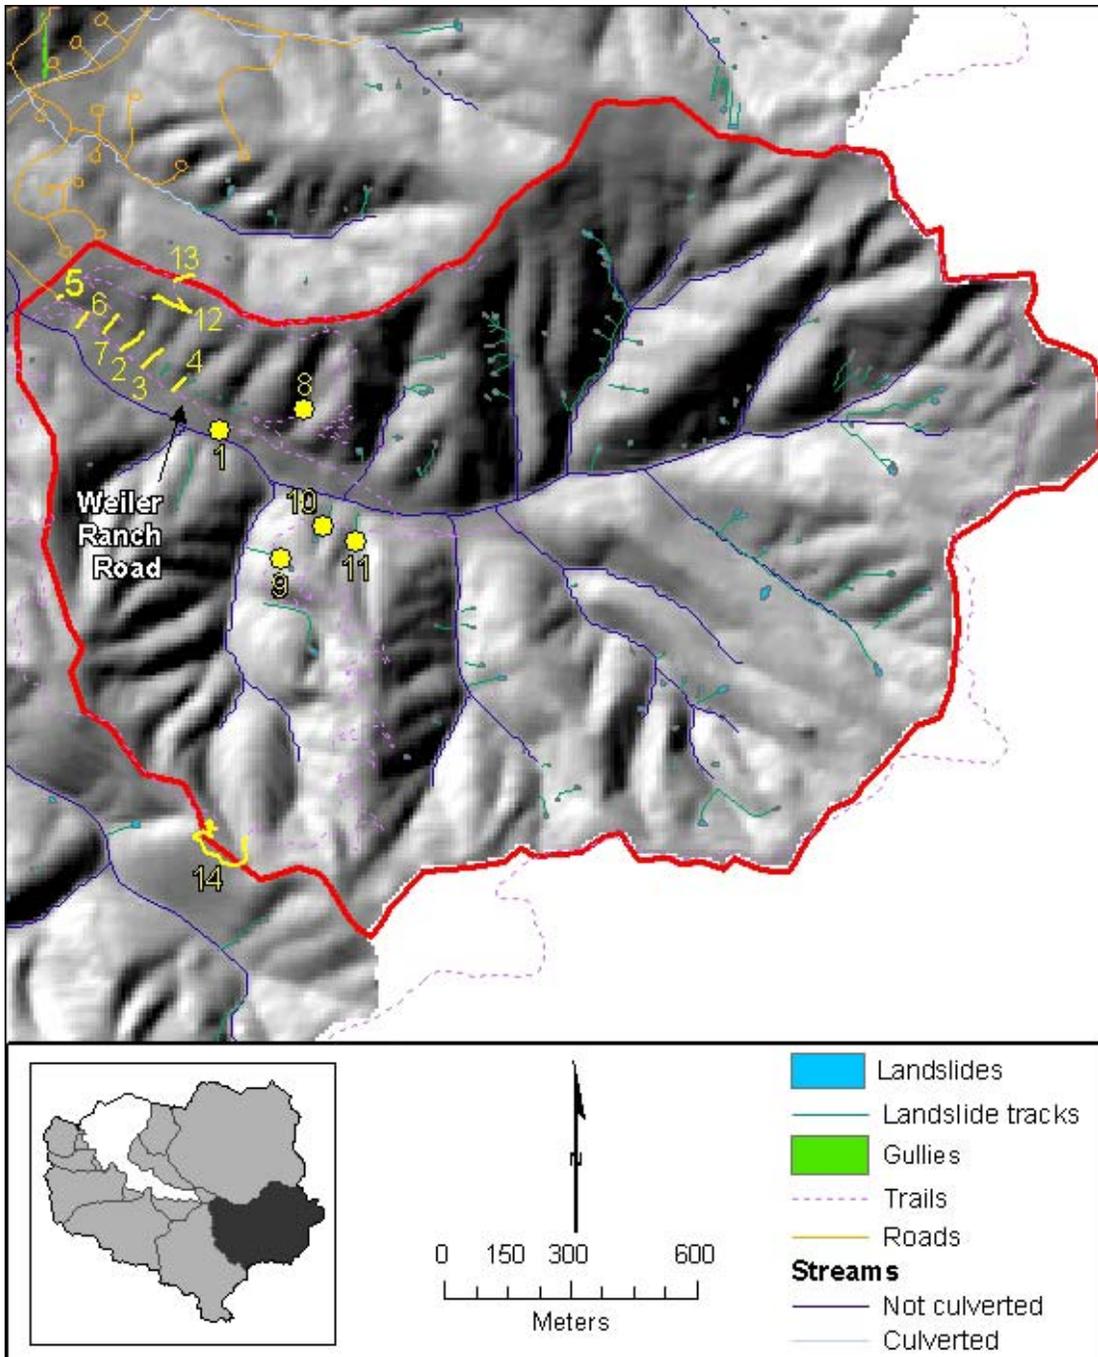
Figure 53: Middle subwatershed outlined in red indicating significant sediment sources in yellow. Also showing landslides and gullies with predicted connectivity.

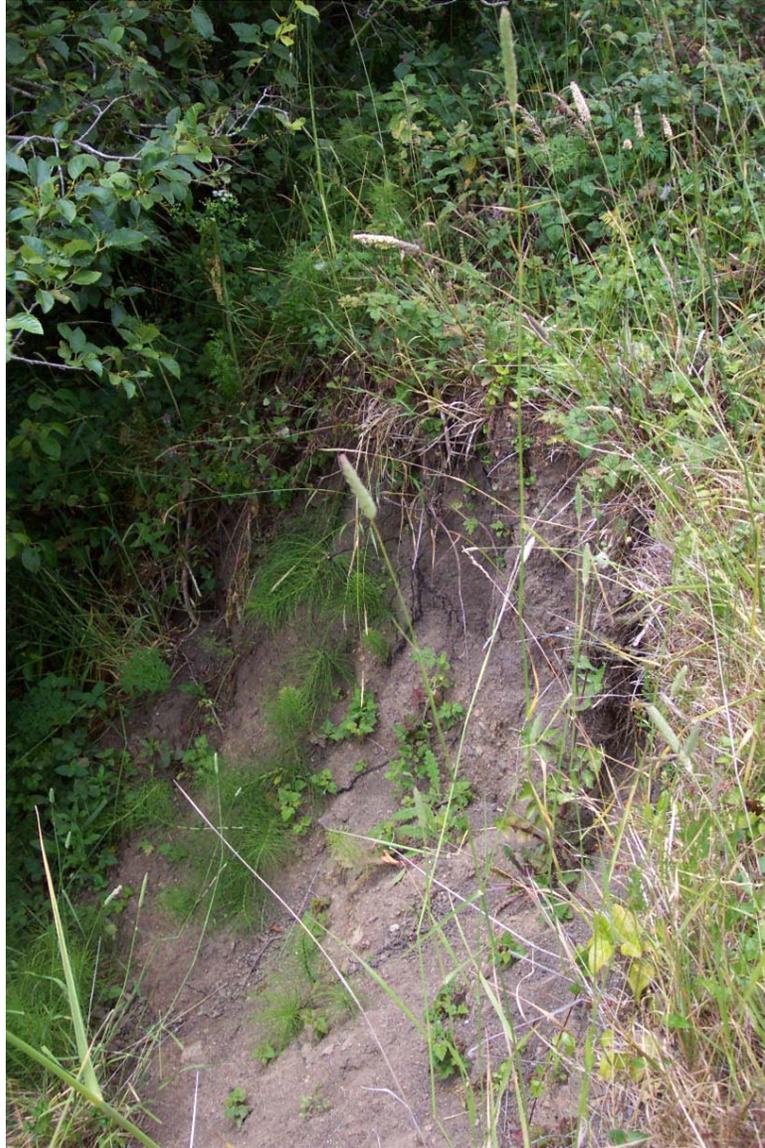
Figure 54: Slump on terrace between Weiler Ranch Road and the Middle Fork (Point 1 on Figure 53).

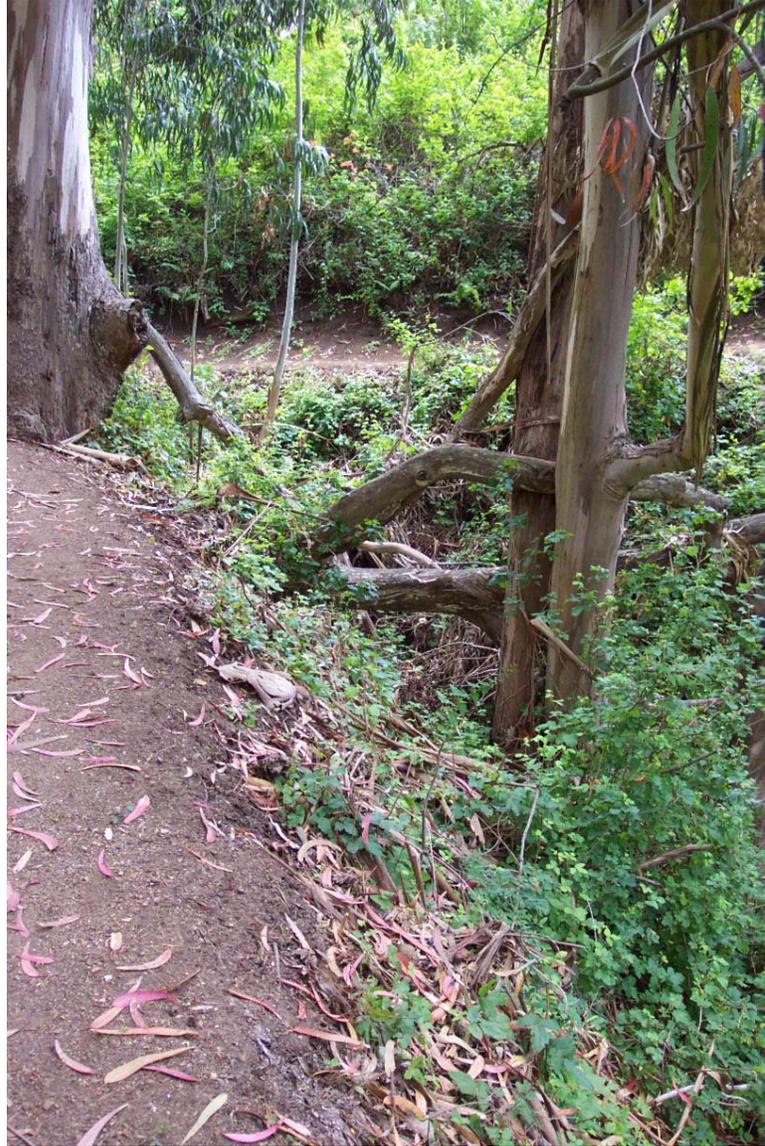
Figure 55: Deeply incised drainage in colluvium with repeat history of landslides (Point 8 on Figure 53).

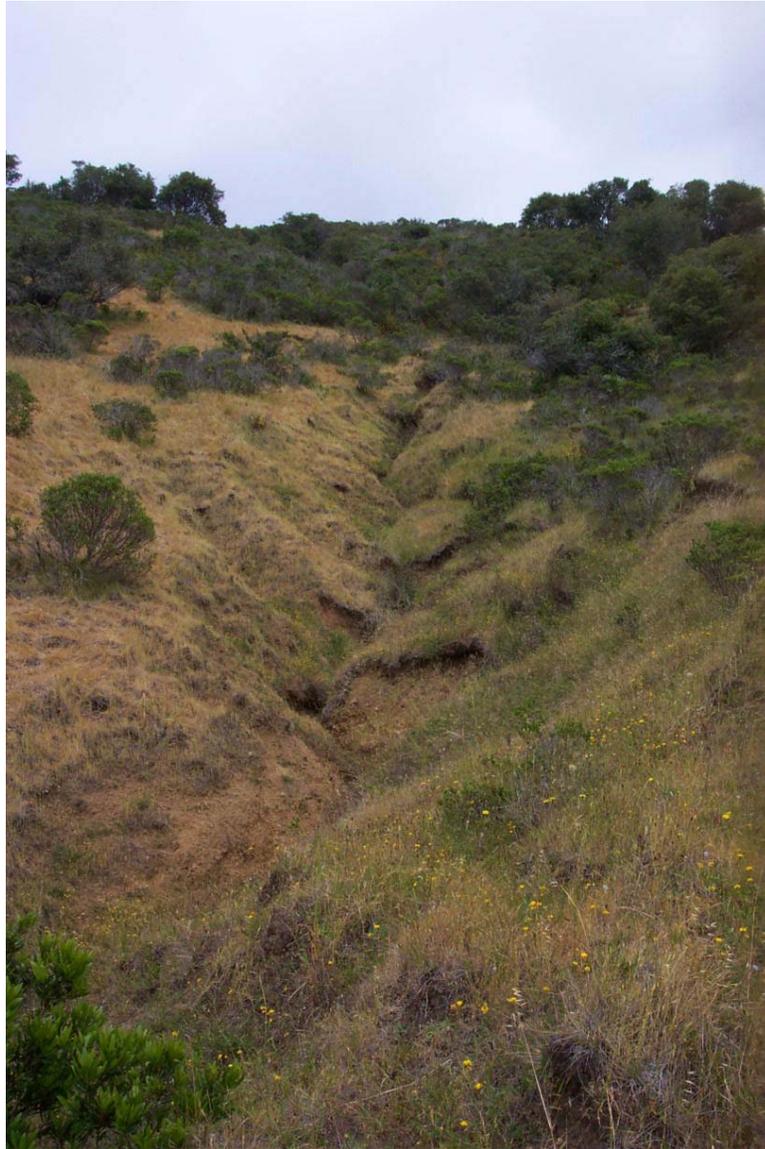
Figure 56: Gully incising through landslide deposit along Weiler Ranch Road (Line 4 on Figure 53).

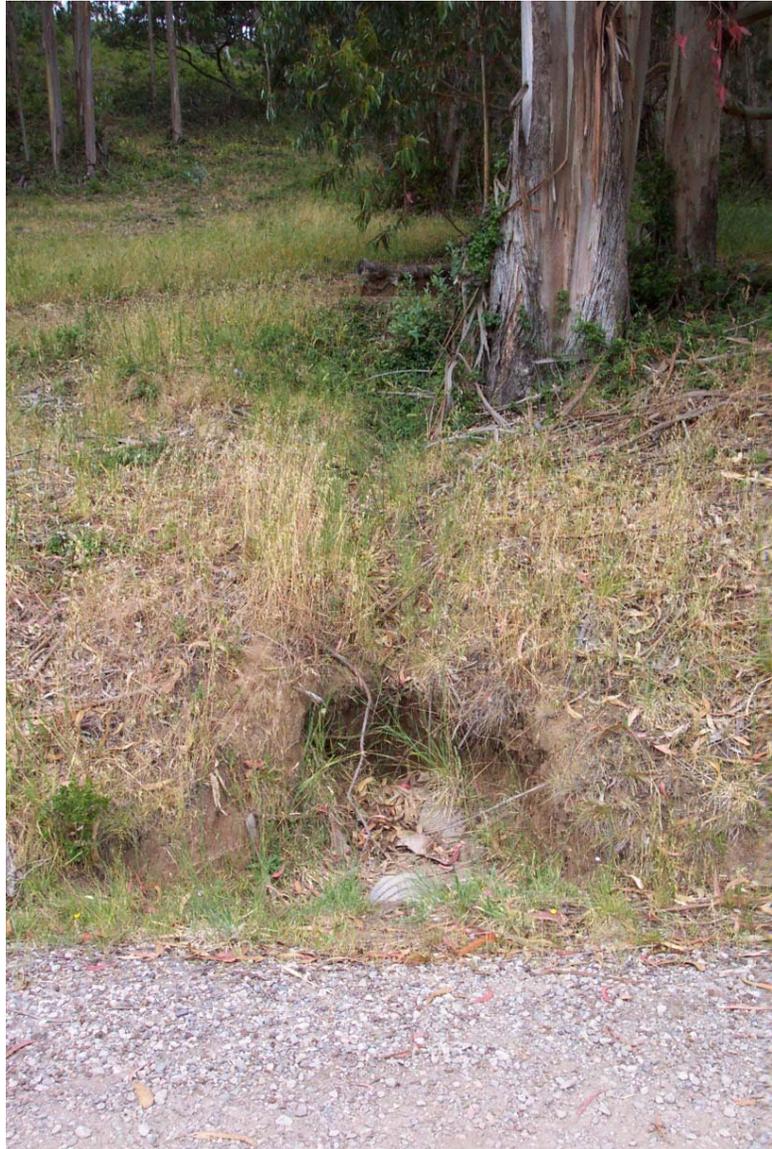
Figure 57: Incision at culvert from uphill ephemeral drainages (Point 6 on Figure 53).

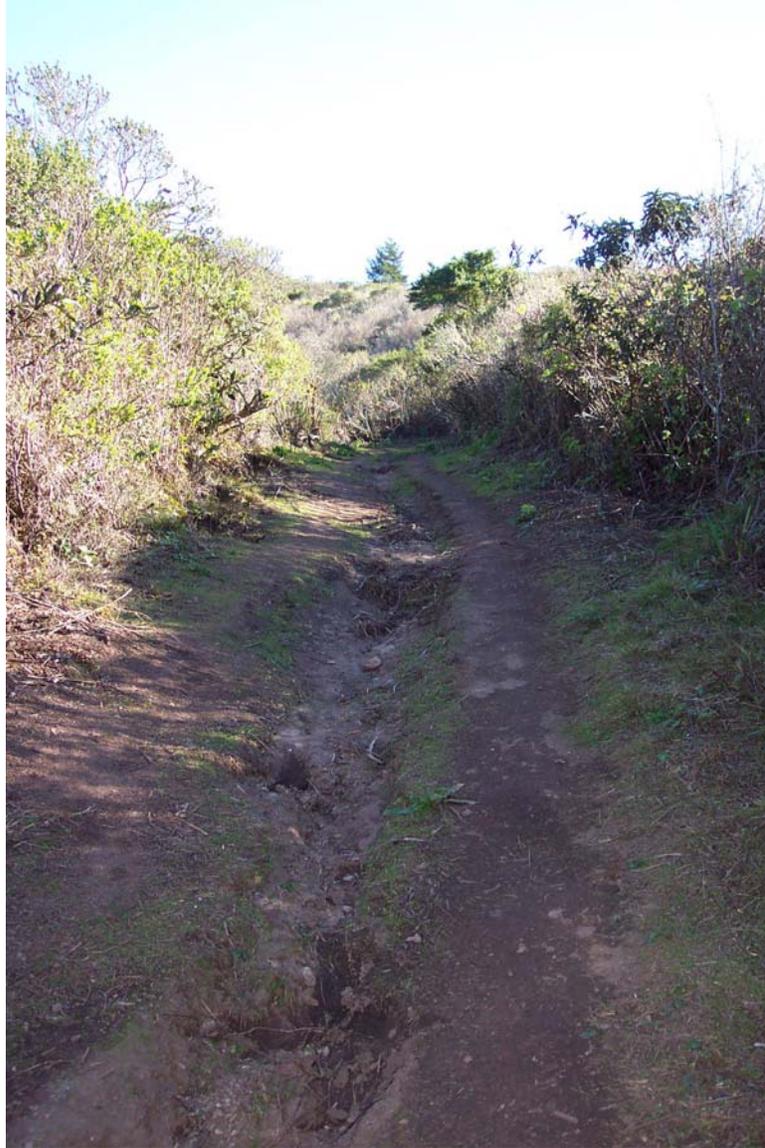
Figure 58: An ephemeral drainage along a portion of Hazelnut trail. Stream piracy is occurring along this stretch as flow is diverted from the South subwatershed to the Middle subwatershed (Line 14 on Figure 53).

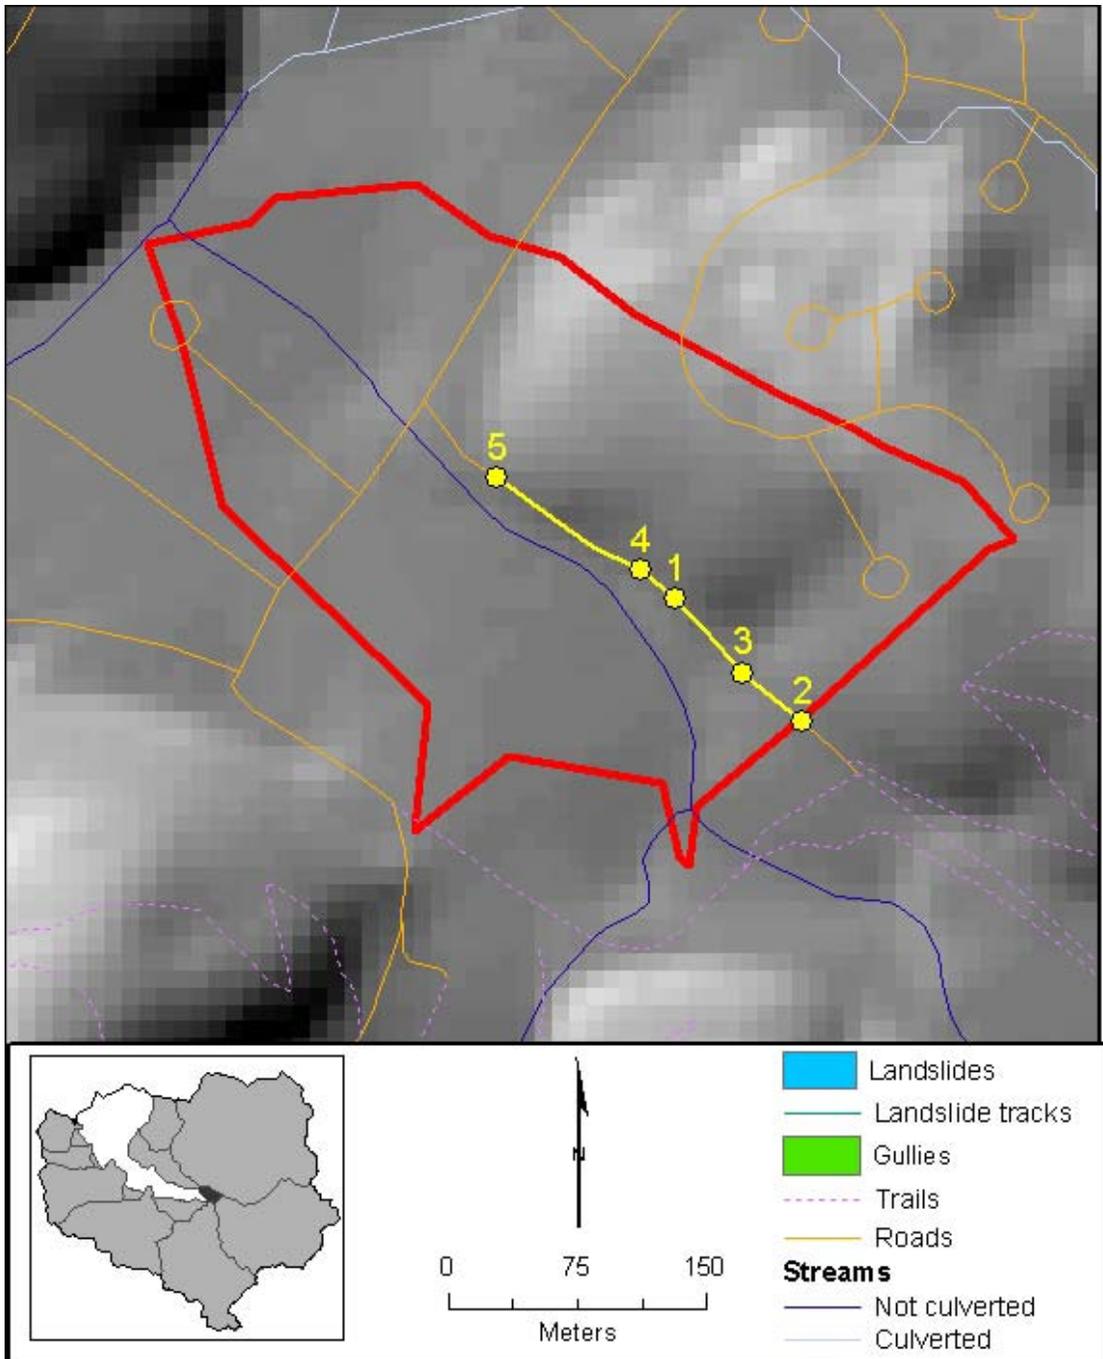
Figure 59: Middle/South subwatershed outlined in red indicating significant sediment sources in yellow. The yellow line indicates flow in drainage ditch that is diverted by culverts.
