**SAN PEDRO CREEK WATERSHED
SEDIMENT SOURCE ANALYSIS**

**Volume II:
Hillslope Sediment Source Assessment**

Stephanie Sims

San Francisco
State University

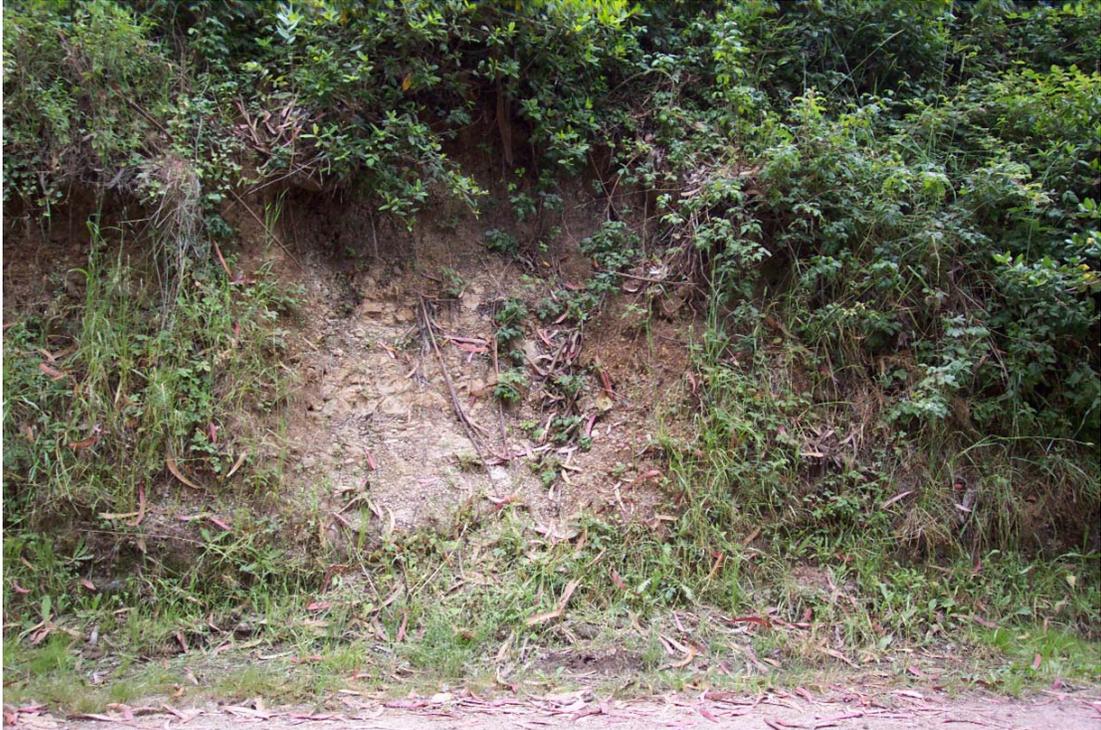
Figure 60: Surface erosion along an upslope roadcut draining to ditch and culverted under the road directly to the Middle/South fork (Point 1 on Figure 59).

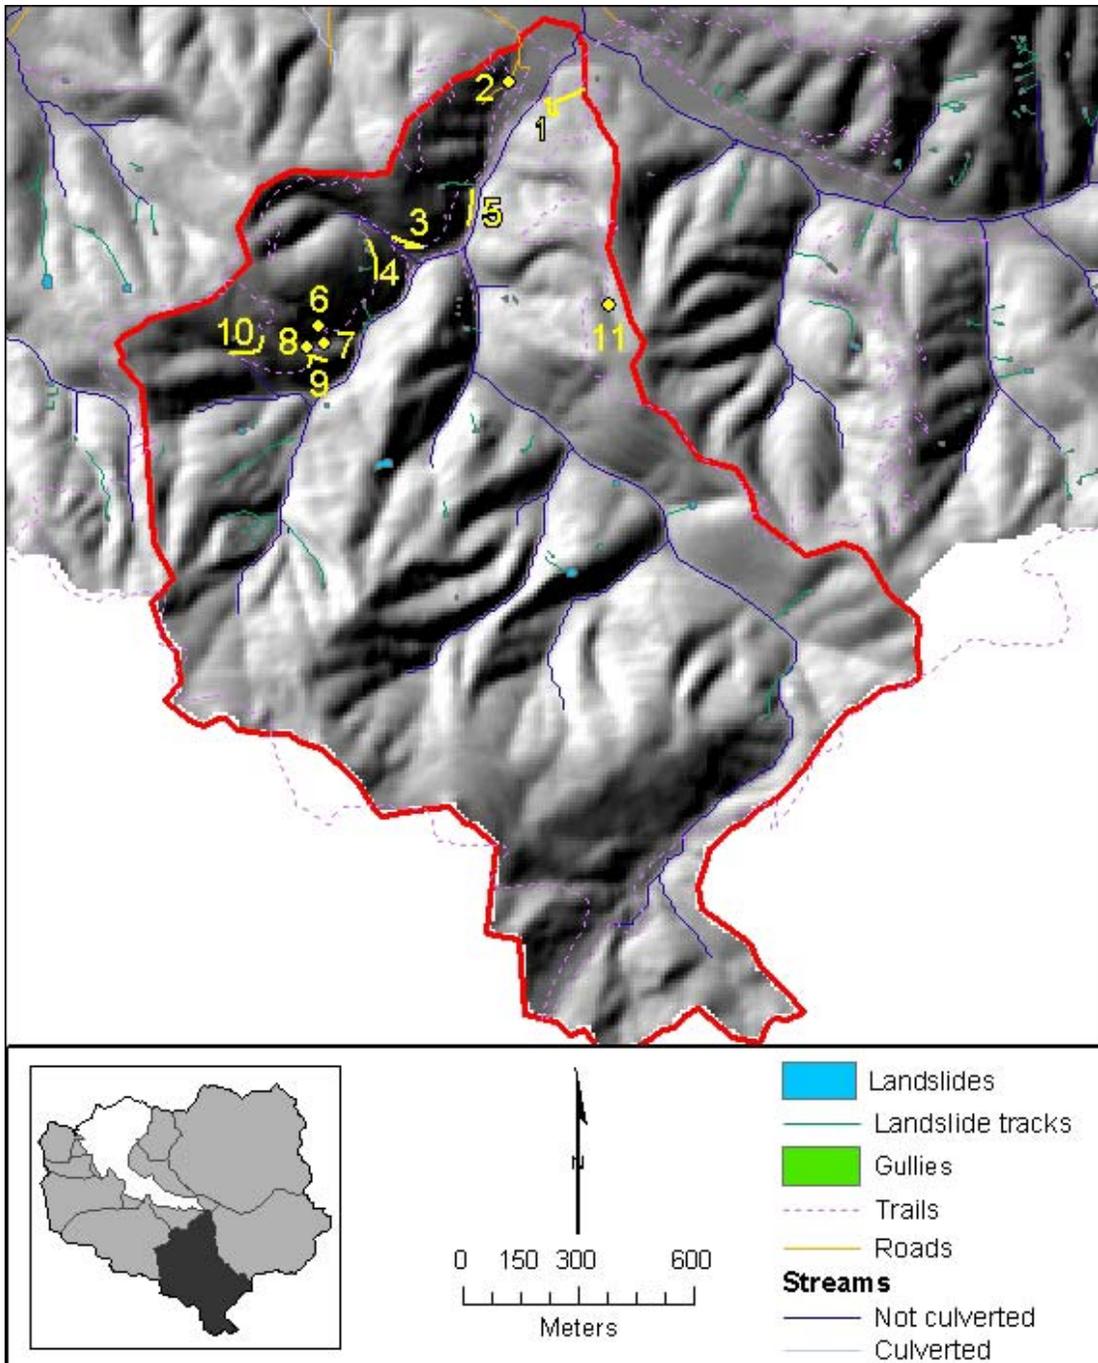
Figure 61: South subwatershed outlined in red indicating significant sediment sources in yellow. Also showing landslides with connectivity to the stream network.

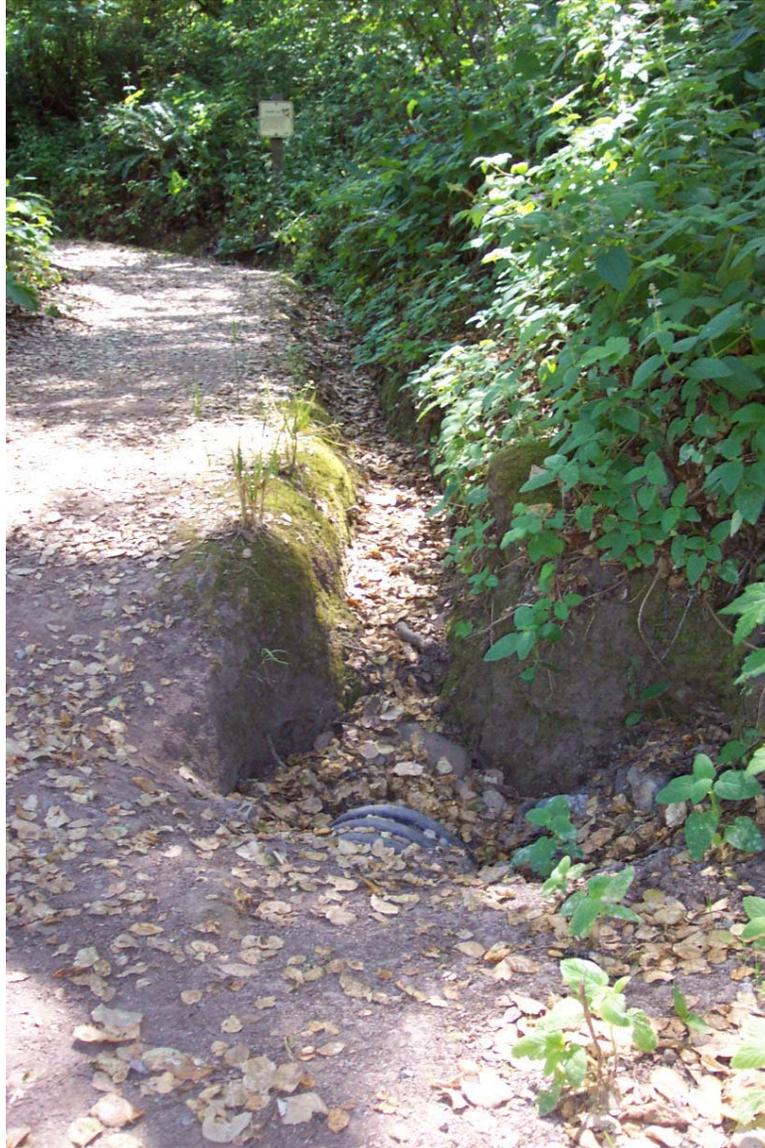
Figure 62: Fluvial erosion along a ditch from ephemeral drainage along uphill section of lower Hazelnut Trail (end of Line 1 on Figure 61).

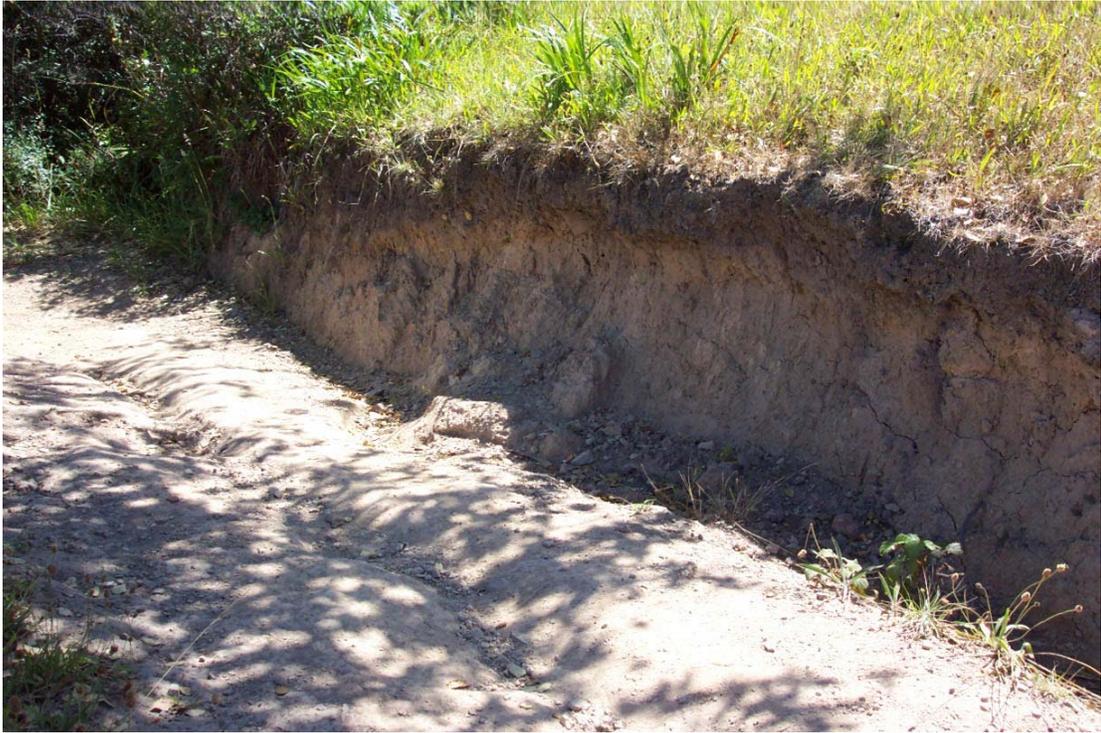
Figure 63: Surface erosion along uphill section of trail. Channel on inside where sediment deposits and in the middle of the trail (upper portion of Line 1 on Figure 61).

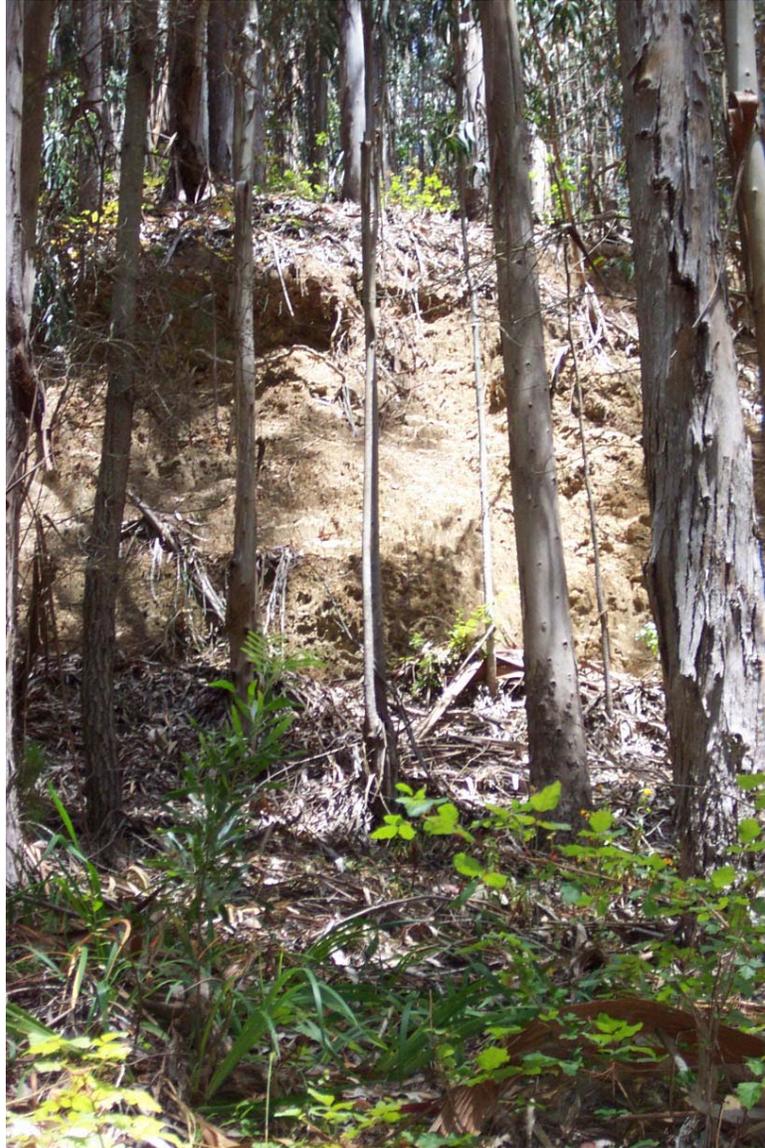
Figure 64: Surface erosion along on barren hillslope, which was a former road cut, along Brooks Creek Trail upslope of upper trail along Line 3 on Figure 61.

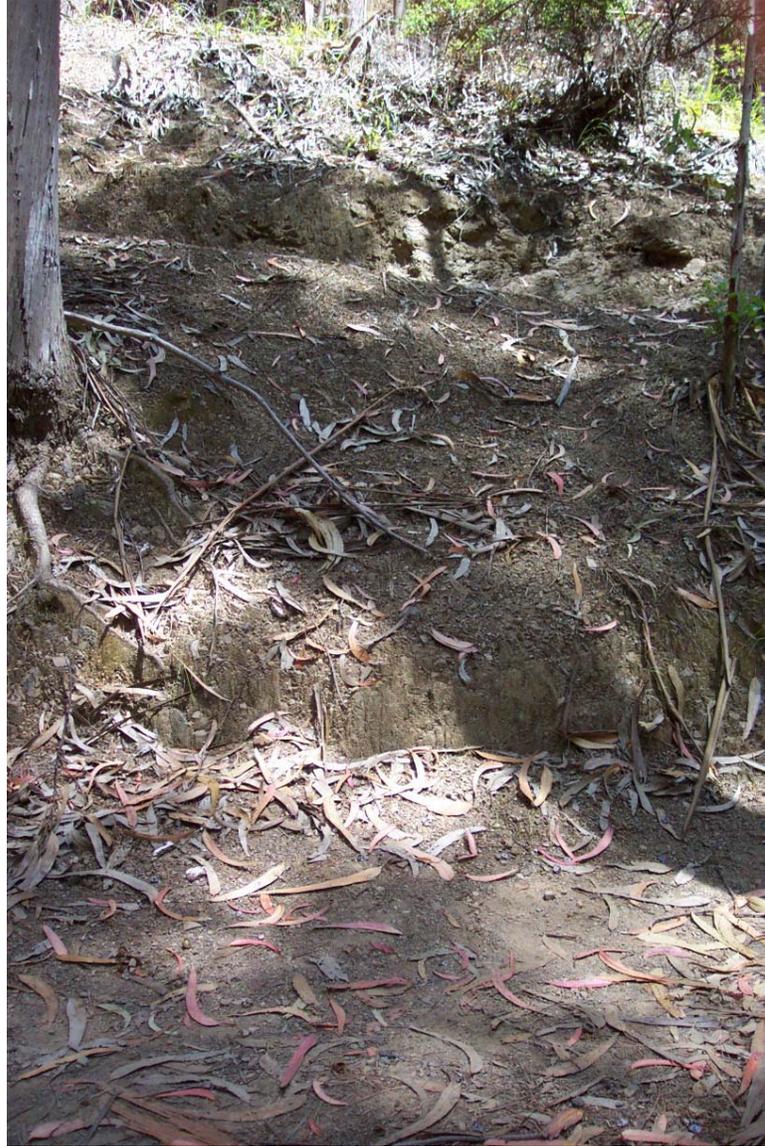
Figure 65: Barren loose soil from upper trail dumping onto lower trail and further downslope (Line 3 on Figure 61).

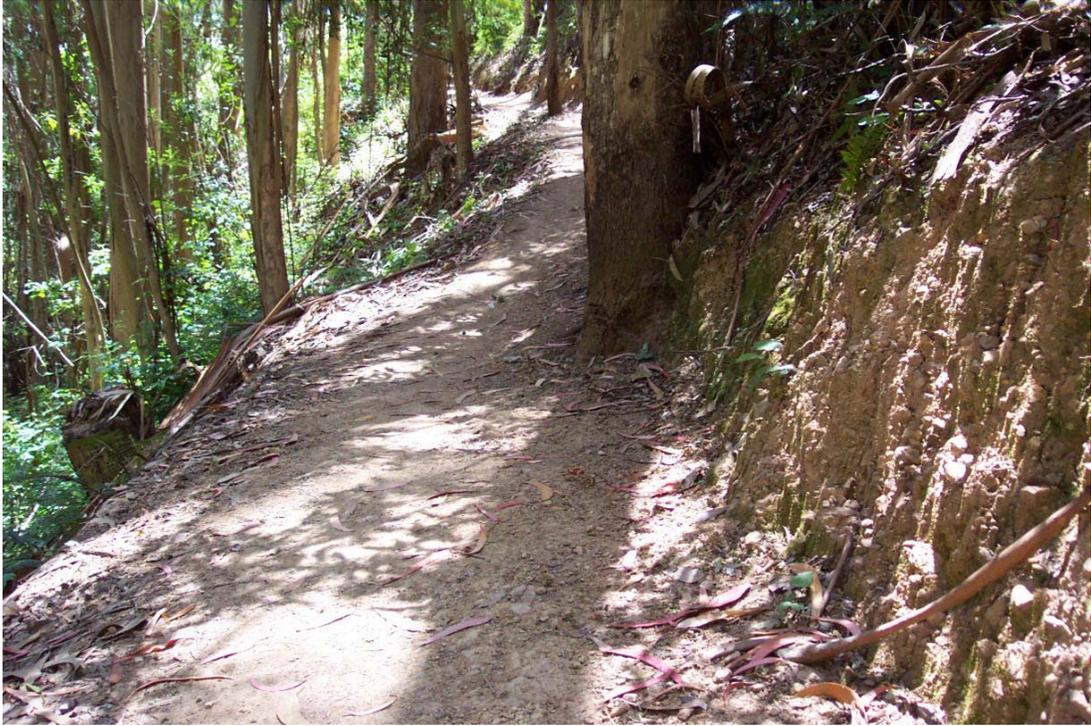
Figure 66: Surface erosion on Brooks Creek Trail with rilling in unconsolidated landslide deposits on the upper trail cut (Line 4 on Figure 61).

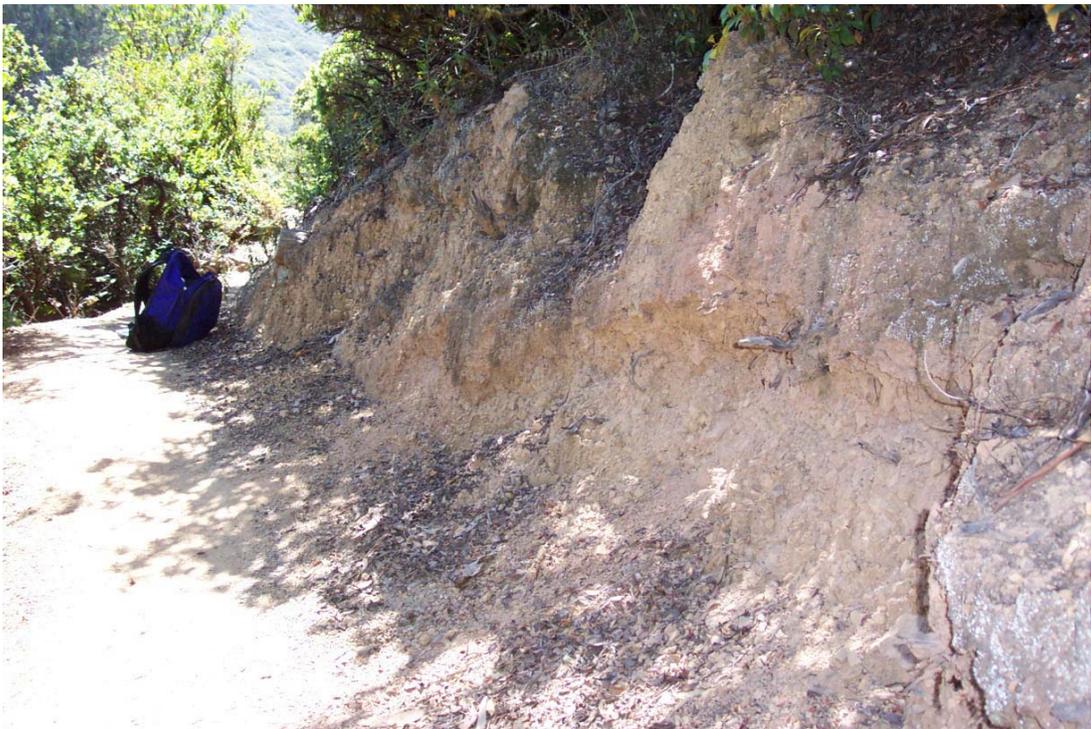
Figure 67: Surface erosion along Brooks Creek Trail (Line 4 on Figure 61).

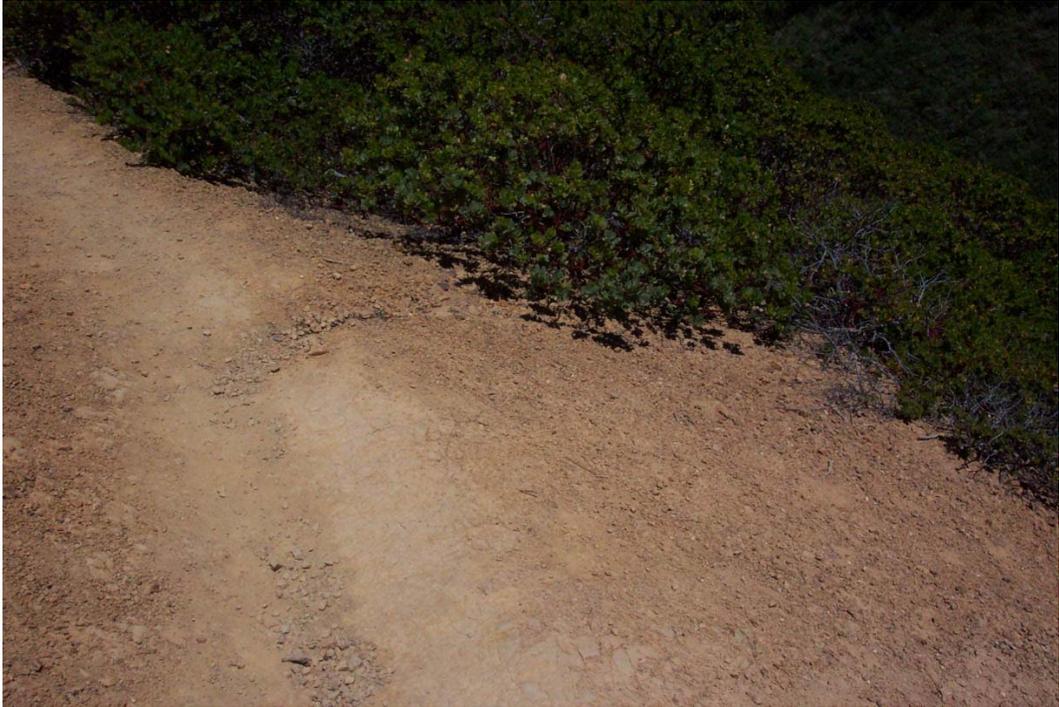
Figure 68: Channel along Brooks Creek Trail draining on the upper slopes (Line 9 on Figure 61).

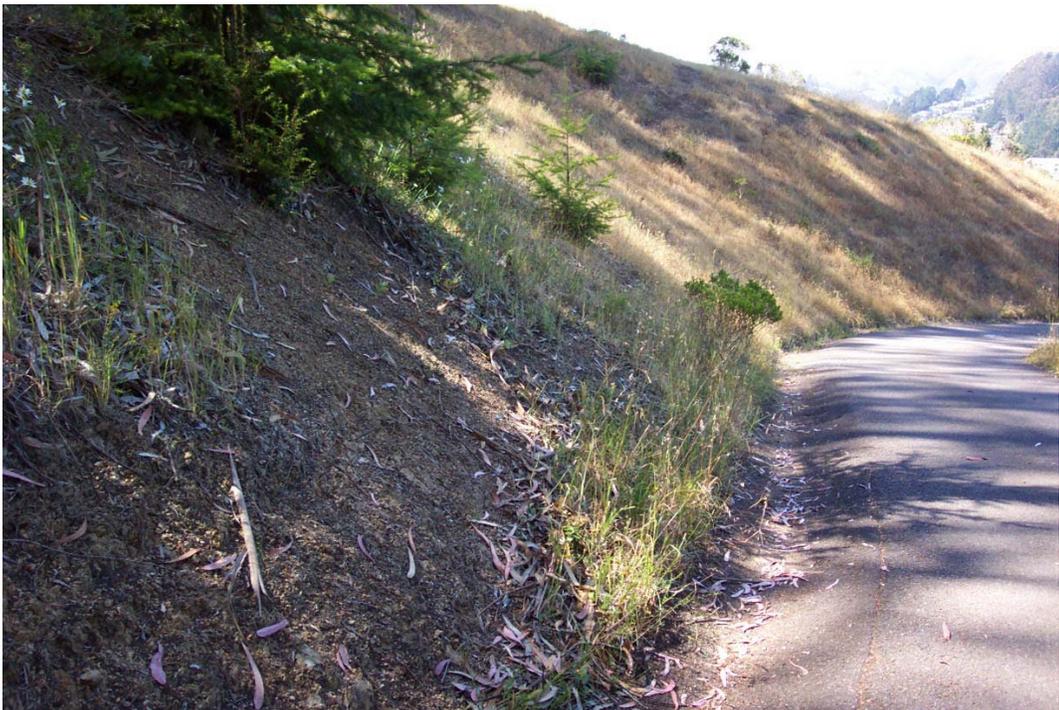
Figure 69: Surface erosion upslope from road eroding directly to drainage ditch (Point 2 on Figure 61).

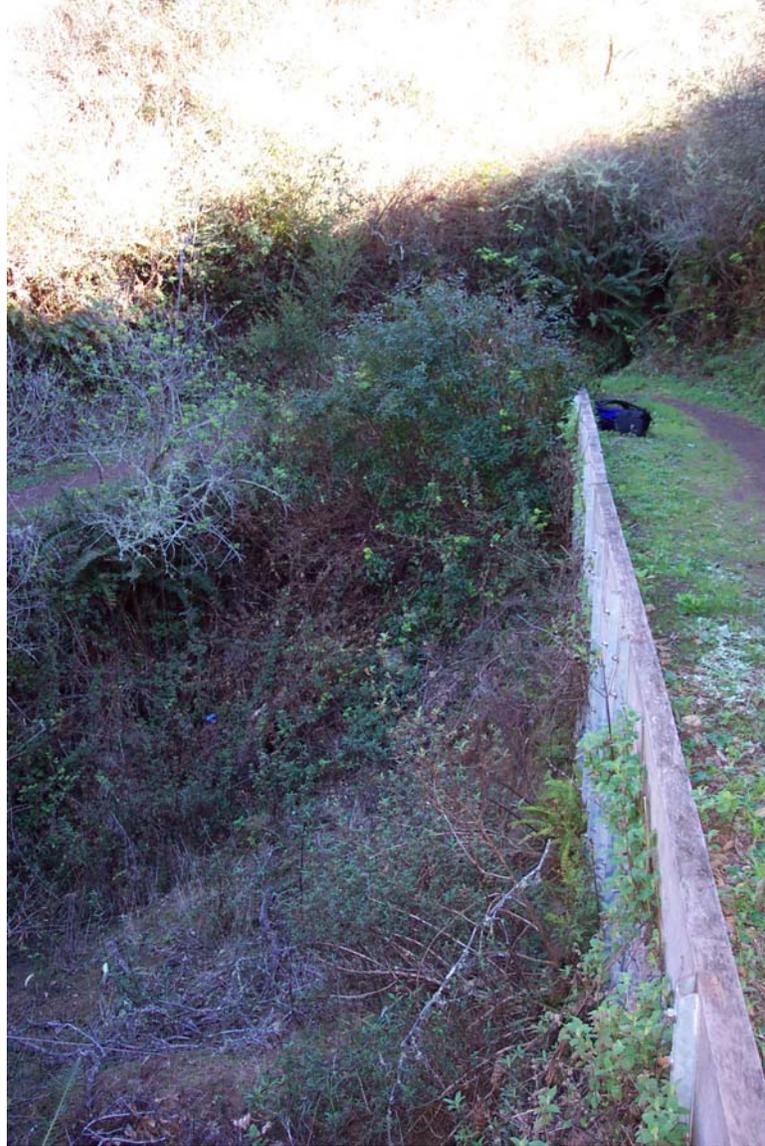
Figure 70: Control structures implemented after a slide. Colluvium is still collecting downslope in drainage with direct connectivity observed from field observations (Point 11 on Figure 61).

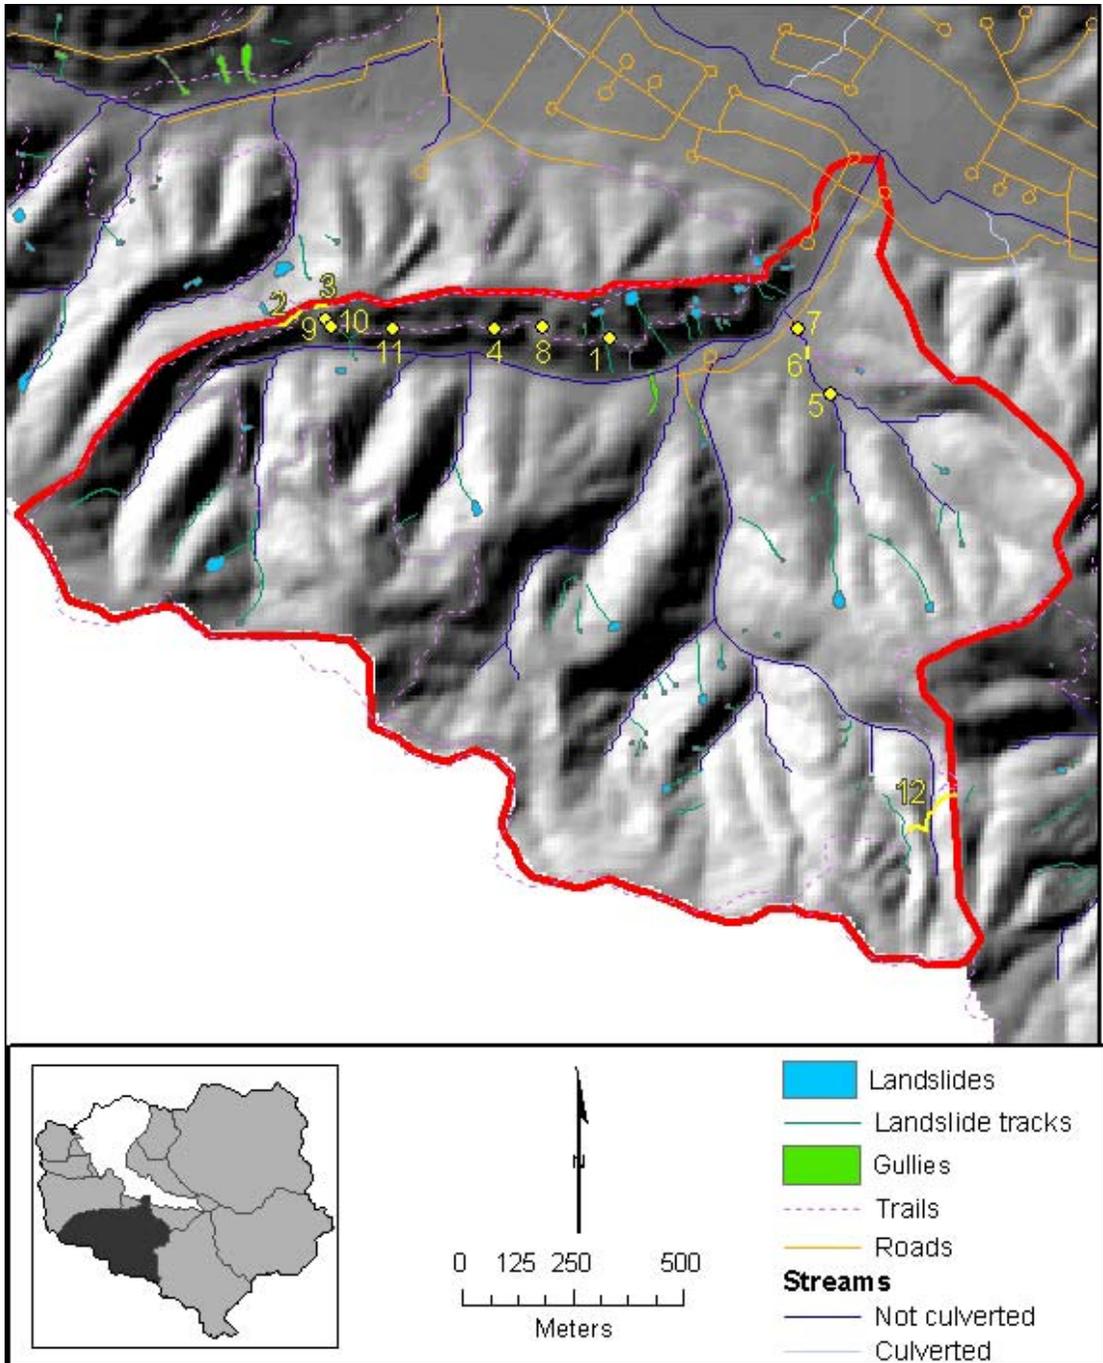
Figure 71: Sanchez subwatershed outlined in red indicating significant sediment sources in yellow. Also showing landslides with connectivity to the stream.

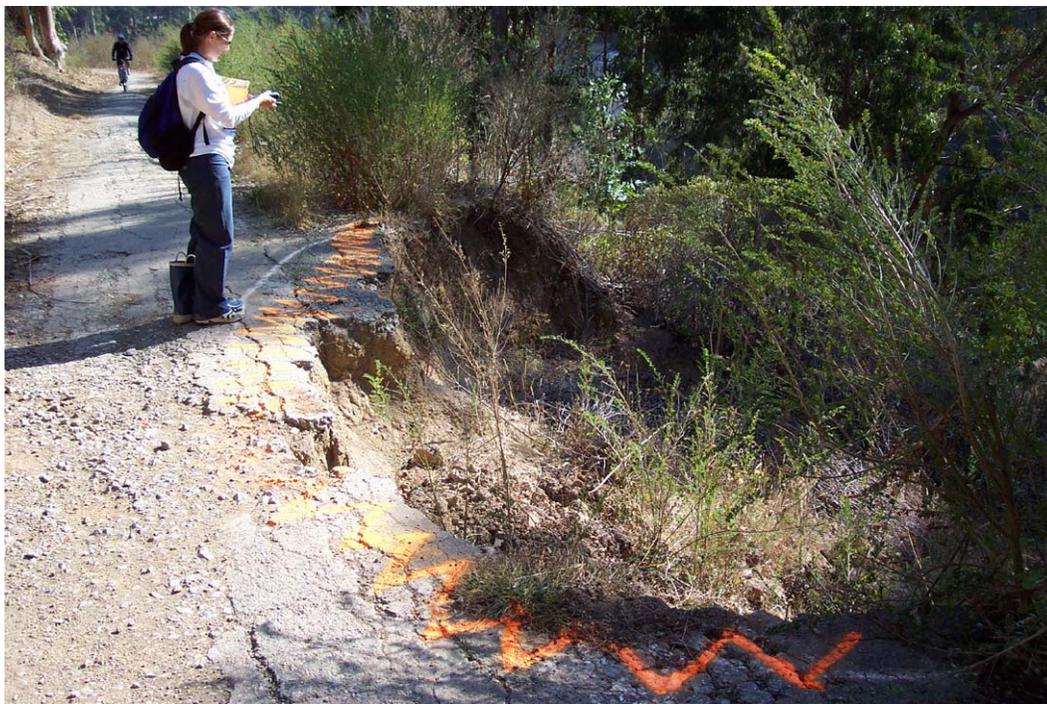
Figure 72a: Severe mass wasting and subsequent surface erosion downslope of Coastside Boulevard draining to Sanchez Fork (Point 1 on Figure 69).

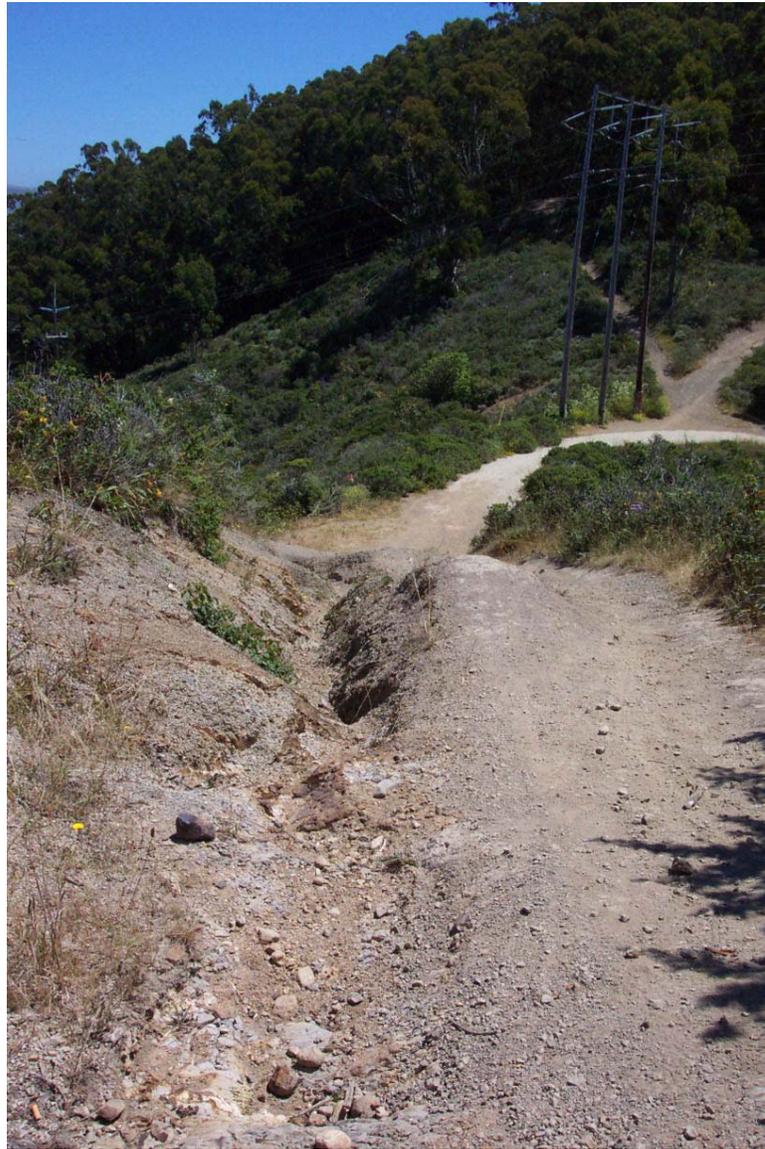
Figure 73: Rutted trail heavily utilized by mountain bikers (Line 2 on Figure 71).

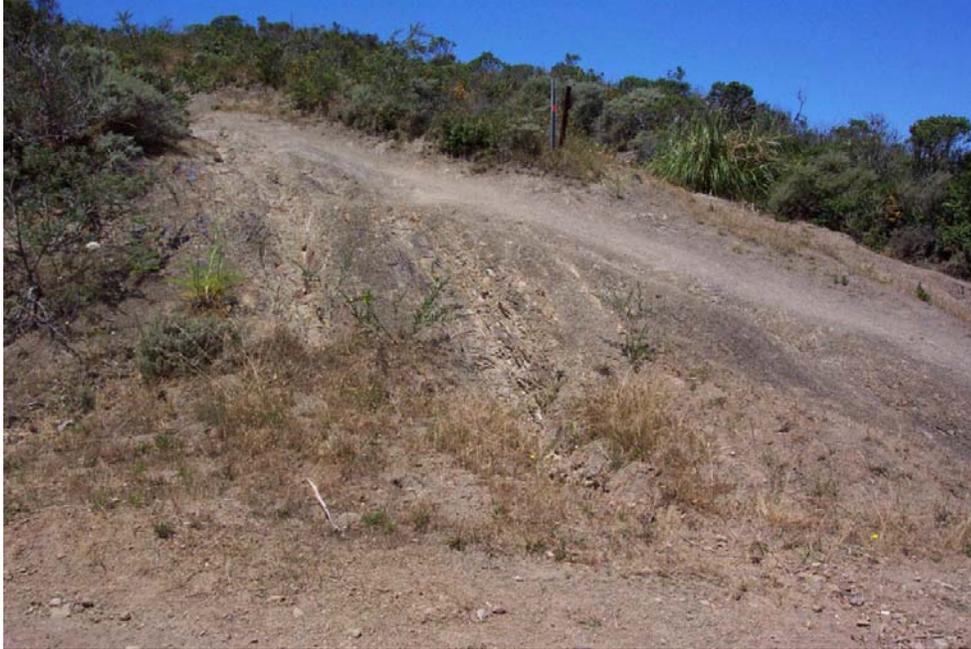
Figure 74: Surface erosion along compacted and gullied trail on the ridgeline between Sanchez and Shamrock subwatersheds (Line 2 on Figure 71).

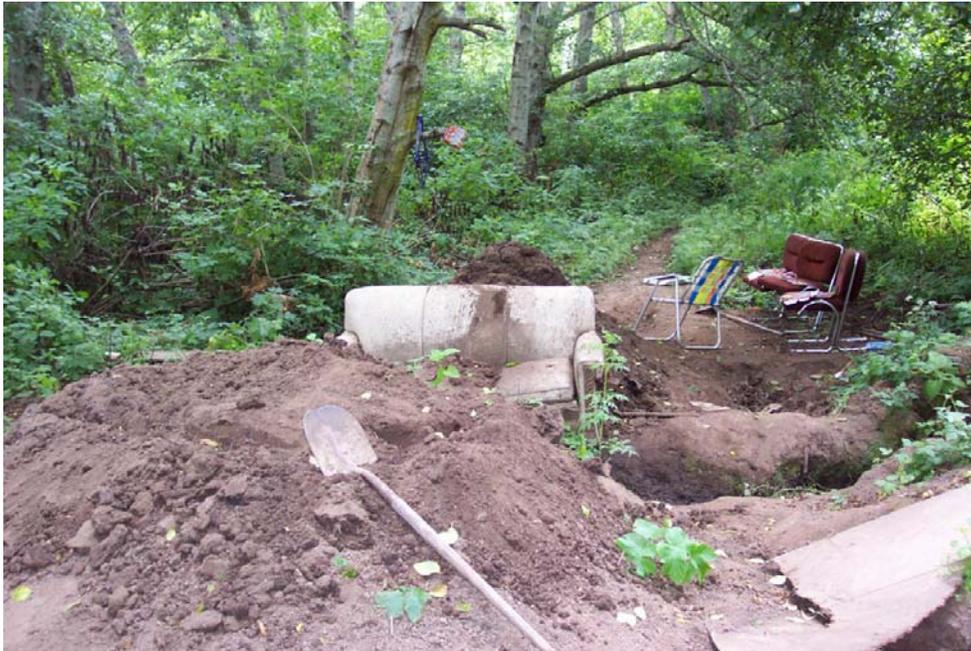
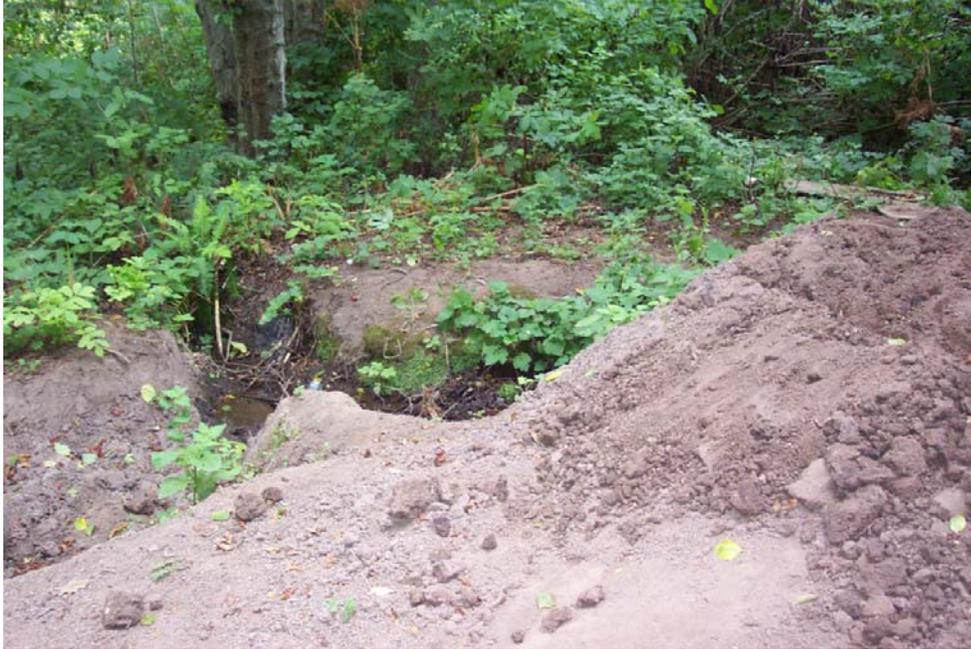
Figure 75a: Loose unconsolidated soil exposed from significant recreational use (Point 5 on Figure 71).

Figure 75b: Loose unconsolidated soil exposed from significant recreational use (Point 5 on Figure 71).

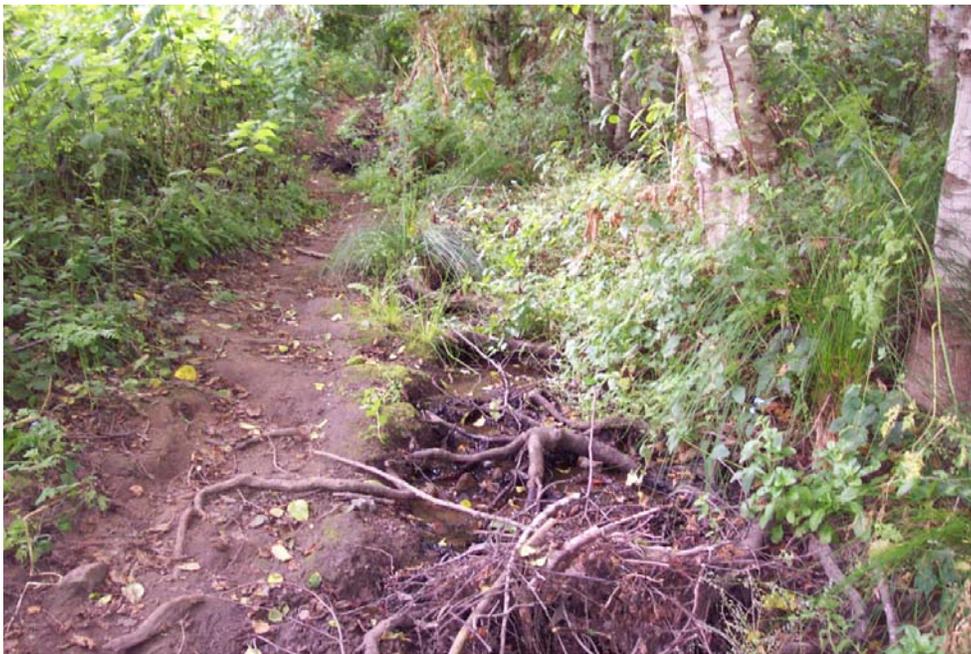
Figure 76: Channel with significant incision and very exposed tree roots adjacent to heavily compacted trail (Line 6 on Figure 71).

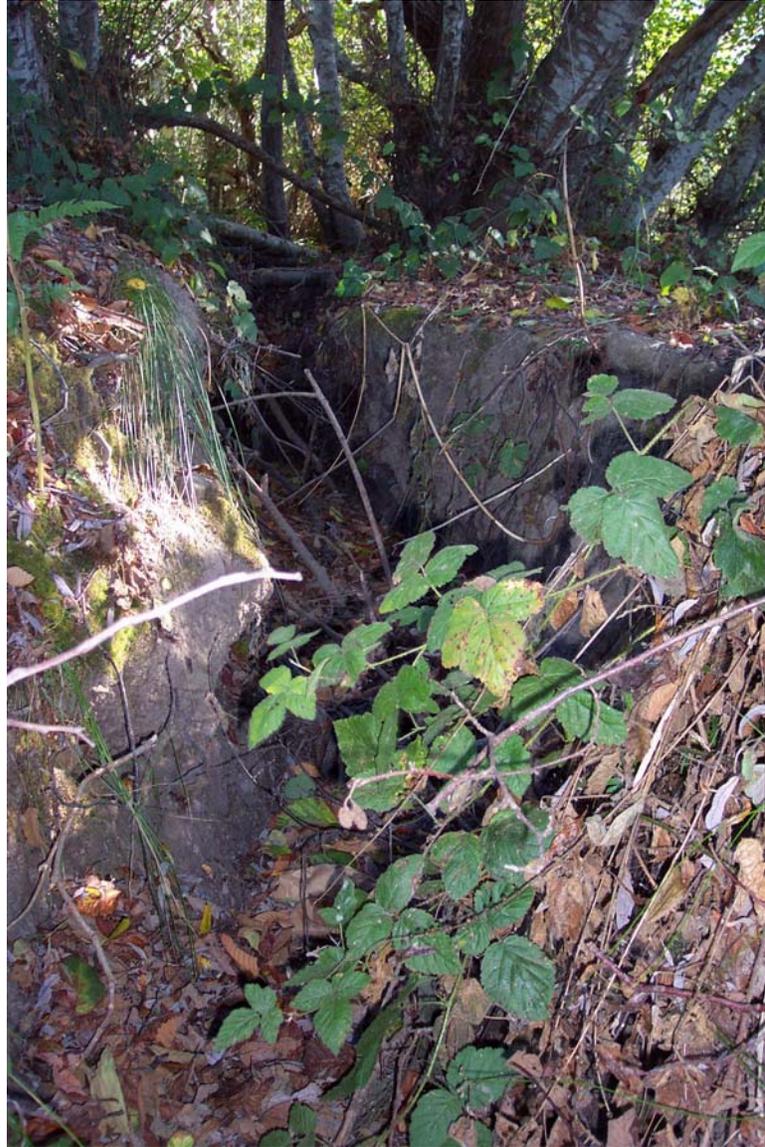
Figure 77: Deep channel incision into landslide deposit (Point 7 on Figure 71).

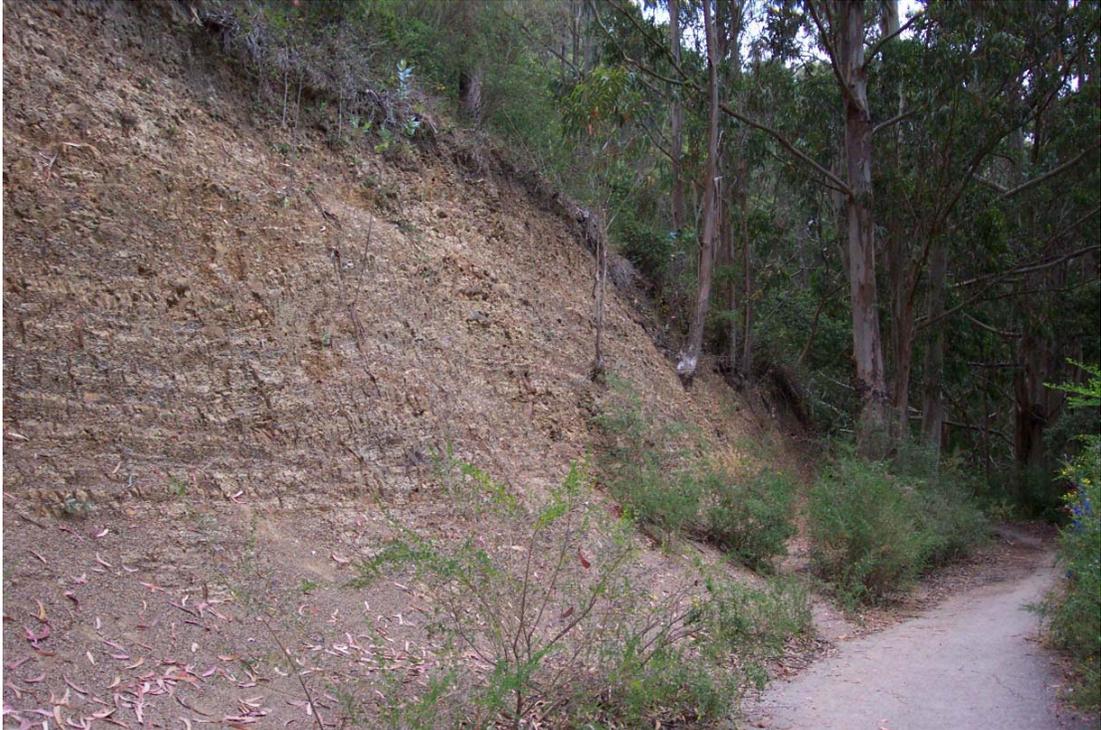
Figure 78: Trail cut eroded to bedrock with sediment accumulation along the base from surface erosion along upslope soils (Point 8 on Figure 71).

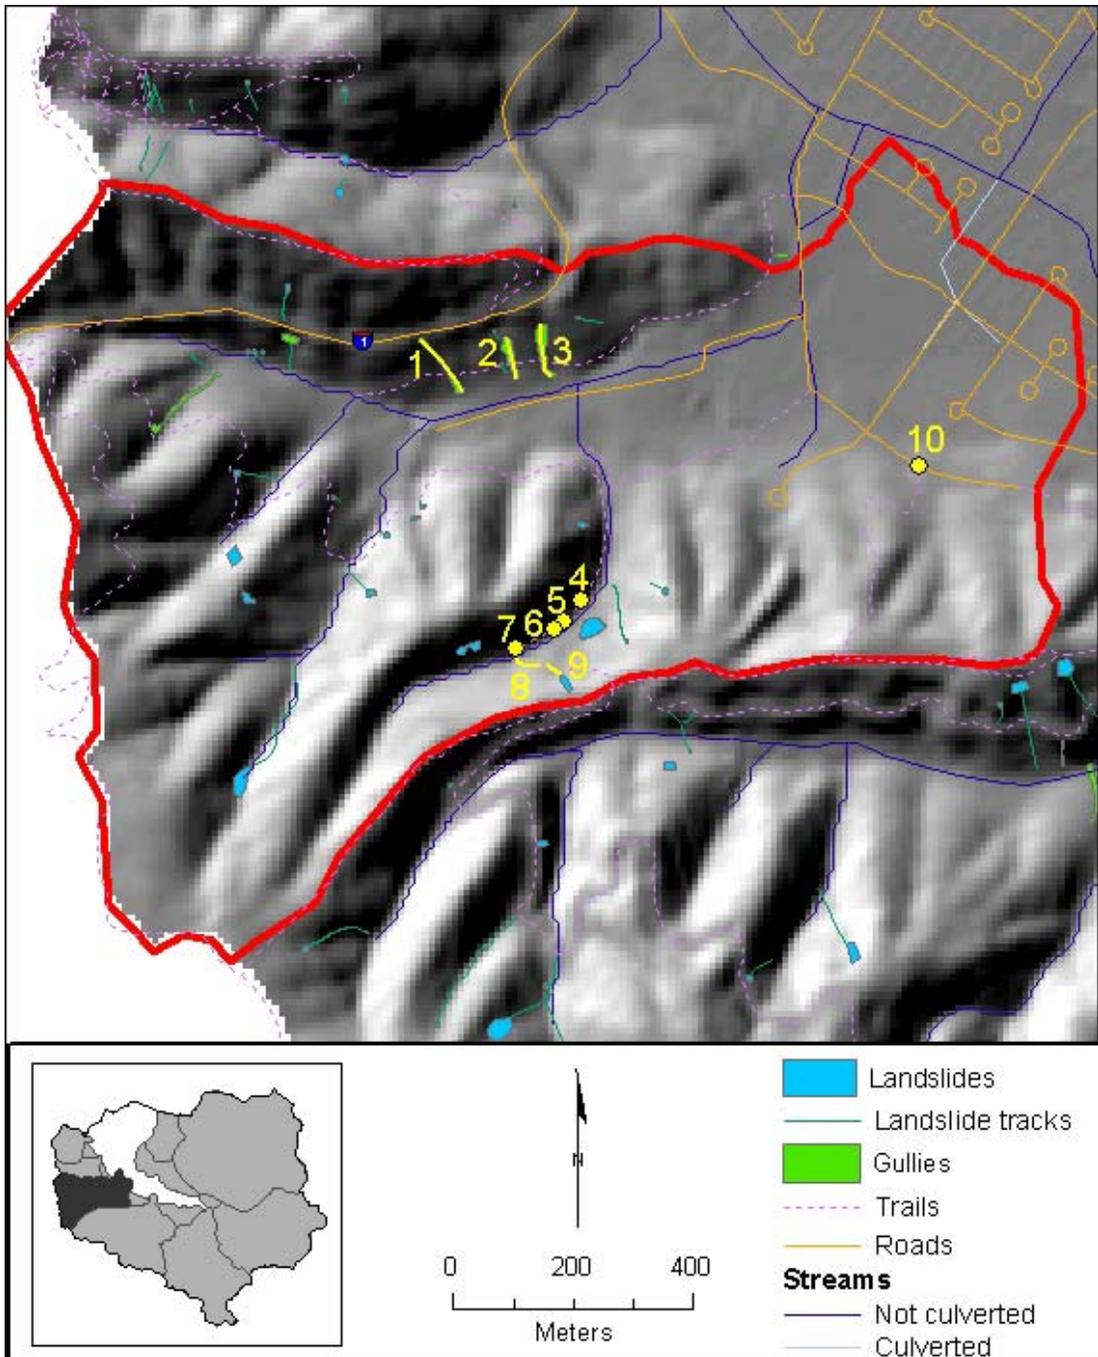
Figure 79: Shamrock subwatershed outlined in red indicating significant sediment sources in yellow. Also showing landslides and gullies with predicted connectivity to the stream network.

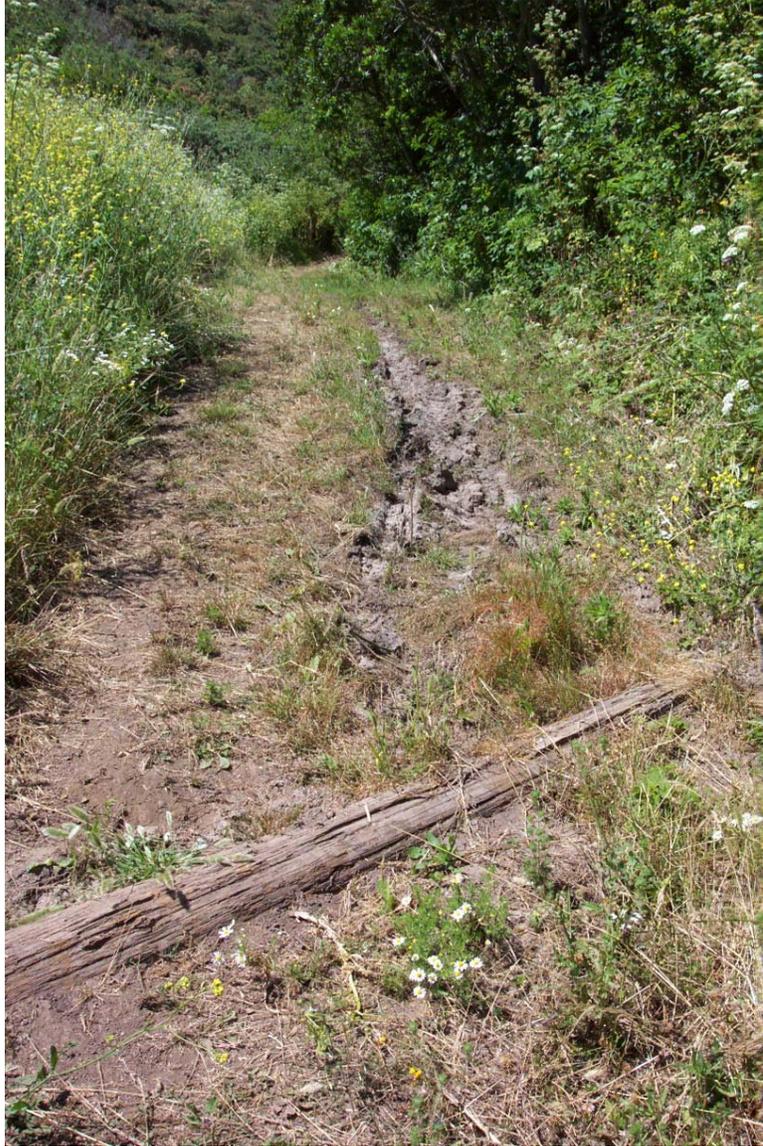
Figure 81: Incision in trail routing sediment directly into stream (Point 5 on Figure 79).

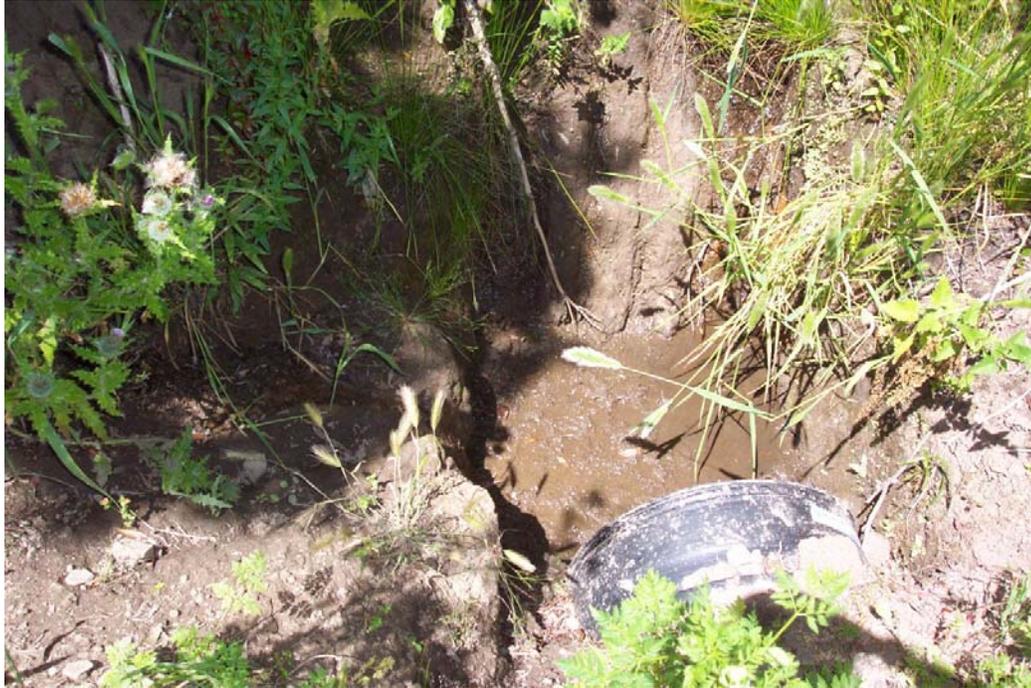
Figure 83: Sediment in excavated culvert draining directly to stream along the trail upslope from the Shamrock Ranch (end of Line 8 on Figure 79).

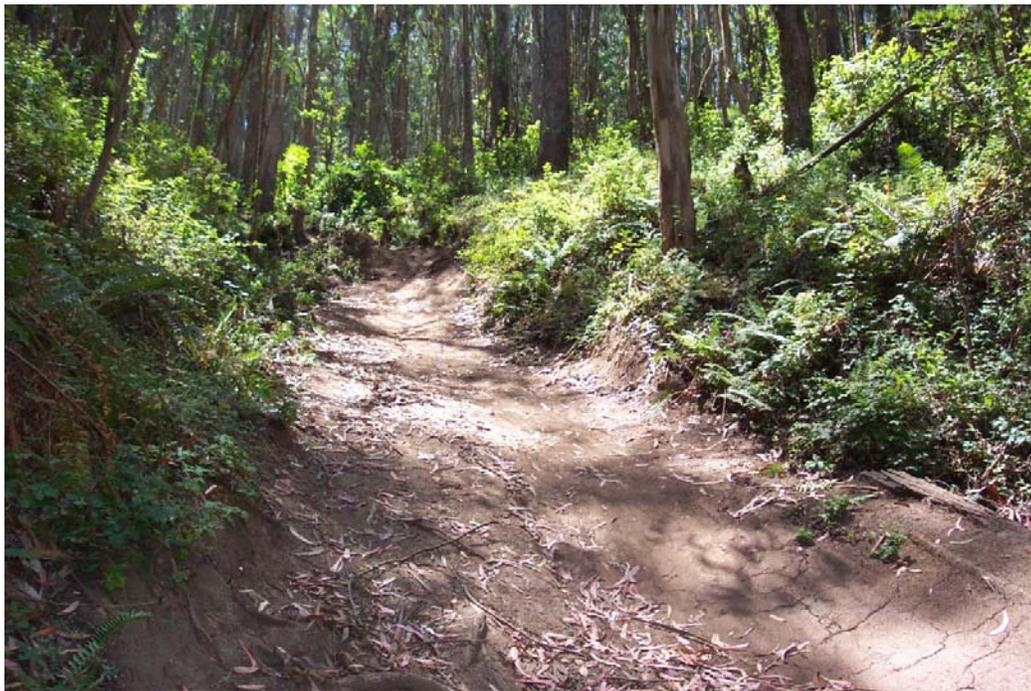
Figure 84: Nearly impervious compacted trail used significantly by mountain bikers. The cumulative flow drains down the trail to the road at Point 10 on Figure 79.

Surface erosion is occurring along the gullies and trails. The Candlestick variant loam soil complex underlying the three gullies is especially susceptible to detachment. The gully at point 1 on Figure 77 drains most of Highway 1 through the culvert just uphill. Erosion occurring along the trail leading to the southern boundary is directly routed to the stream network through water bars and culverts (Points 4 to 7 on Figure 79; Figure 81). Concentrated flow along the trail creates incision directing sediment to the tributary (Lines 8 & 9 on Figure 79; Figure 83). The ranch at the base of this valley maintains horses and the trail appears to be frequented by equestrians. This use supplies loose soils that are readily entrained as sediment. In addition, surface erosion is also likely significant on the sparsely vegetated lands used at the base of the valley for horse grazing in Shamrock Ranch (Figure 80). Mountain bike trails, which are also accessed for equestrian use, switchback down the northern slope of the ridge forming the southern boundary of Shamrock subwatershed. Only a sample of these trails was mapped. The intensive use accompanied with these trails has created impervious surfaces with adjacent loose sediment that ultimately spills onto the road and directly into the stream network through the culverted storm drain system (Point 10 on Figure 79; Figure 84).
