**SAN PEDRO CREEK WATERSHED
SEDIMENT SOURCE ANALYSIS**

**Volume II:
Hillslope Sediment Source Assessment**

Stephanie Sims

San Francisco
State University

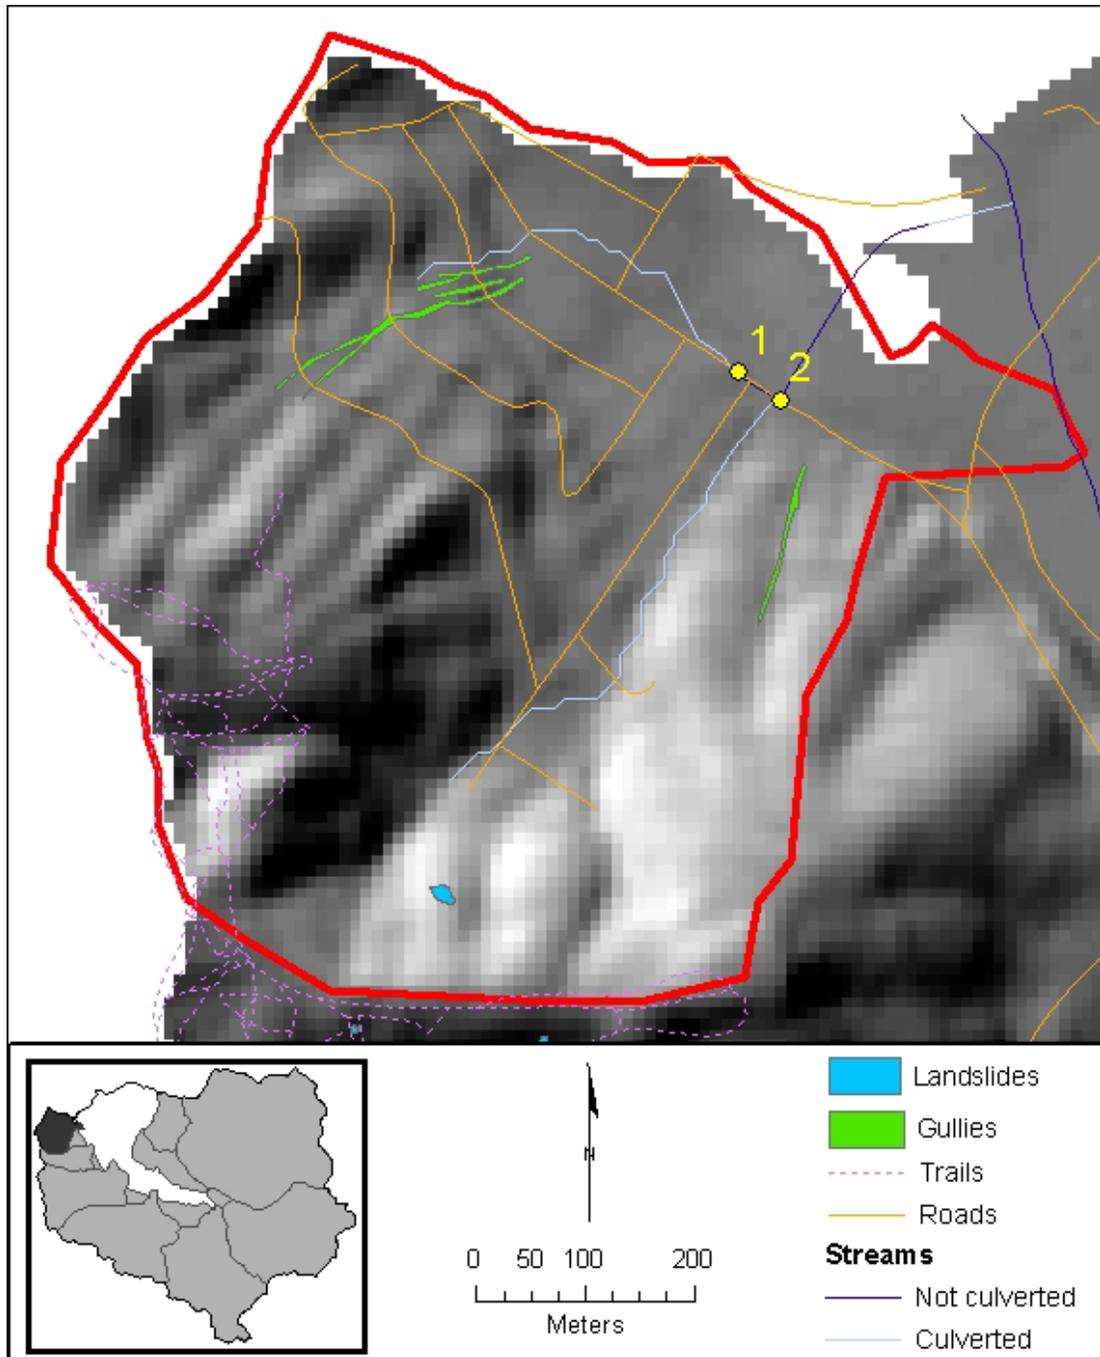
Figure 85: Pedro Point I subwatershed outlined in red indicating significant sediment sources in yellow. Also showing the only landslide and gullies with predicted connectivity.

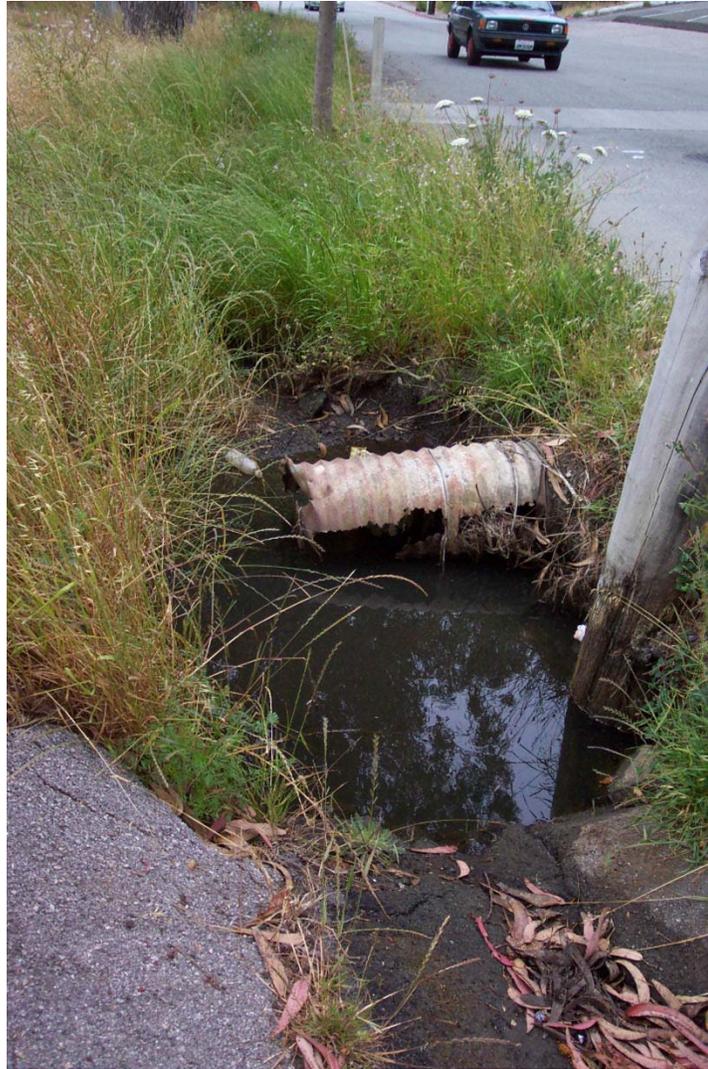
Figure 86: Channel incision from culvert draining the urbanized hillslope at Point 1 on Figure 85.

Soil detachment is low to moderate in Pedro Point I subwatershed. Areas most susceptible to erosion are downslope where the flow from the impervious surfaces is concentrated as shown from the culverts on Figure 86 and 87. Points 1 and 2 in Figure 85, the outflows of culverts connected to the storm drain system of the upper slopes, were the only significant sediment source found with predicted connectivity to Pedro Point I tributary. The culvert draining the urbanized hillslope has created a significantly incised channel extending approximately 55 meters before dissipating into a thickly vegetated riparian corridor. The low gradient, thickly vegetated corridor probably filters the majority of the sediment.

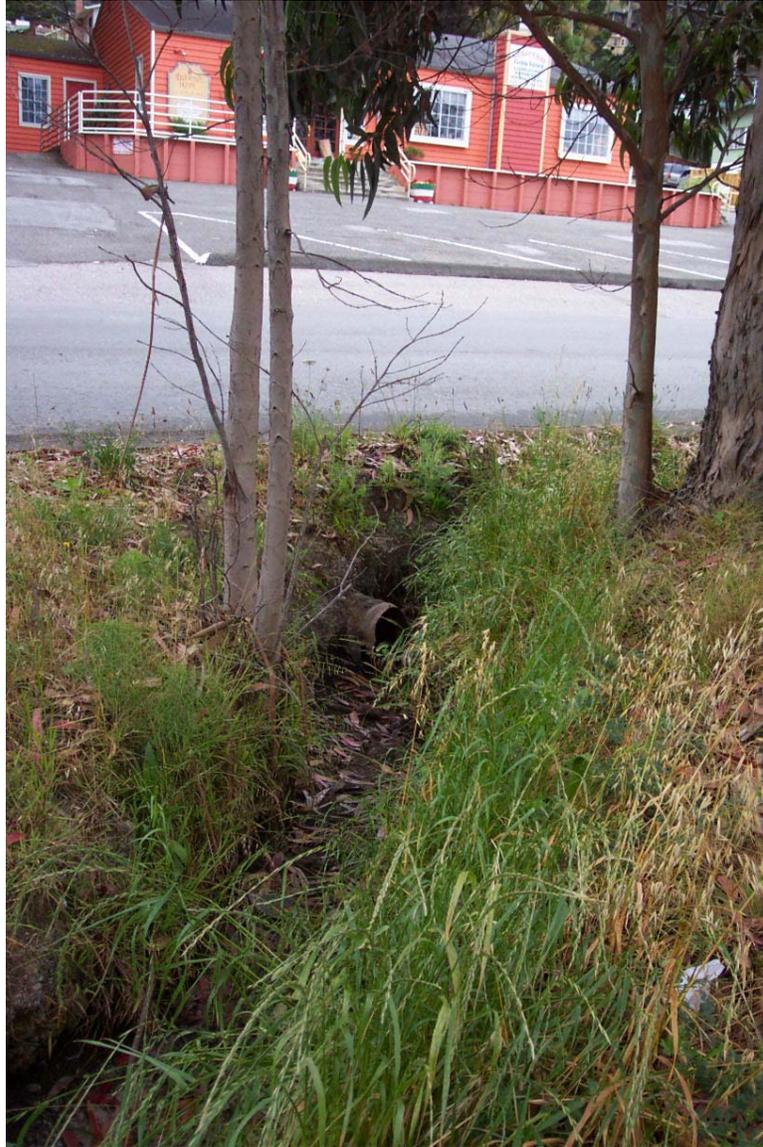
Figure 87: Channel incision from another culvert draining the urbanized hillside and accumulated flow from culvert at Point 2 on Figure 85.

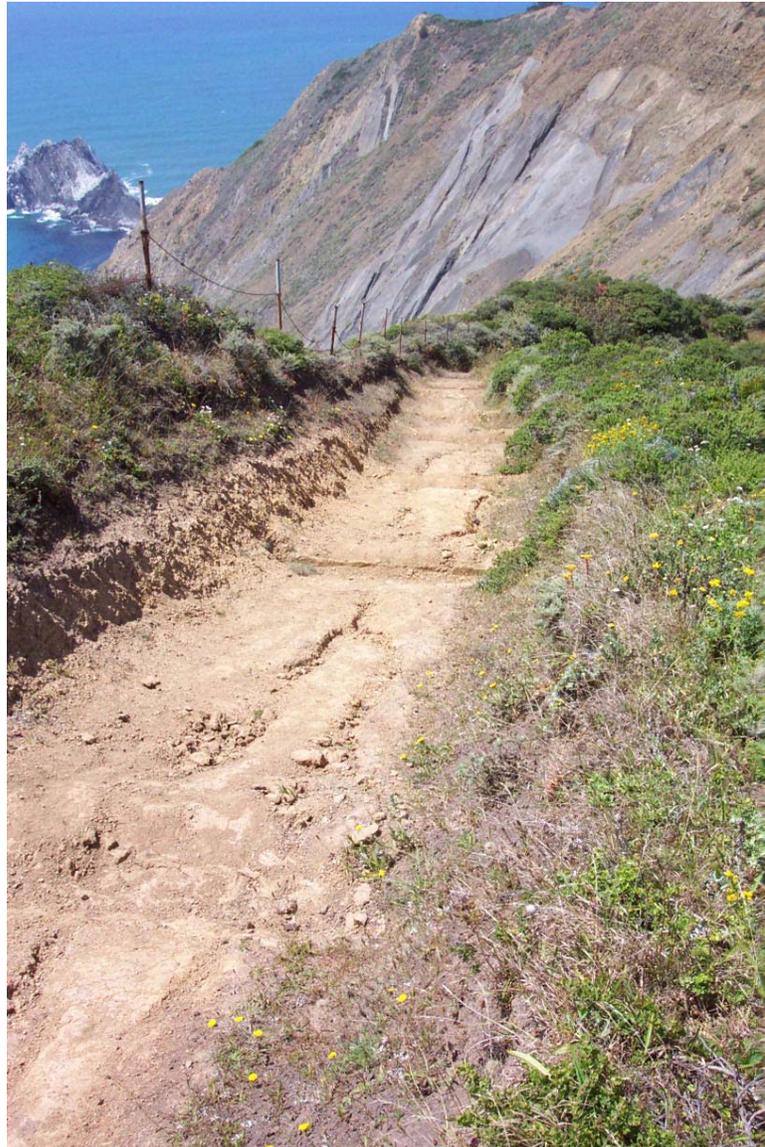
Figure 88: Severe surface erosion on trails that have not yet established connectivity in the upper Pedro Point I subwatershed. The impervious nature of these trails slows infiltration of rainfall increasing the speed of runoff similar to urban land cover.

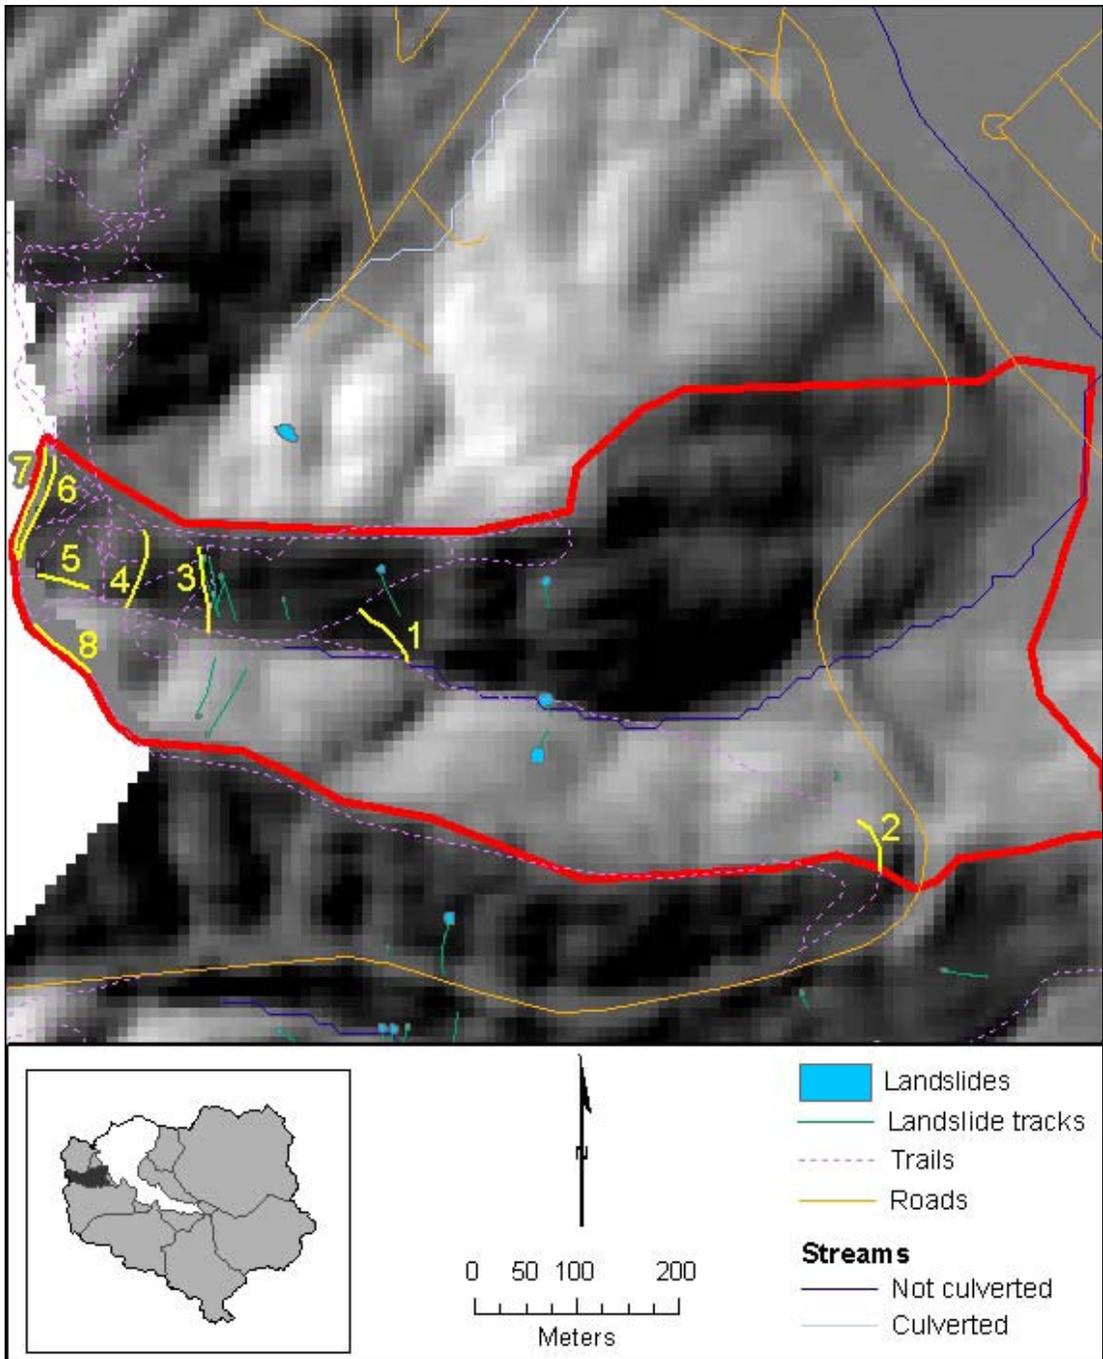
Figure 89: Pedro Point II subwatershed outlined in red indicating significant sediment sources in yellow. Also showing landslides with predicted connectivity.

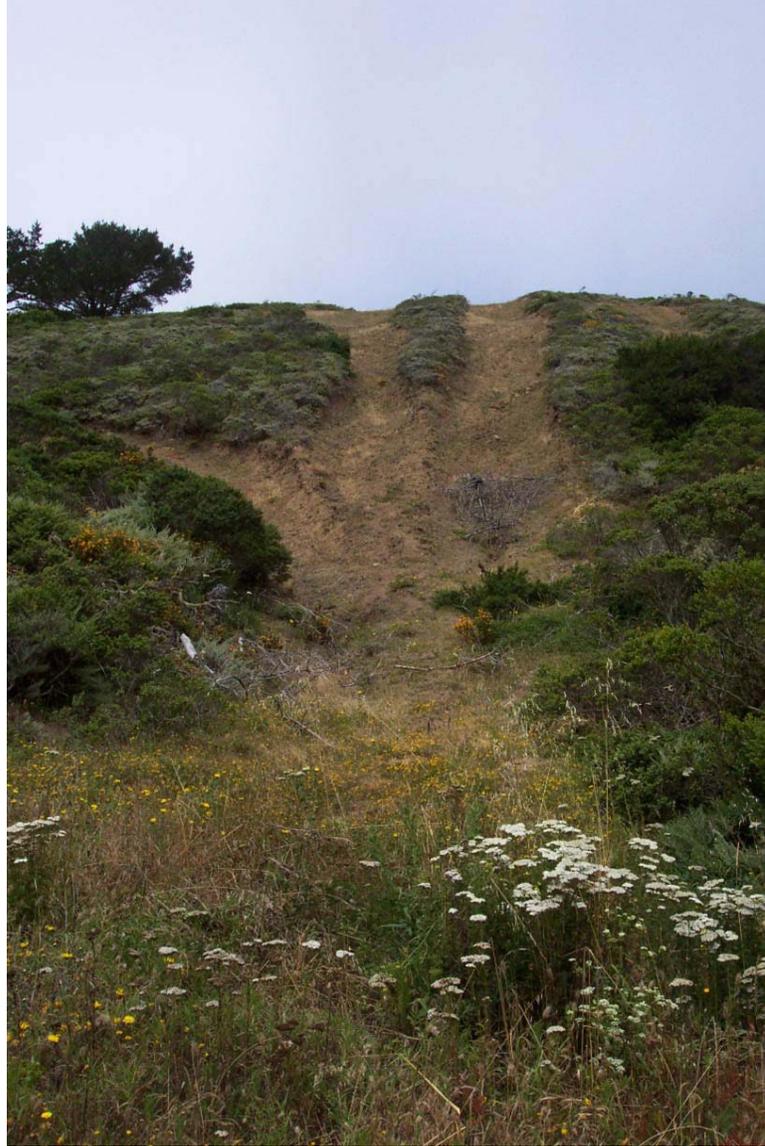
Figure 90: Surface erosion along former trails (line 3 in Figure 89). An estimated 150 m³ of sediment has been removed from this portion of the trail network.

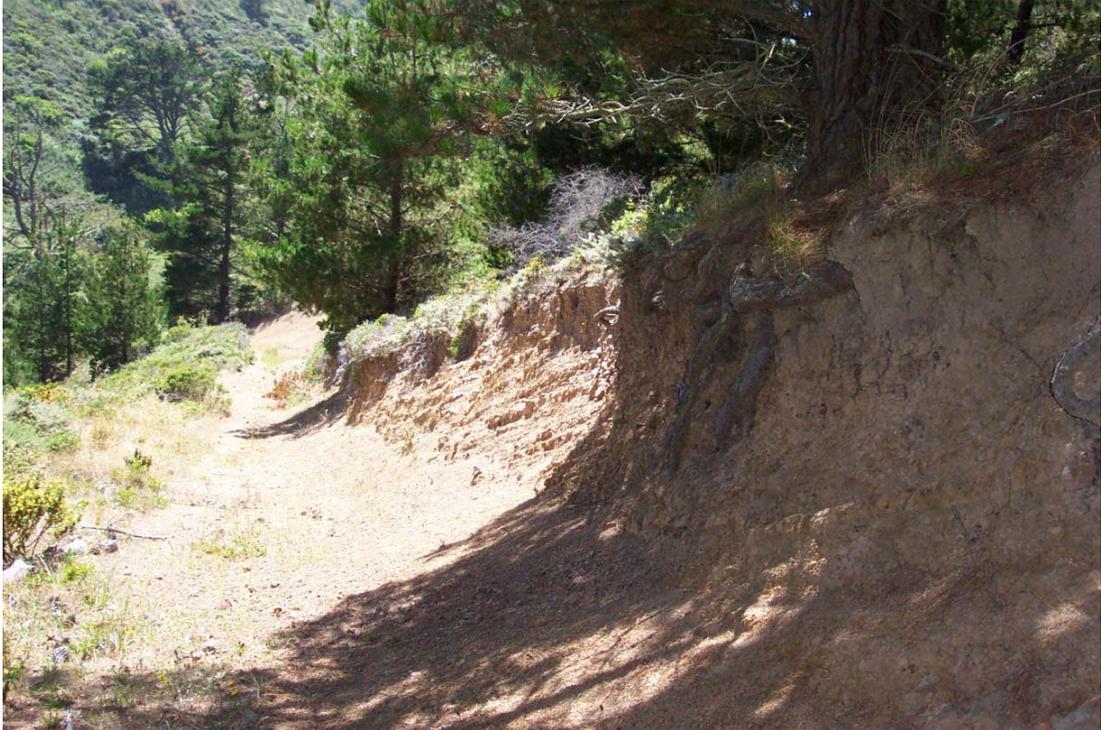
Figure 92: Erosion to bedrock exposing tree roots along upper trail cut. Upslope from eroded trail at line 1 on Figure 89 increasing the effective drainage where incision is initiated.

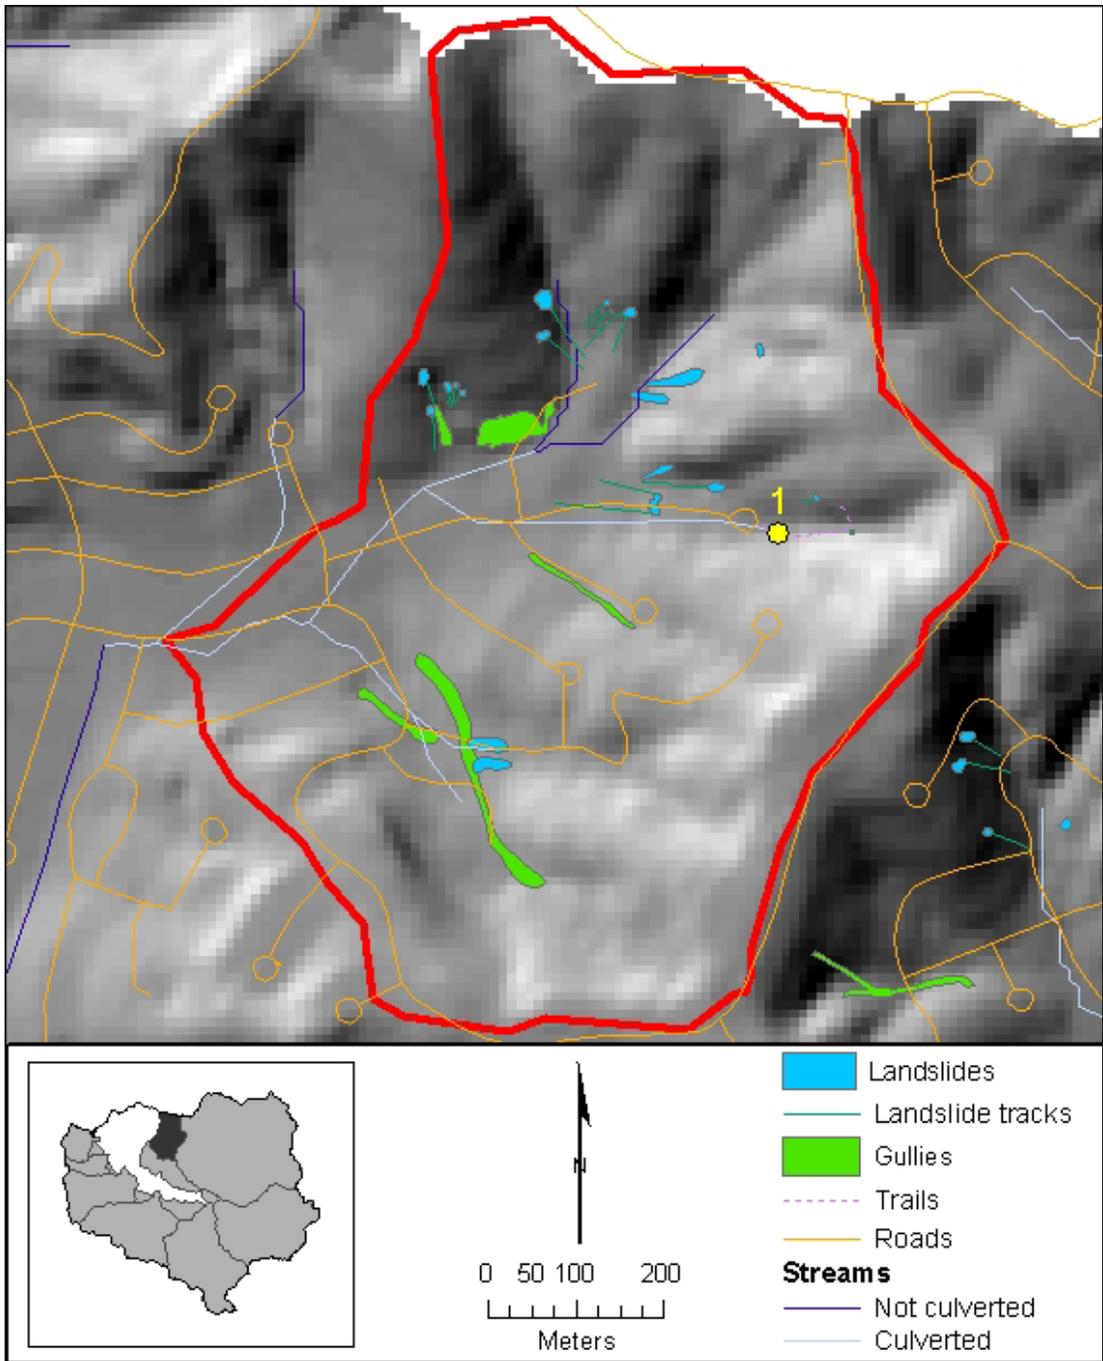
Figure 93: Crespi subwatershed outlined in red indicating significant sediment sources in yellow. Also showing landslides and gullies with predicted connectivity to the stream network.

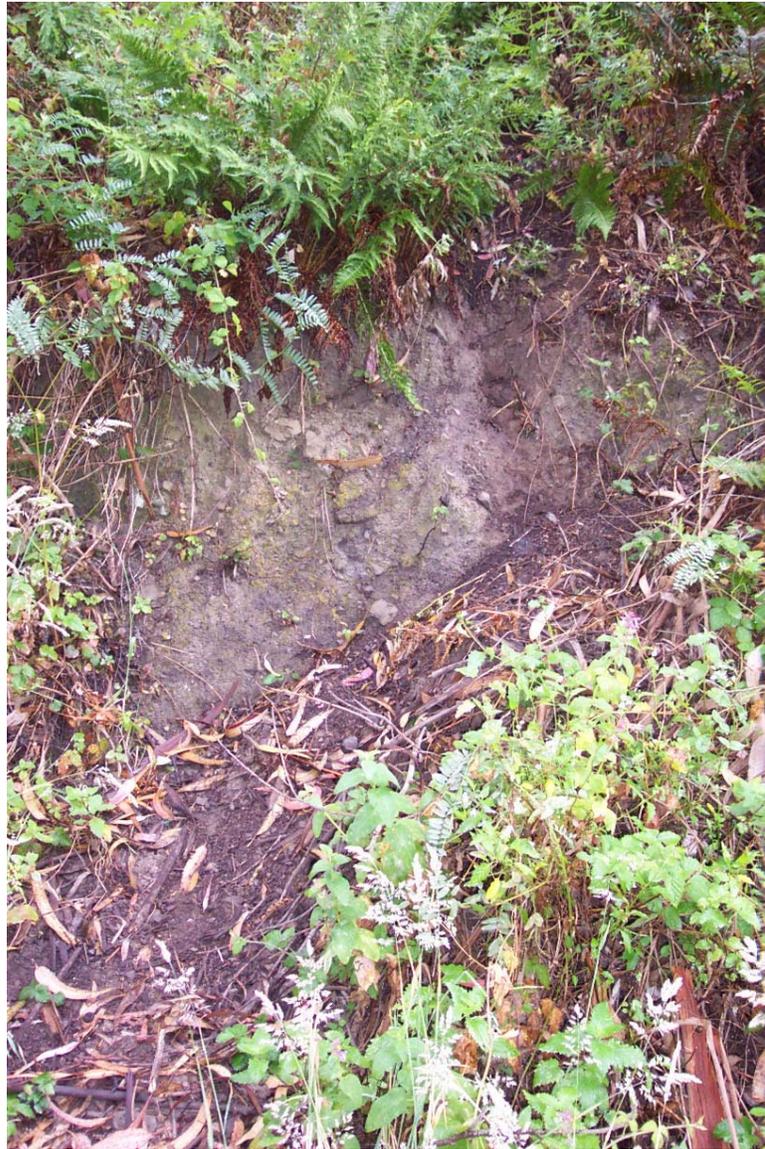
Figure 94: Surface erosion over unconsolidated material delivering sediment to the downslope trail and adjacent drainage (Point 1 on Figure 93).

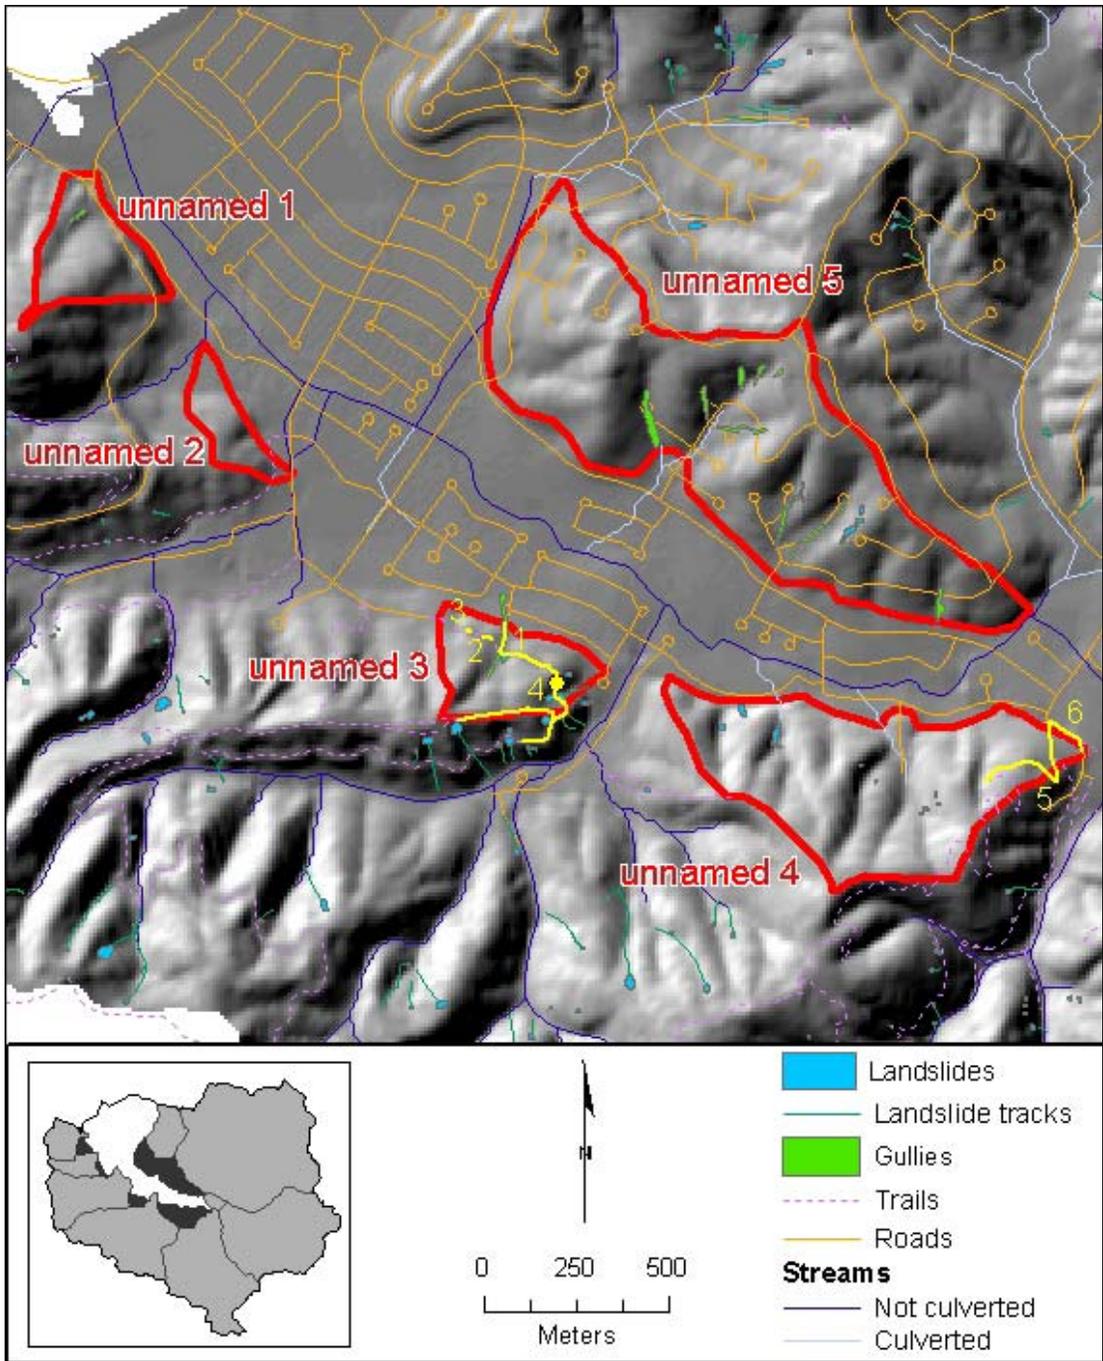
Figure 95: Unnamed subwatersheds outlined in red indicating significant sediment sources in yellow. Also showing landslides and gullies with predicted connectivity to the stream network.

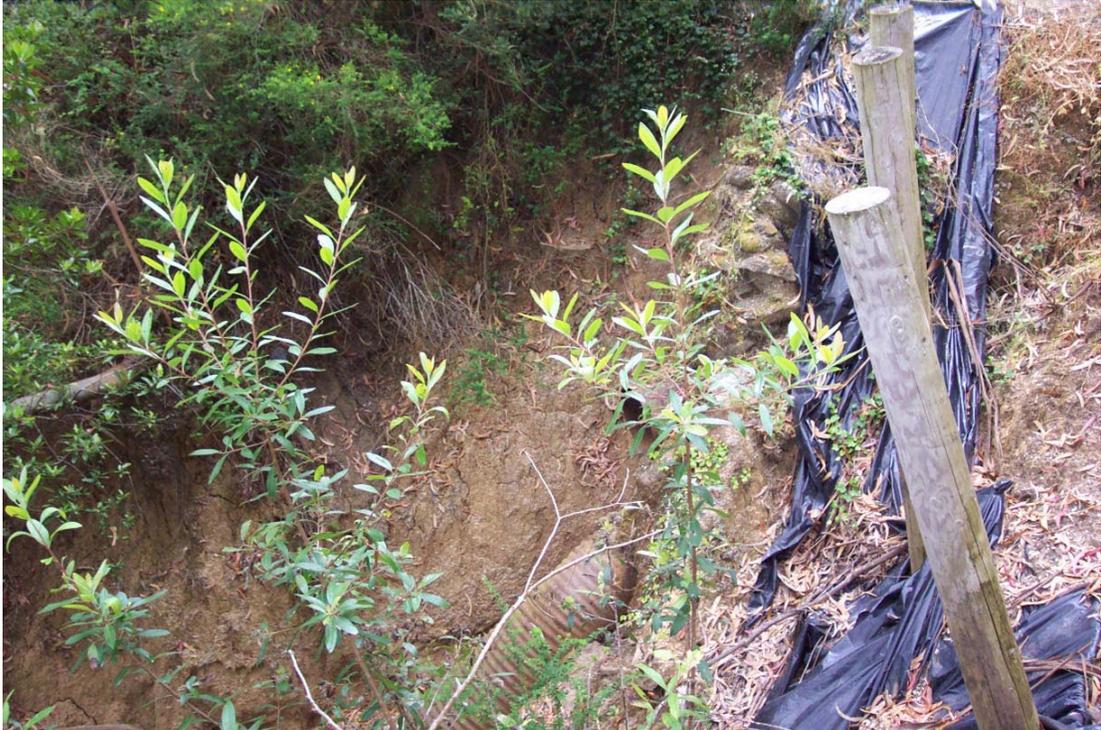
Figure 96b: Severe gully in drainage downslope of paved Coastside Boulevard. Same gully as shown in 96a taken 8 months later after one complete rainy season. Tarps have washed downslope and culvert has broken and moved partially downslope (Point 1 on Figure 95).

Figure 97: Convergence of flow from rutted upper trail and partially paved lower trail. Trails in Sanchez subwatershed draining to gully in unnamed 3 subwatershed contributing to the gully in Figure 96a & b.

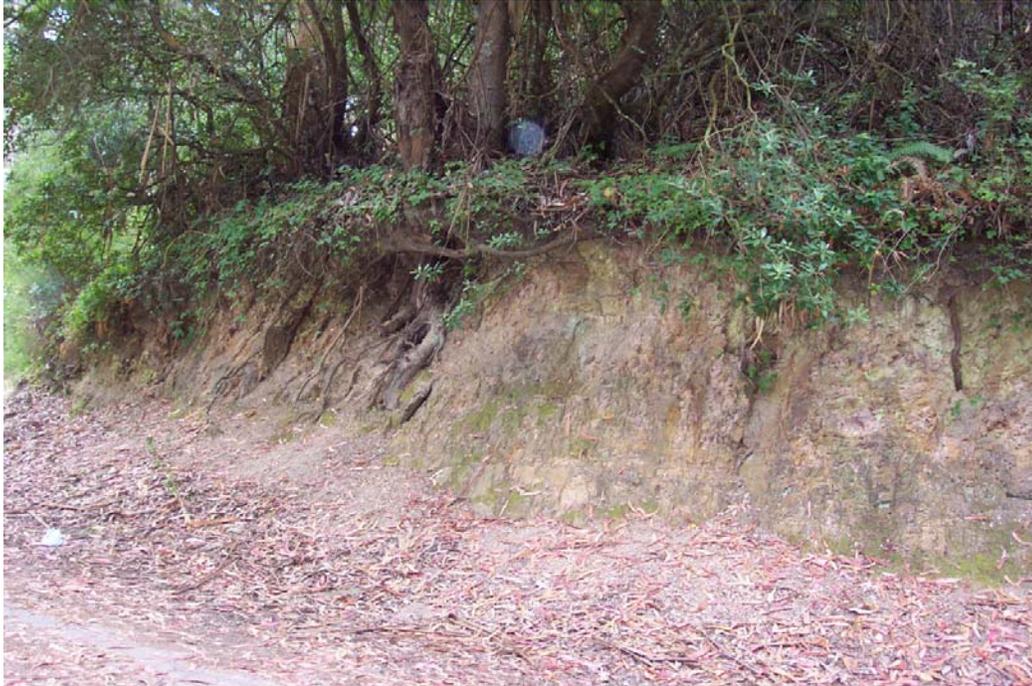
Figure 98: Undercut vegetation and exposed tree roots on upper trail cut along Coastside Boulevard (Point 2 on Figure 95).

The total amount of sediment connectivity from surface erosion for the unnamed subwatersheds is unknown. However, select stretches of significant erosion (lines 2, 3, and 6 in Figure 95; Figure 98) along trails, roads, and in gullies are estimated collectively at 80 m³. Line 5 in Figure 95 also acts as an ephemeral drainage generating sediment and effectively delivering it to the drainage network through a downslope culvert.

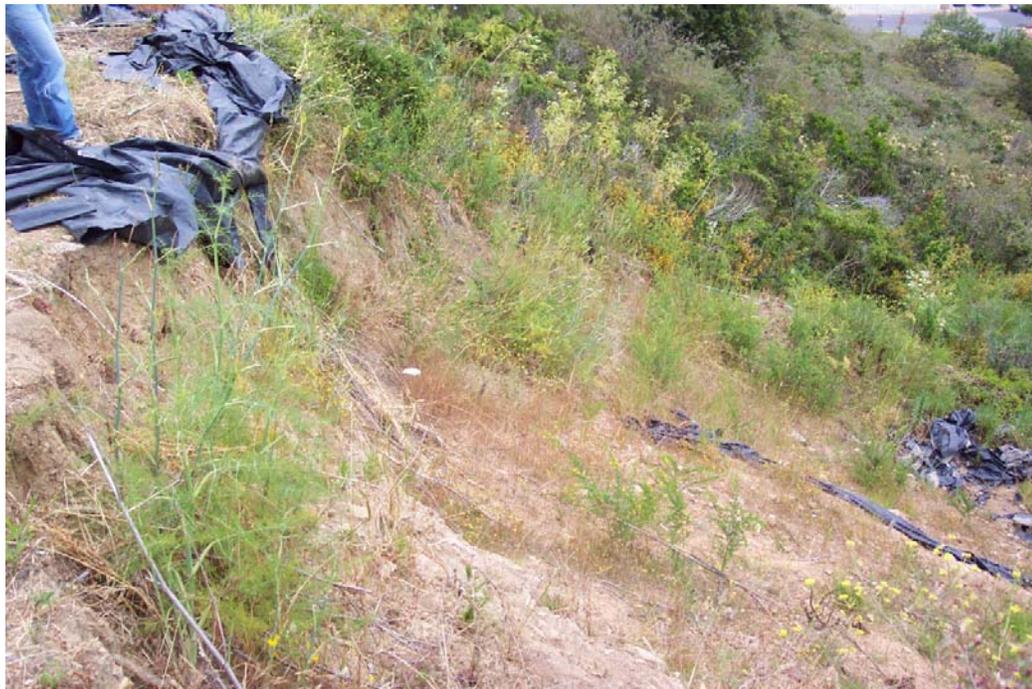
Figure 99: Erosion control tarps washed downslope of trail on landslide deposit. (Point 4 on Figure 95).

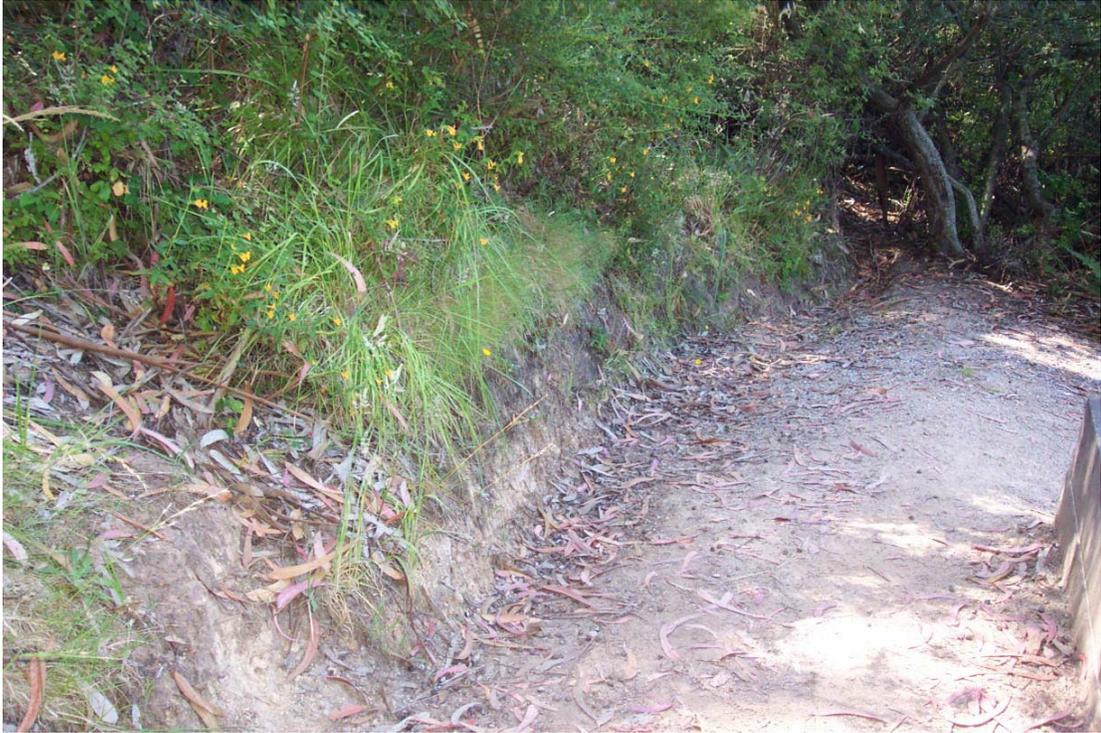
Figure 100: Ephemeral drainage from upslope switchbacks (line 5 in Figure 95).

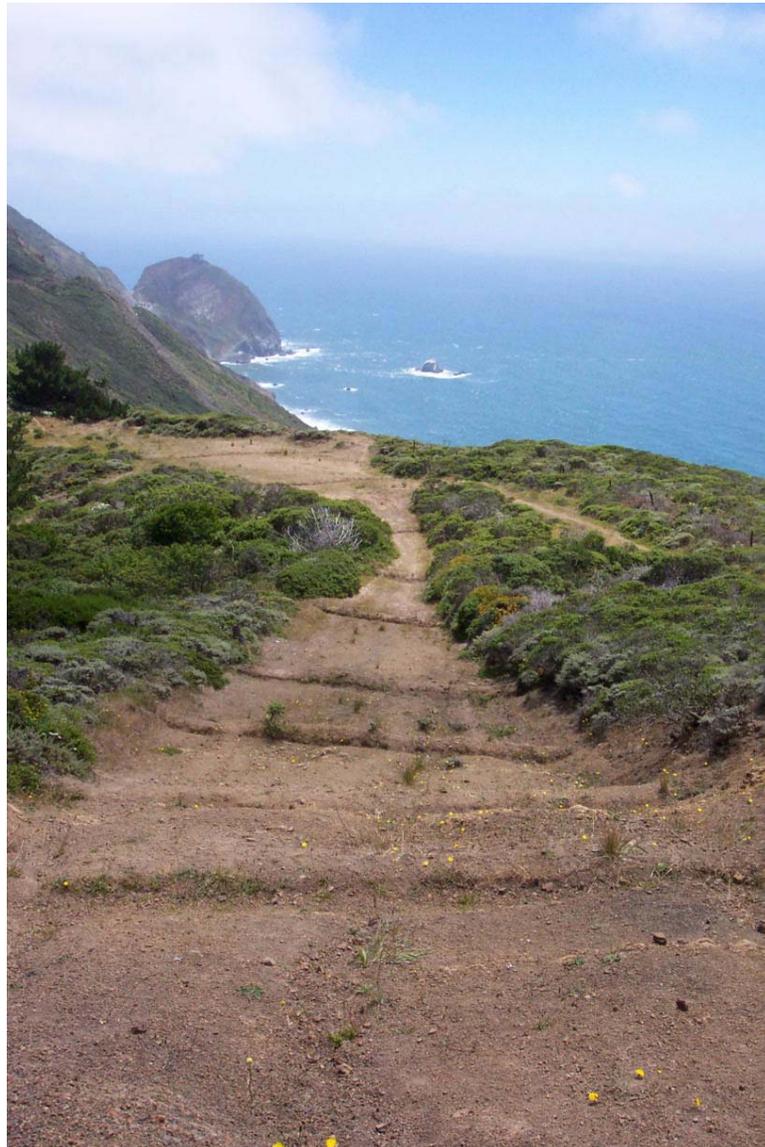
Figure 101: Existing and apparently effective sediment control measures implemented in Pedro Point II subwatershed.

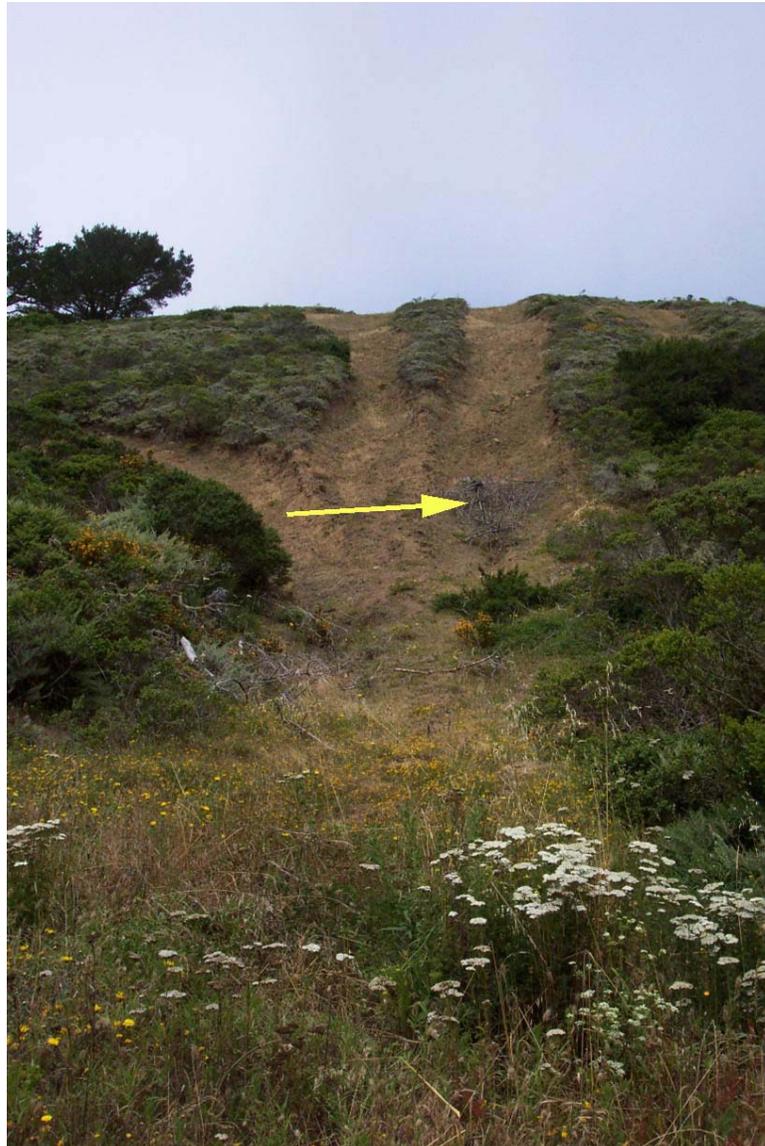
Figure 102: Tree and shrub cuttings (at arrow) placed along trail in an area with deep incision to reduce erosion and promote vegetation growth.

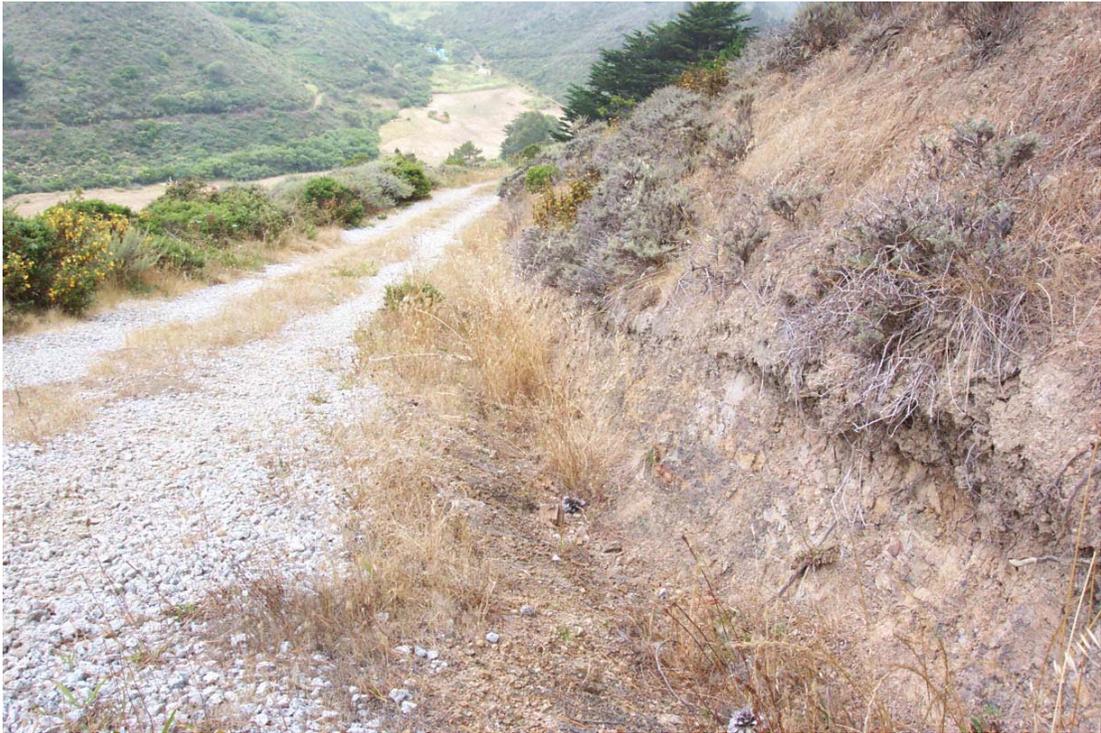
Figure 103: Large gravels spread onto the nearly impervious surface of the road. Over time the gravels will aerate the soils making the road more permeable to moisture.

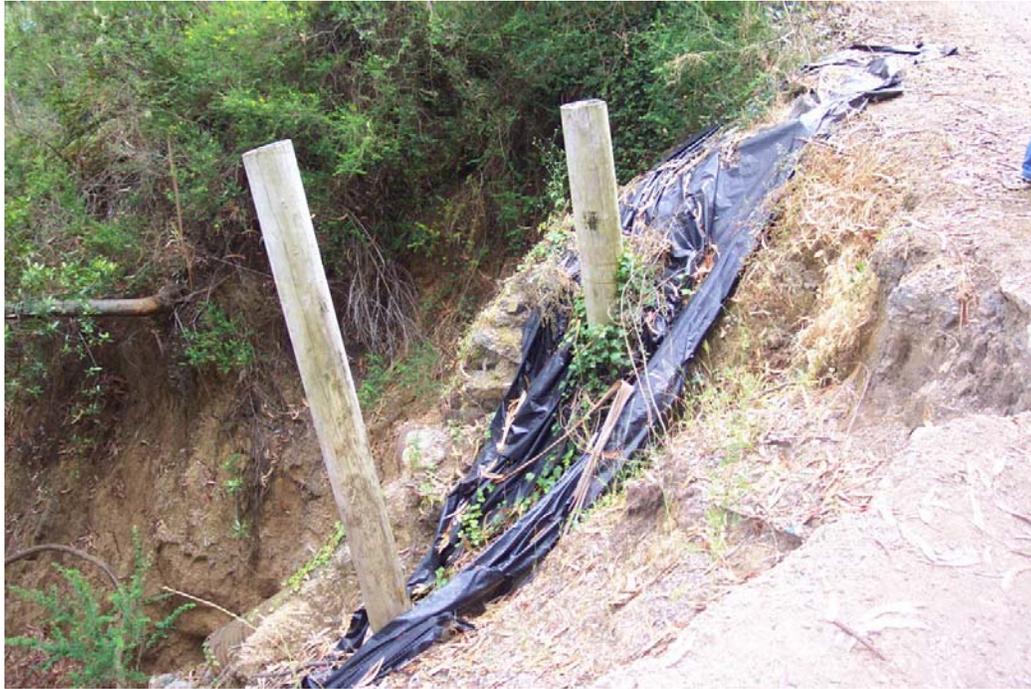
Figure 104: Ineffective erosion control structures. Tarps have washed downslope over the sandbags supporting the trail in just one rainy season.

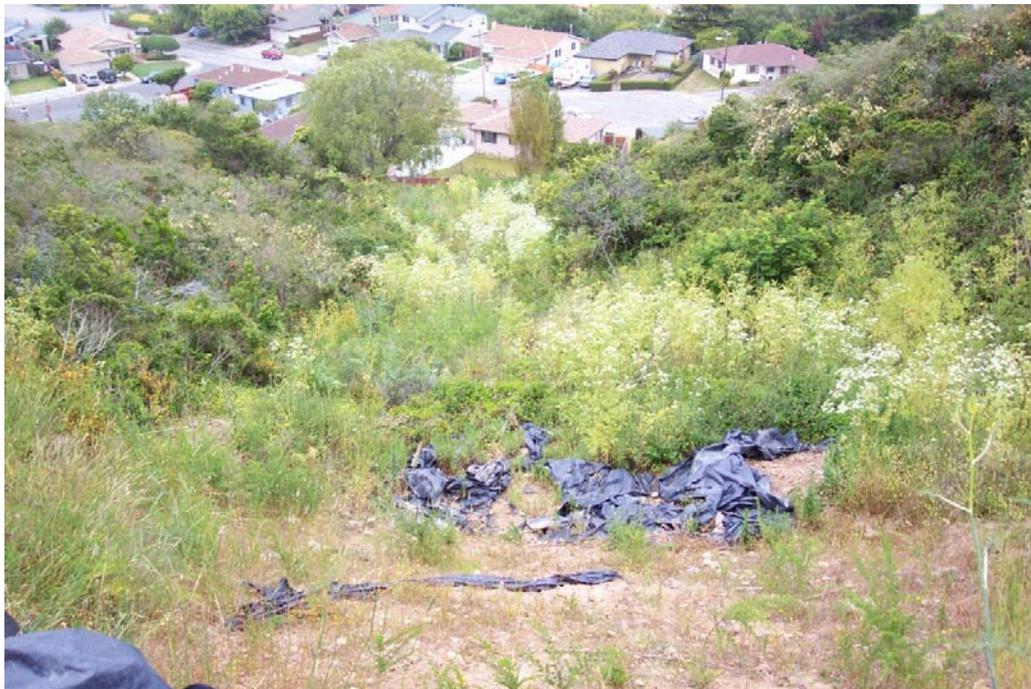
Figure 105: Tarps proving to be ineffective control measures have washed downslope of an area of an eroding area along the Coastside Boulevard.

Some of the simpler engineering structures already in place that have proven to be ineffective could be modified or removed. Tarps draped across problem areas to abate surface erosion prevent both evaporation of saturated soils and establishment of vegetation. In a few areas, these tarps have washed downslope and are now preventing new vegetation from growing where they have been displaced (Figures 104 & 105). The partially paved Coastside Boulevard (Figure 106) that was built in 1915 (VanderWerf 1994) concentrates runoff to a few sites on the lower slopes creating gullies. Erosion in one gully is so severe that sandbags, tarps, retention poles, and a failing culvert have been

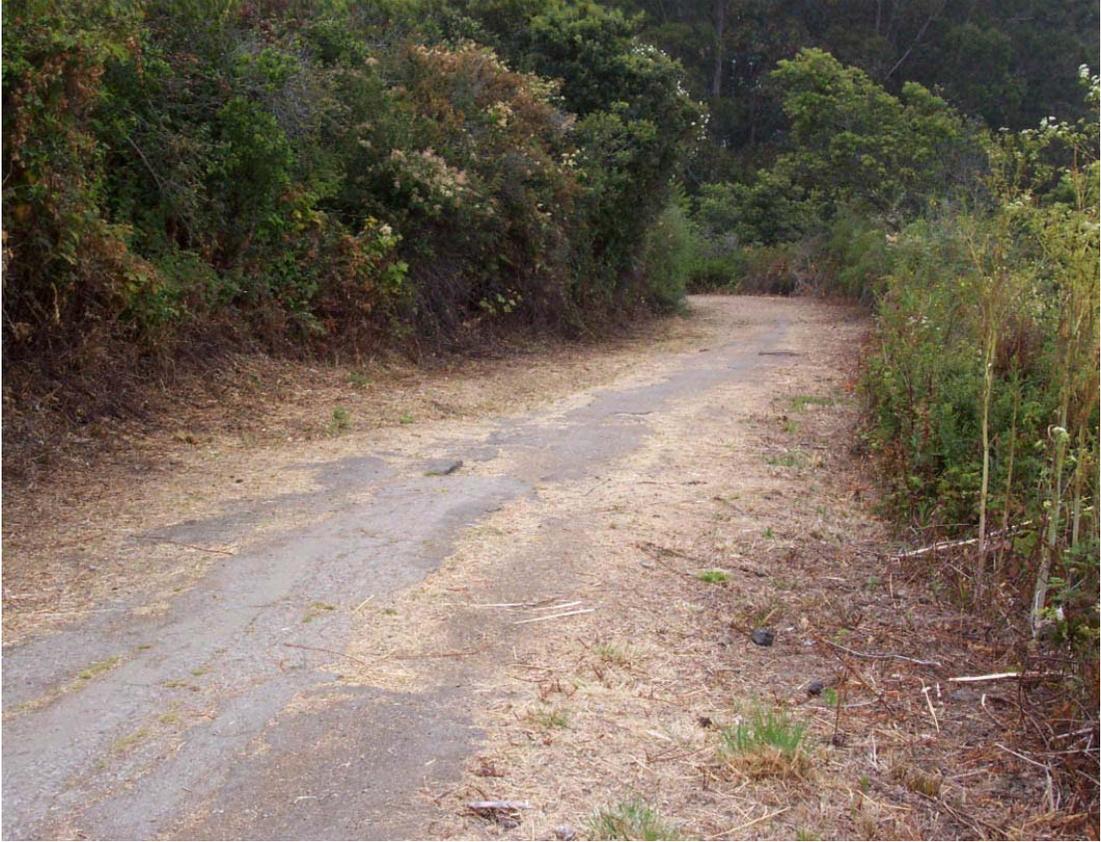
Figure 106: The partially paved surface of the Coastside Boulevard.

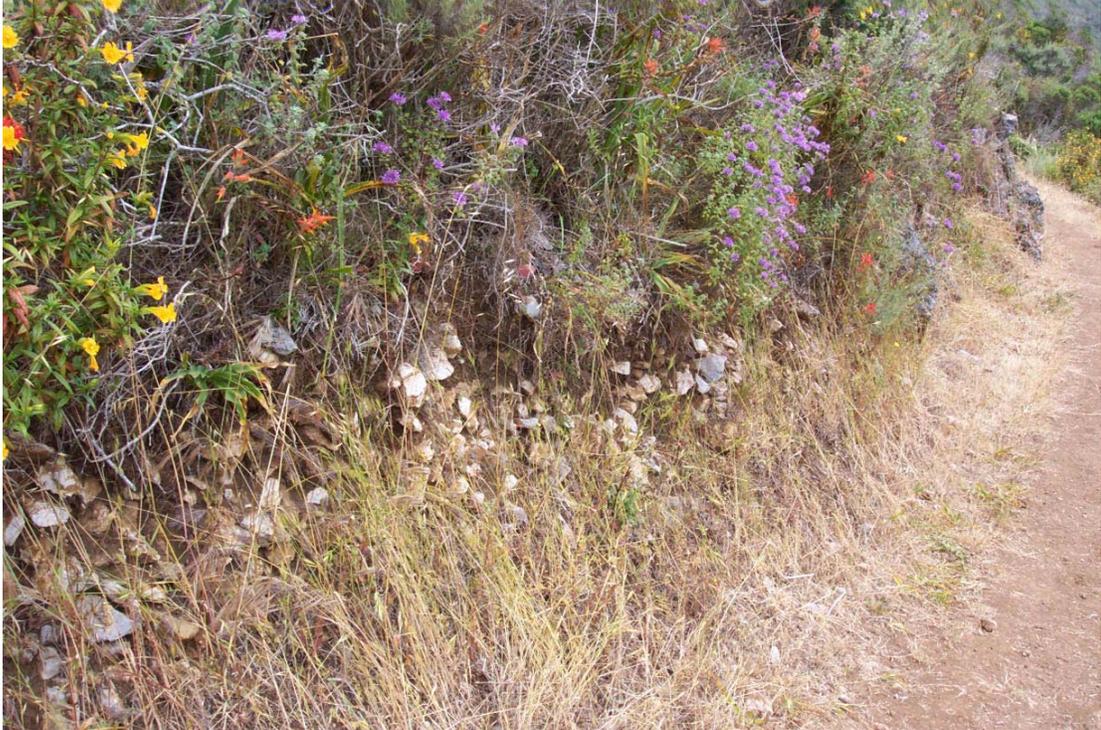
Figure 107: Unconsolidated landslide material along the upper hillslope of the Valley View Trail in the Middle subwatershed. Landslides were not observed on aerial photographs but evidence of occurrence was found in the field.
