ASSESSMENT OF A STEP-POOL URBAN STREAM RESTORATION:
SAN PEDRO CREEK, PACIFICA, CALIFORNIA

A thesis submitted to the faculty of
San Francisco State University
In partial fulfillment of
The requirements for
The degree

Master of Arts
In
Geography

Marilyn Hope Smulyan
San Francisco, California

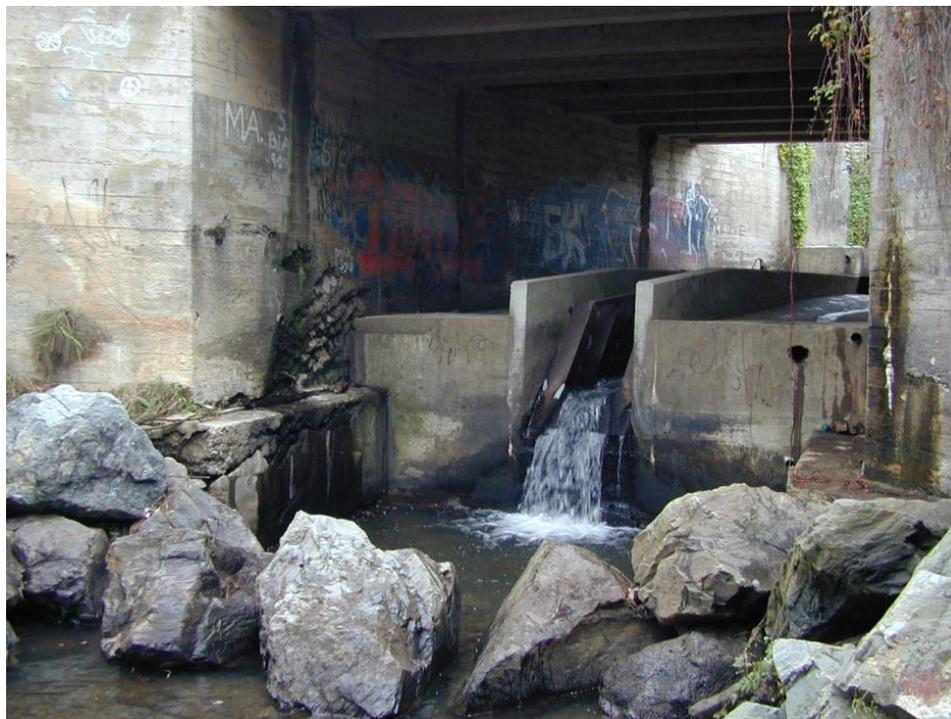
floodplain in parts of the creek (Collins et al. 2001). Incision also initiated at the Capistrano Bridge culvert (Davis et al. 2002). The concrete culvert acted like a knickpoint, an abrupt change in a stream profile formed by a more resistant surface which prevented the stream from eroding back. The first fish ladder was installed in 1965 and the second in the late 1980s (Lee 2003). By the late 1990s, overall incision had reached 5 m (15 ft), creating a 3.6 m (12 ft) jump from the creek to the culvert. The fish could no longer get up the ladder, creating a barrier to fish passage for threatened steelhead trout (Davis et al. 2002). Bridge incision, and related downstream bank failure, are evident in Photos 1 and 2. In 2001, NOAA Marine Fisheries issued a letter warning the City of Pacifica of a potential violation of the 4(d) rule of the US Endangered Species Act of 1973, as amended, and a temporary weir was installed to improve fish passage. The Capistrano Bridge was temporarily closed in 2002, and repairs were made to undercuts that were ~ 3 m (10 feet) deep on each side.

Photo 1: Capistrano Bridge Culvert and fish ladder 1999.
Photo courtesy of San Pedro Creek Watershed Coalition.

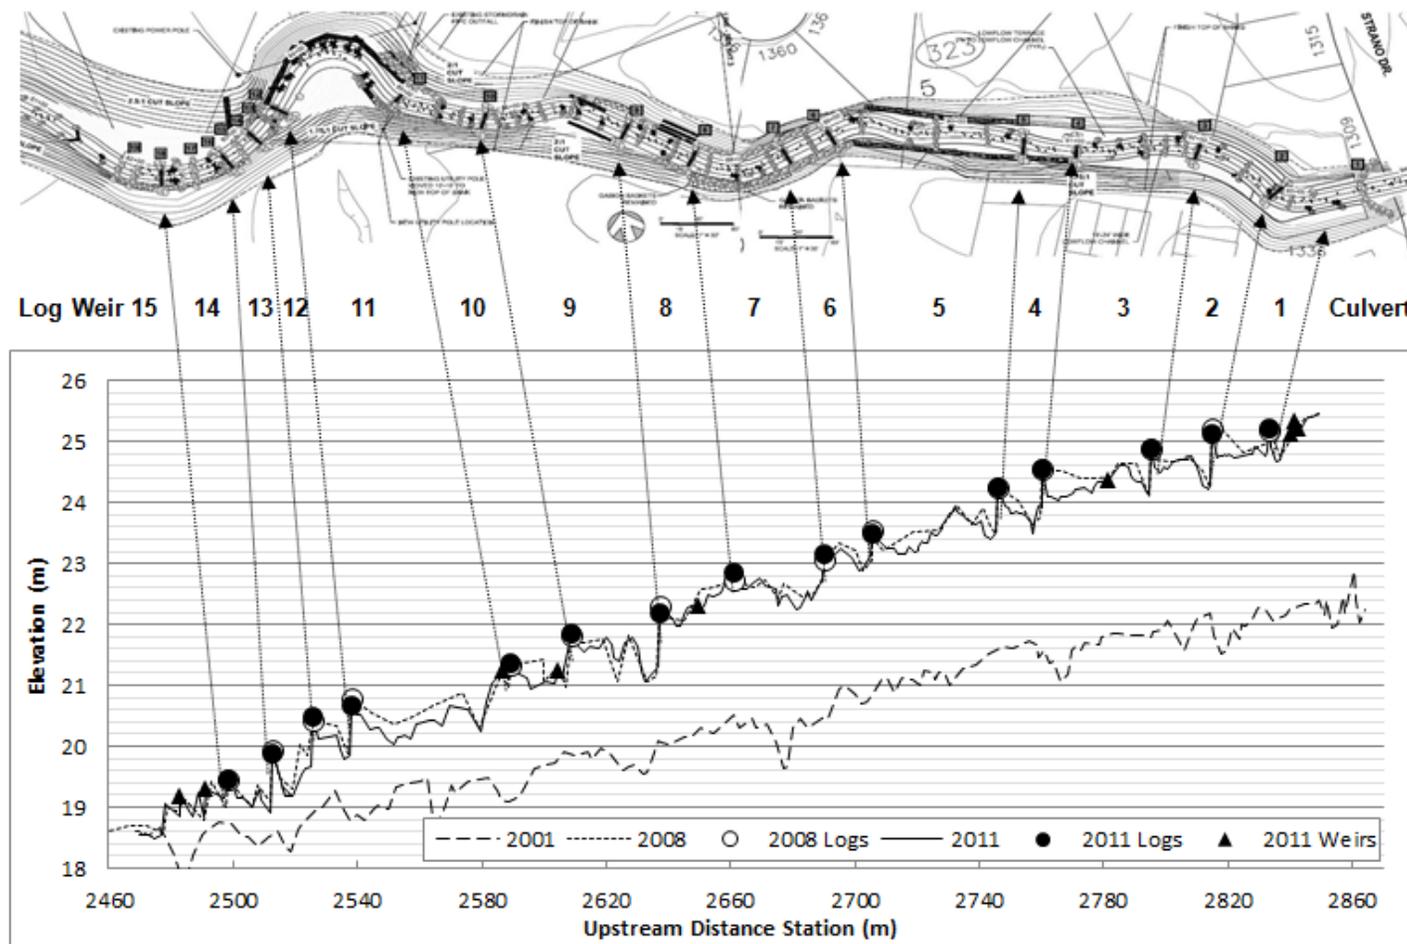
While the primary comparison data is from 2008 (Balance 2008), the as-built plans (Questa 2005c) and 2001 survey by Collins et al. are also referenced (Figure 6). The 2001 survey is relevant to the study question of potential impacts downstream and the as-built plans provide a frame of reference for understanding the restoration. However, not all of the features were as they appeared in the as-built plans. Most

notably, there was an extra log weir step, fewer rock weirs, and the V-shaped log weir shown at the downstream end of the restoration was not there. The anchors for the V-shaped weir failed during a storm on December 31, 2005, and the two logs were cabled to the right bank approximately 25 m (82 ft) downstream (Temple, January 30, 2012, pers. comm.). The storm, estimated at 950 f³/s (26.9 m³/s) (TRA and Balance 2008), is the largest to have occurred since the restoration. Some of the missing rock weirs may have also repositioned and spread out during the storm. Regarding the extra log step, the researcher was informed that it must have been unintentionally left out of the plans, because no logs have been added since the restoration (Temple, January 30, 2012, pers. comm.). A summary of key findings related to specific variables follows, after which the results are listed by location, referencing log weir numbers and distance stations.

Figure 6: Restoration Reach longitudinal profiles 2001, 2008, and 2011 in relation to as-built plans. 2001 data source Davis et al. (2002). 2008 data source Balance Hydrologics. Diagram created using partial as-built drawing courtesy of Questa E.C.

The longitudinal profile suggests (Figure 6), and interpolated data from the two matched datasets (Figure 7) confirms that, while aggradation occurred in some places within the reach, degradation has occurred throughout most of it. When the data was interpolated, 21 of the 79 matched points required crossing steps to calculate the interpolation so they were rejected. Therefore, the results are slightly more reflective of areas further away from the steps than close to them. The mean elevation change between 2008 and 2011 was -8.5 cm (-0.28 ft) with an average annual rate of change of -2.8 cm (-0.9 ft). According to the survey data, the most degradation occurred in two pools, both located immediately above log steps; -40 cm (-1.3 ft) above Log Weir 4 and -30 cm (-1.0 ft) above Log Weir 2. Correlation between elevation change and distance station was tested and rejected using Spearman's test. The correlation coefficient was 0.008 and the single-tailed p-value of 0.478 was greater than 0.05; therefore, it is not significant at a 95% confidence level.

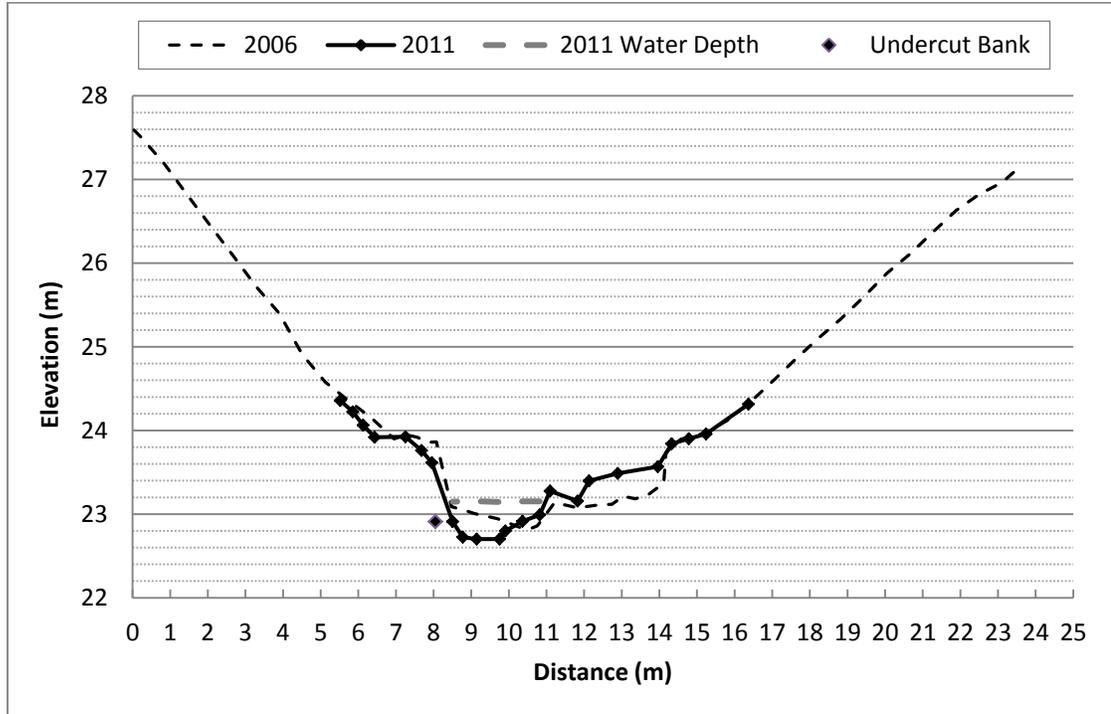
The cross-section (Figure 8) was surveyed in a straight, riffle reach at approximately 2595 m (8514 ft) between Log Weirs 10 and 11, where the channel bed consists of sand and gravels. It indicated aggradation averaging 20 cm (0.7 ft) on the right bank, degradation in most of the channel, and an undercut in the left bank of 45.7cm (1.5ft). These changes could be due to a minor perturbation, or the undercut could be a sign of lateral widening caused by the increase in stream power from the steeper slope and relatively steep bank. The comparison data for the cross-section is from 2006, two years earlier than that used in the longitudinal profile.

Figure 8: Restoration Reach cross-section 2006-2011. 2006 data source Crowley (2006).

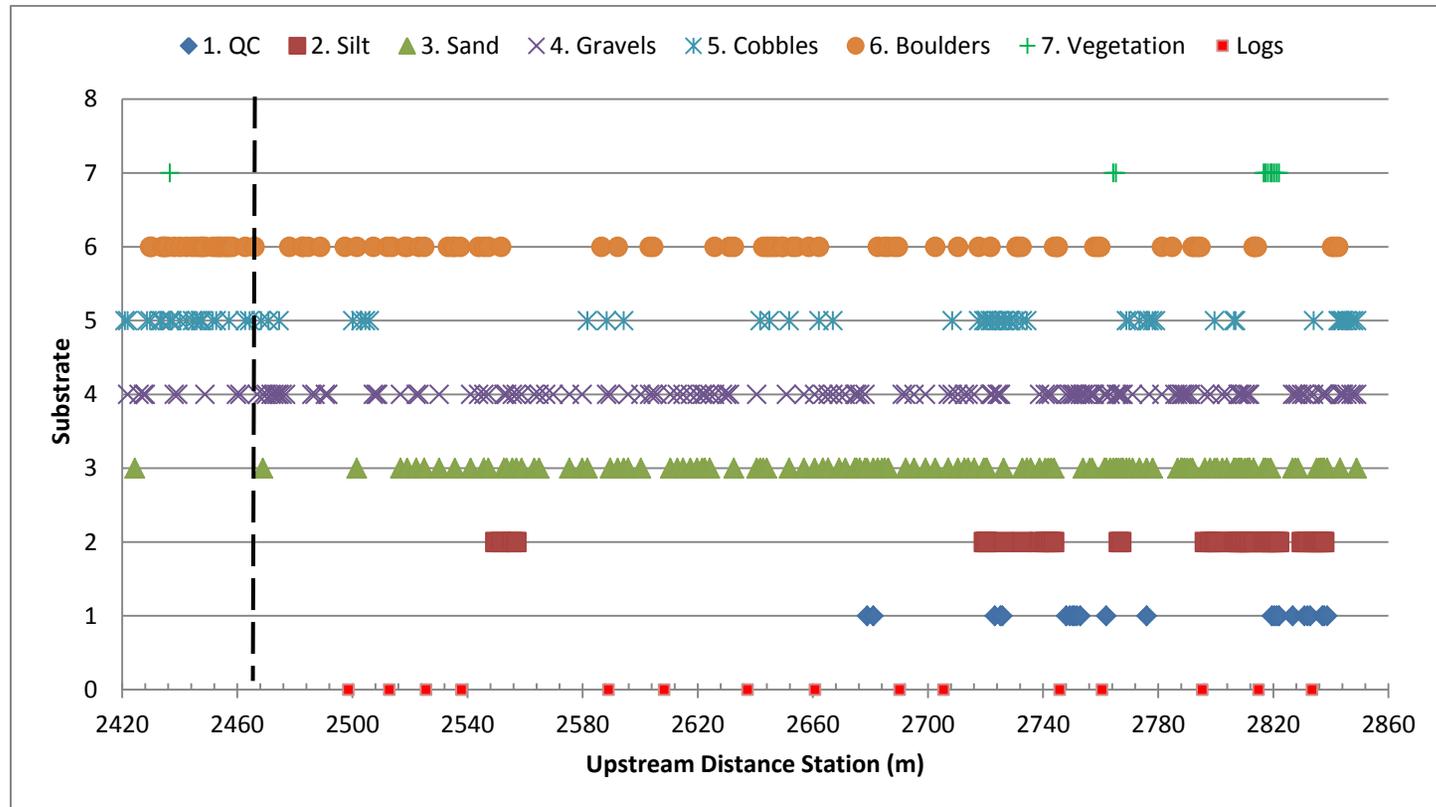
Figure 9 shows the distribution of substrate for the Restoration and Downstream reaches. There was no comparison data from 2008. In 2011, the distribution of boulders increased downstream. This is in contrast to the substrate found before the restoration. Prior to the restoration, the Restoration Reach was considered a pool-riffle reach, which is typically made up of gravels. Gravels were the dominant substrate (39%) found in the 1999 survey (Collins et al. 2001), and no boulders were identified at that time. The presence of boulders in 2011 is likely due to the large amount of rock that was added to the channel bed to create surface roughness (Photo 4, p. 15). Additionally, the December 31, 2005 storm likely moved some of the rock, as well as some of the rock weir material, downstream. Cobbles, which were also absent in the 1999 survey, occurred in clusters, with more in the upper third of the reach. Gravels were generally distributed throughout, but they decreased downstream. Although not shown on the substrate survey, a large gravel bar has developed inside the Capistrano Bridge Culvert indicating greater sediment supply than transport capacity at this location. Sand was found in most of the reach except at the lower end, beginning near Log 14. Most silt and Quaternary clay was found in the upper third of the reach.

Figure 9: Distribution of substrate in the Downstream and Restoration reaches. The dashed line separates the two reaches; red markers on the bottom indicate log weir locations.

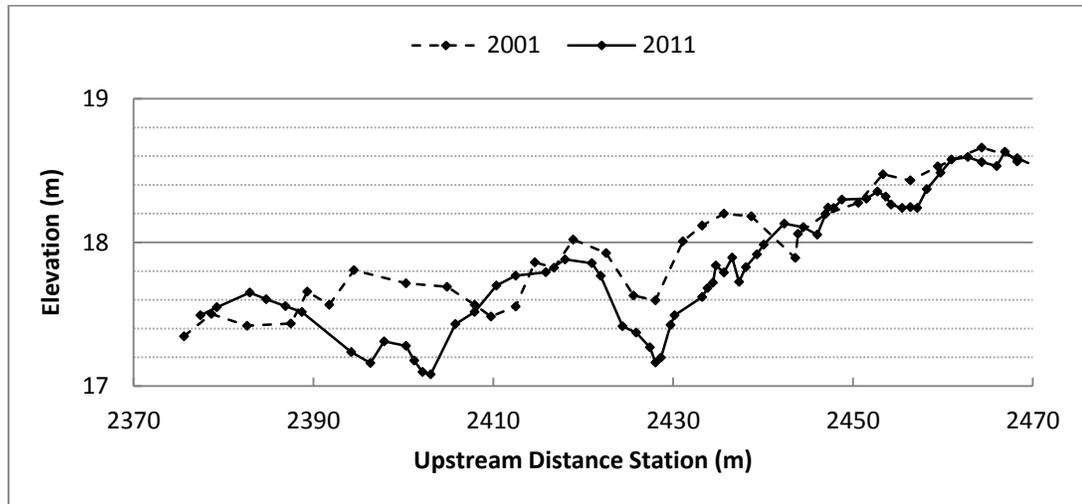
The longitudinal profile (Figure 10) suggests, and interpolated data from the two matched datasets (Figure 11) confirm, degradation throughout most of the reach. The mean elevation change over the ten year period was -15.6cm (-0.51 ft) or -1.55 cm (-.05 ft) per year. The highest amount of degradation occurred in a downstream pool located approximately 6 m (19.6 ft) downstream from a 30.48 cm (1 ft) culvert that comes in on the left bank. Correlation between elevation change and distance station was tested and rejected using Spearman's test. The correlation coefficient was 0.437 and the single-tailed p-value of 0.062 was greater than 0.05; therefore, it is not significant at a 95% confidence level. Four distinct pools were identified, separated by three riffle areas and a riffle/step area upstream. The areas with the most aggradation were two riffle areas; one above and the other below the area of deepest degradation. An approximate 7 m (23 ft) long area of recent erosion was identified on the right bank, immediately below the area where the two logs from the restoration area were cabled to

right bank trees in 2006. Collins' geomorphic analysis (2001) did not indicate any erosion at this site. Table 11 summarizes results by location.

Figure 10: Downstream Reach longitudinal profiles 2001-2011. 2001 source (Davis et al. 2002).

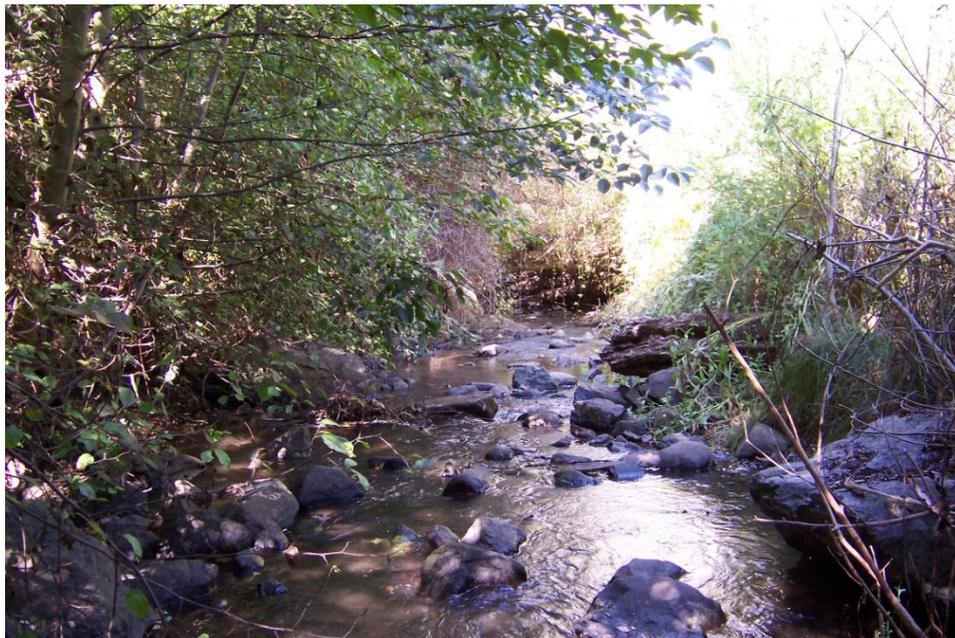
In 2011, substrate data was not collected in the lowest 40 m (131 ft) of the reach, so the comparison is limited to the upper 52 m (170.6 ft). In addition, different methods were used to characterize substrate in the two surveys. In 1999, Collins et al. (2001) made visual median diameter (D50) estimates for the entire channel, whereas the method used in 2011 was based on a visual estimate of the substrate surrounding each point. In 1999, a majority of sediment was sand and gravels (58%), while in 2011 75% was cobbles and boulders (Table 12). The difference between boulders was large, with 4% in 1999 and 41% in 2011. It seems likely that this material has been recruited from the Restoration Reach, given the large number of boulders placed during the restoration and the current distribution of substrate which shows the percentage of boulders increasing downstream (Figure 9 p. 54). Additionally, the higher gradient of the restoration area, especially at the lower end, provides the transport capacity to move larger material into the Downstream Reach. However, once there, the lower gradient

lacks the transport capacity to keep moving it downstream so it is dropping out. Photo 10 shows the Downstream Reach at ~2438 m where boulders are present.

Photo 10: Downstream Reach at ~ 2438 m.

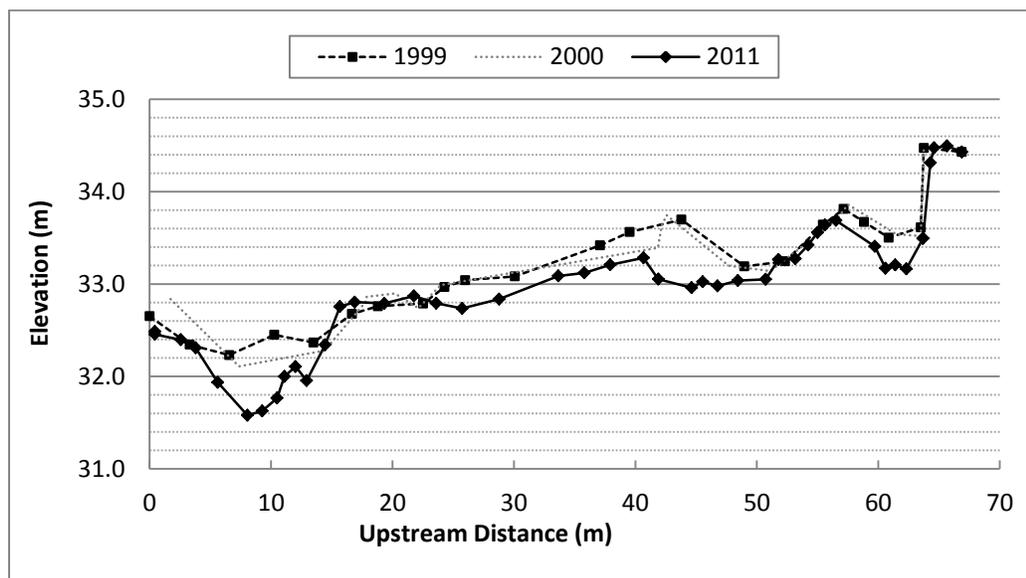
The longitudinal thalweg profile indicates (Figure 12), and the estimate of elevation change as determined by interpolated data from the two matched datasets confirms (Figure 13), a pattern of continuing degradation throughout most of the reach. The mean elevation change was -19.6 cm (-0.6 ft) over the past 12 years with an annual rate of change of -1.6 cm (-0.5 ft).

Figure 12: North Fork Reach longitudinal thalweg profiles 1999-2011. 1999 data source Amato (2003).

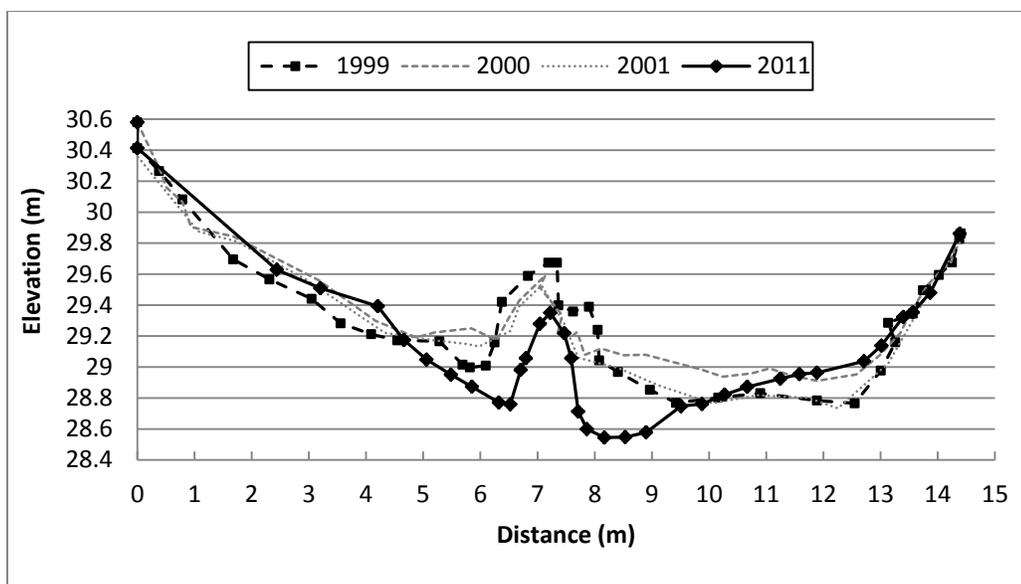
The cross-section (Figure 14) was surveyed at the confluence of the North Fork and the Middle Fork of San Pedro Creek. Facing downstream, it began on the left bank, crossed the Middle Fork, went over the end of the peninsula that separates the two tributaries, and then crossed the deeper North Fork before it reached the right bank. It too mostly showed degradation, with -33 cm (-1.1 ft) vertical degradation on top of the peninsula and -45 cm (-1.5 ft) degradation in the North Fork channel bed. Aggradation occurred 24 cm (0.8ft) from water's edge to right bank. This area was densely vegetated and most likely affected by a small island that was immediately downstream.

Figure 14: North Fork Reach cross-section 1999-2011.
1999-2001 data source Amato (2003).
